**MAIN STREET BRIDGE FEASIBILITY
FHWA NO. 001820**

**RE: FEASIBILITY STUDY
MAIN STREET BRIDGE IN CHARLES CITY
OVER CEDAR RIVER
FHWA No. 001820
CB&A No. 2022192**

STRUCTURE CONDITION REPORT
BRIDGE (001820), DAM, FLUME AND
FLOUR MILL FOUNDATION
MAIN STREET over CEDAR RIVER

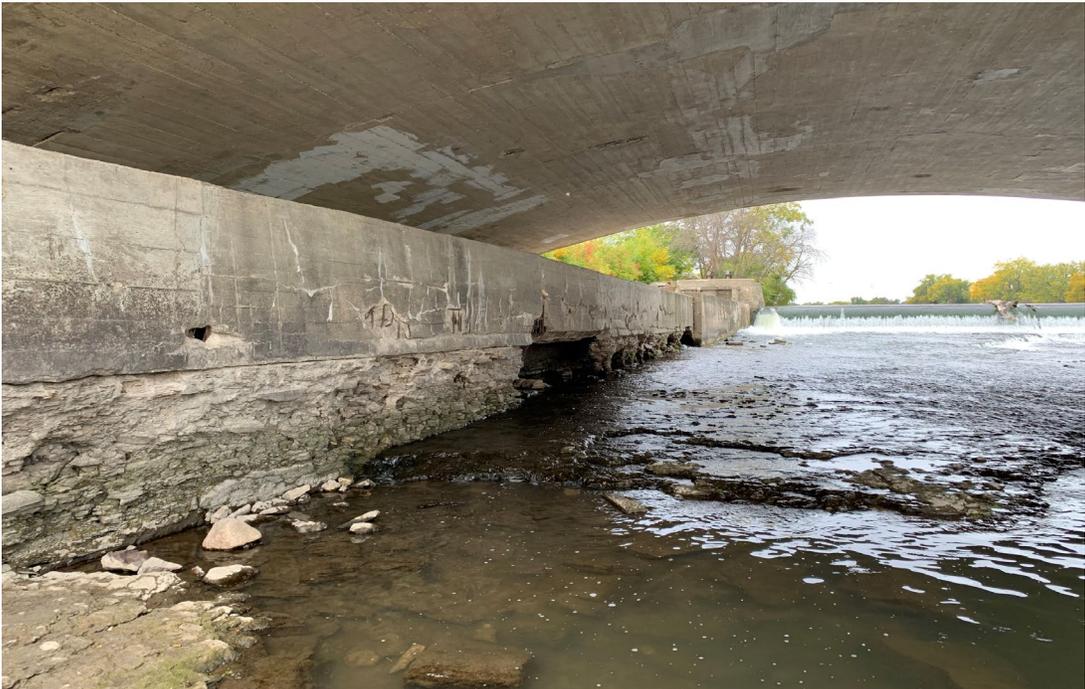
UNDERMINED OUTLET OF SOUTH BANK FLUME

**LOOKING SOUTHWEST, HIGHLY DETERIORATED FLUME WITH SUPPORTING
BEDROCK PARTIALLY MISSING**

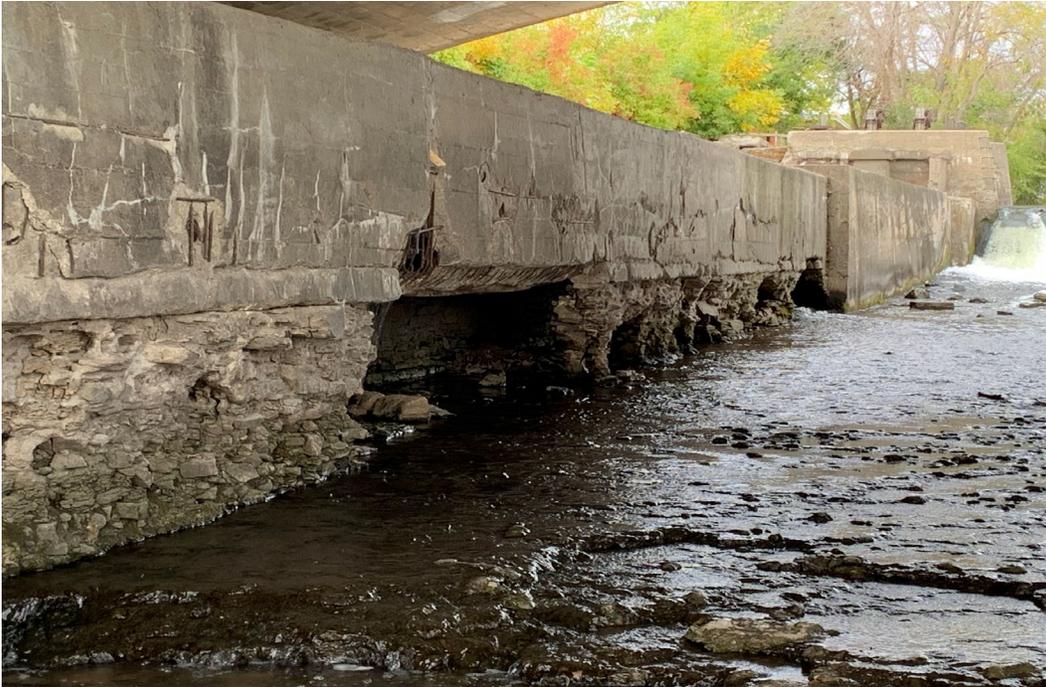
LOOKING SOUTHWEST, HIGHLY DETERMINED FLUME WITH SUPPORTING
BEDROCK PARTIALLY MISSING WITH WATER FLOWING FROM UNDER FLUME

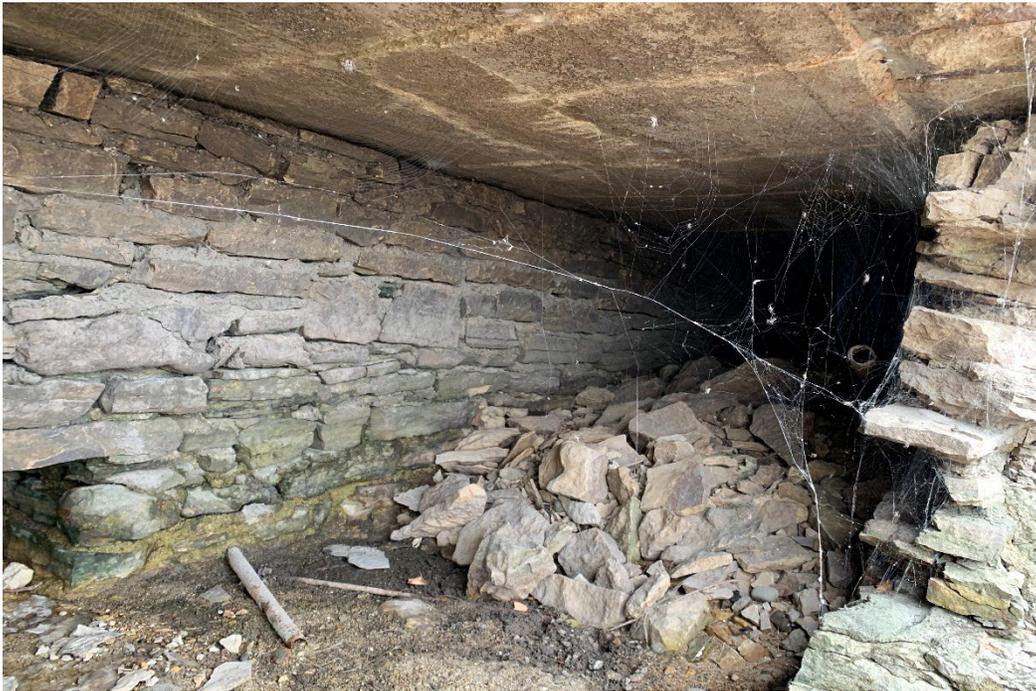
LOOKING UNDER FLUME

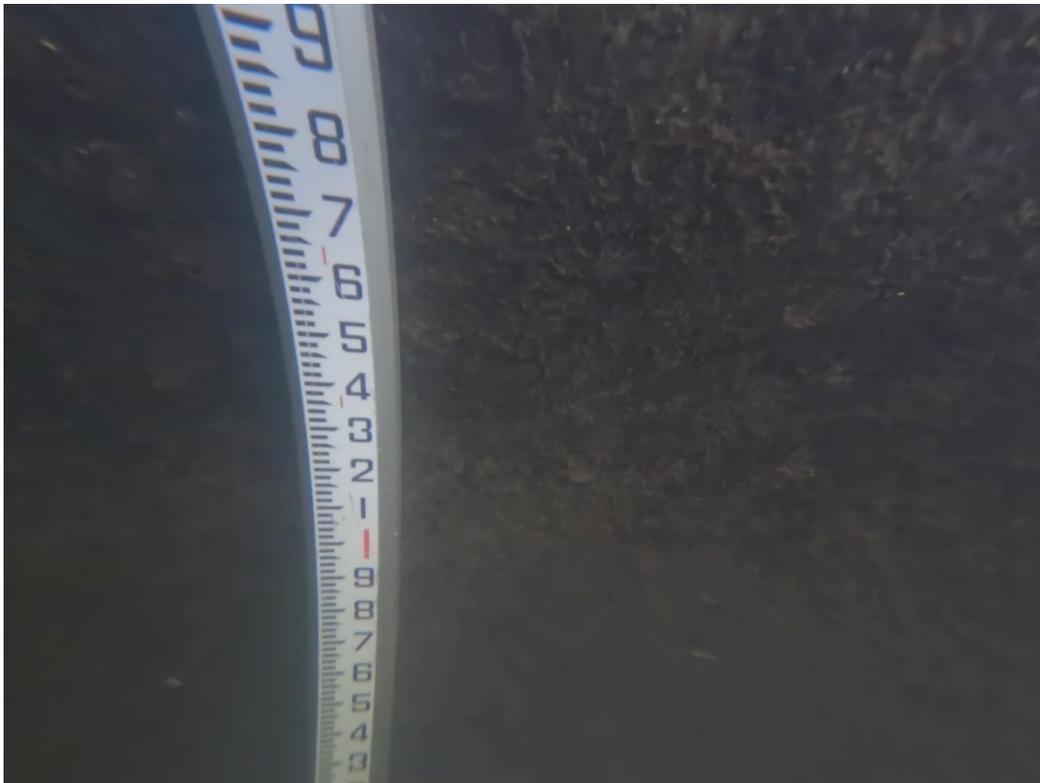
PHOTO 25. SOUTH PIER FOOTING TYPICAL CONCRETE CONDITION BELOW WATER LOOKING NORTH

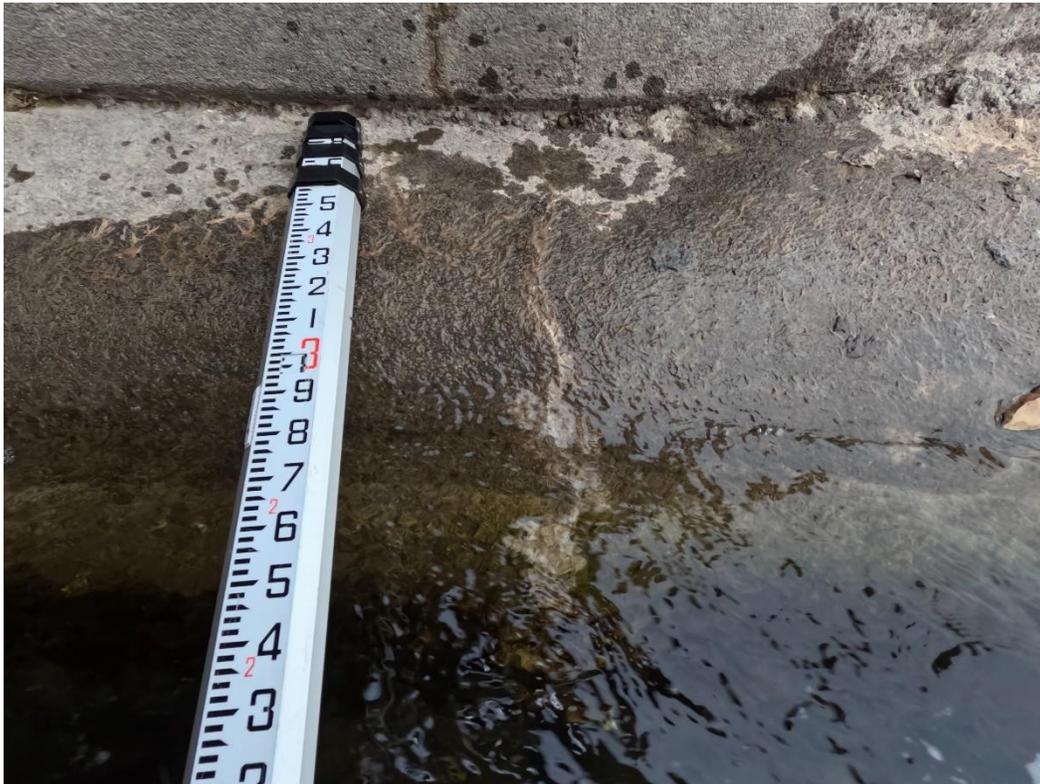
PHOTO 26. SOUTH PIER VERTICAL CRACK IN FOOTING LOOKING NORTH

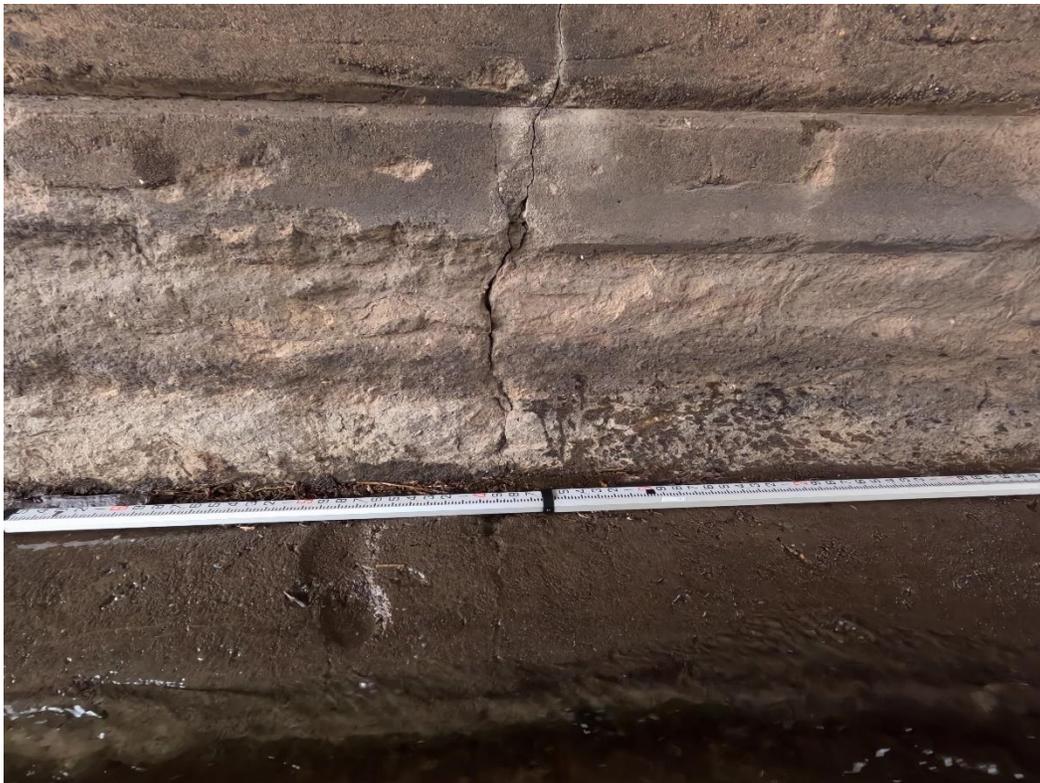
PHOTO 27. SOUTH PIER VERTICAL CRACKING ABOVE FOOTING LOOKING NORTH

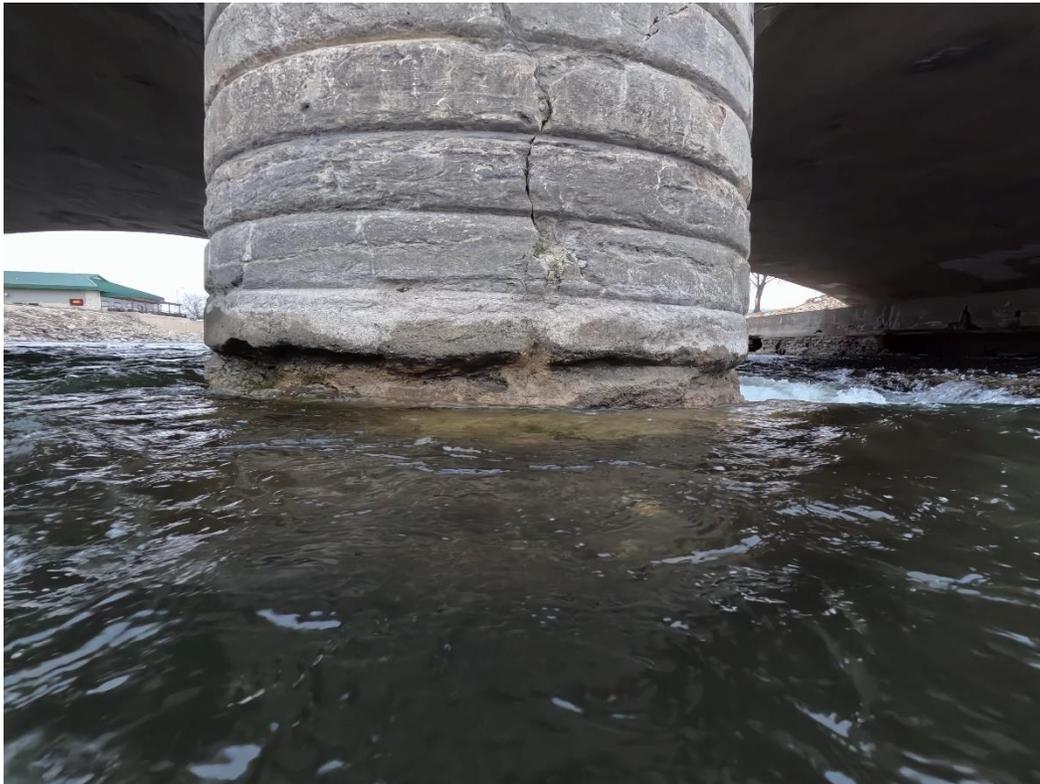
PHOTO 28. SOUTH PIER WEST NOSE HEAVY SCALING AT WATERLINE LOOKING EAST

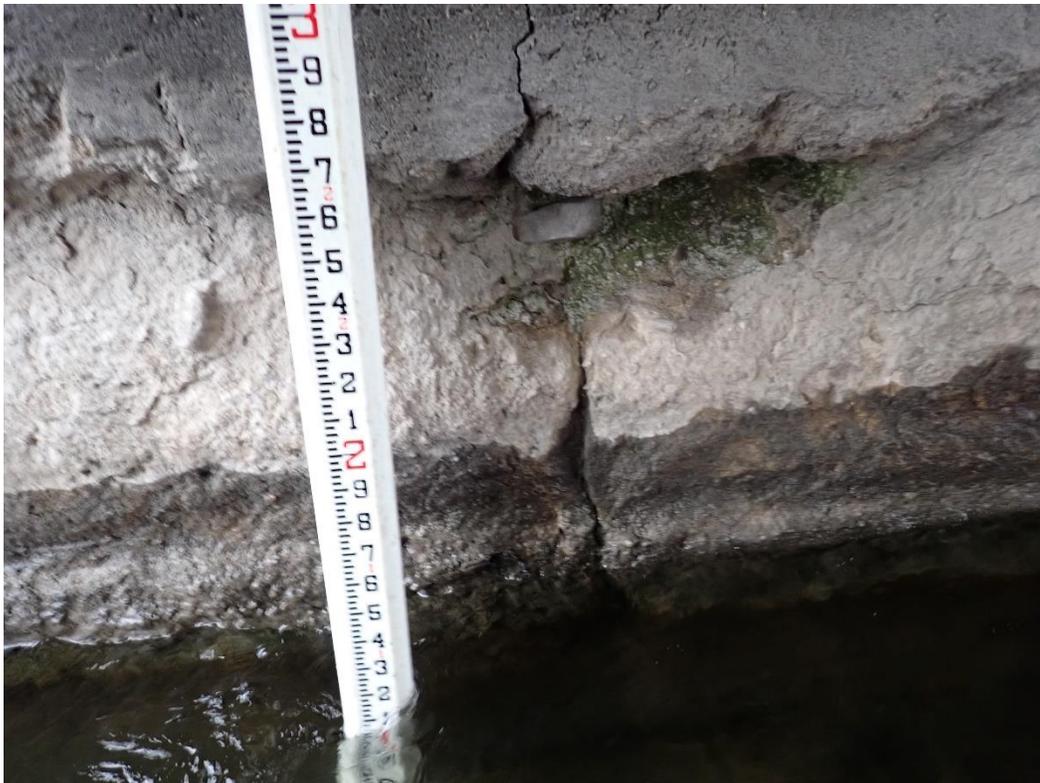
PHOTO 29. NORTH PIER NORTH FACE VERTICAL CRACK LOOKING SOUTH

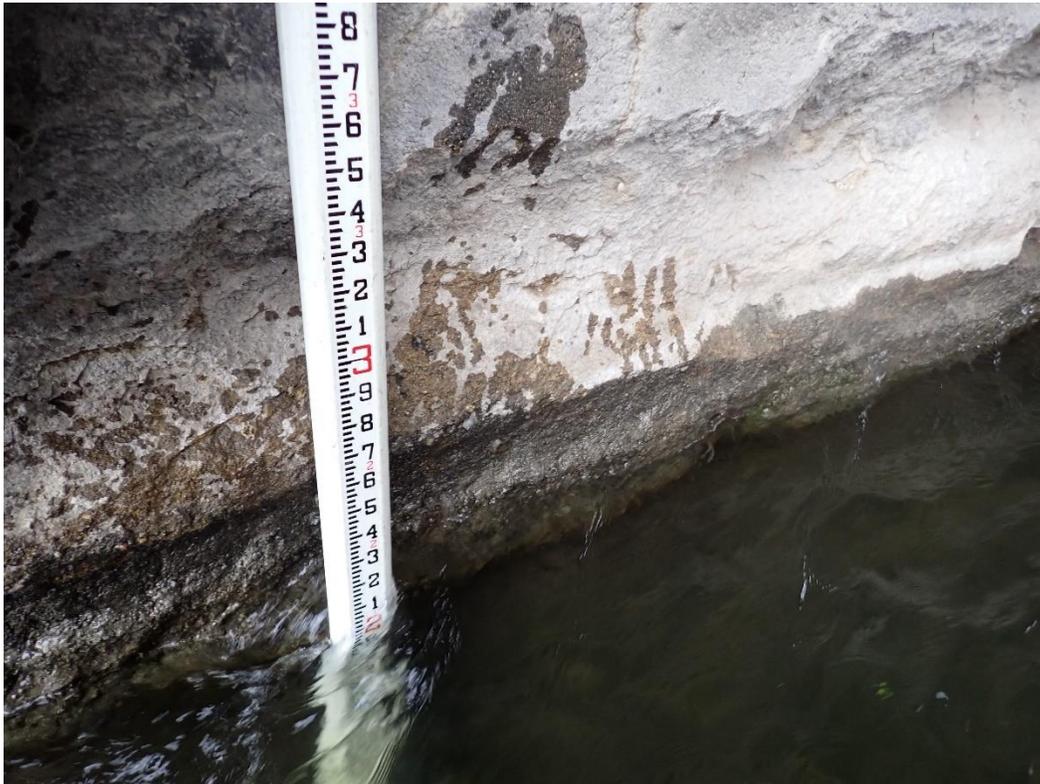
PHOTO 30. NORTH PIER TYPICAL SCALING NEAR WATERLINE LOOKING SOUTHWEST

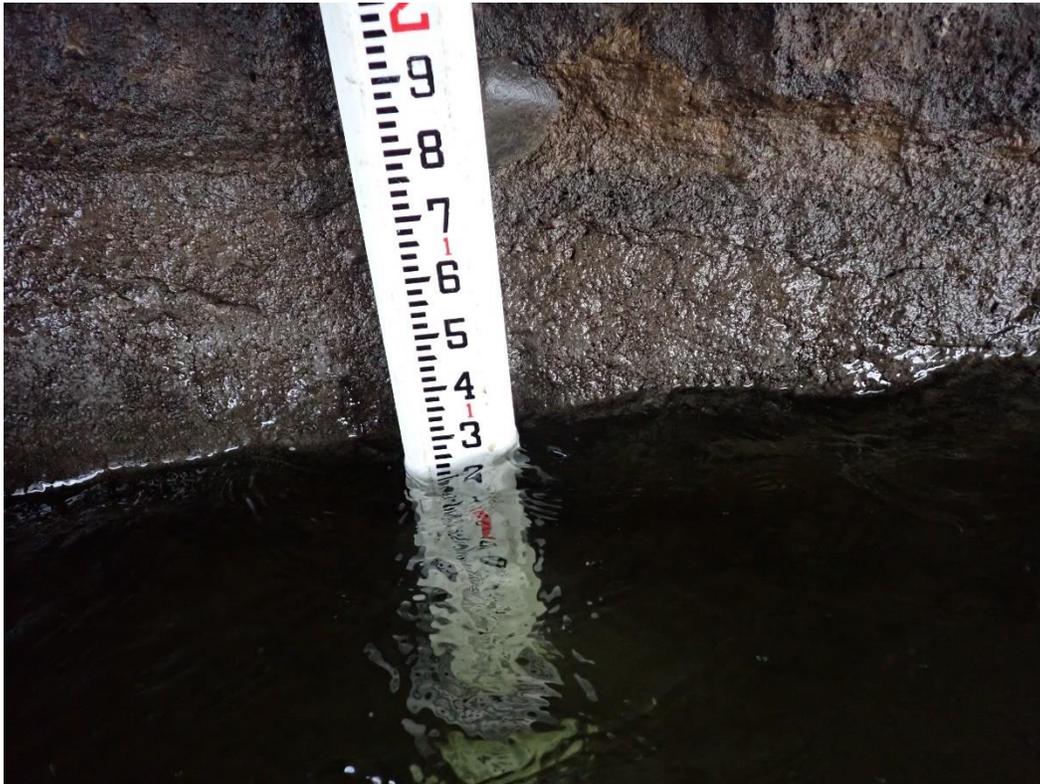
PHOTO 32. NORTH ABUTMENT TYPICAL CONCRETE CONDITION AT WATERLINE LOOKING NORTH

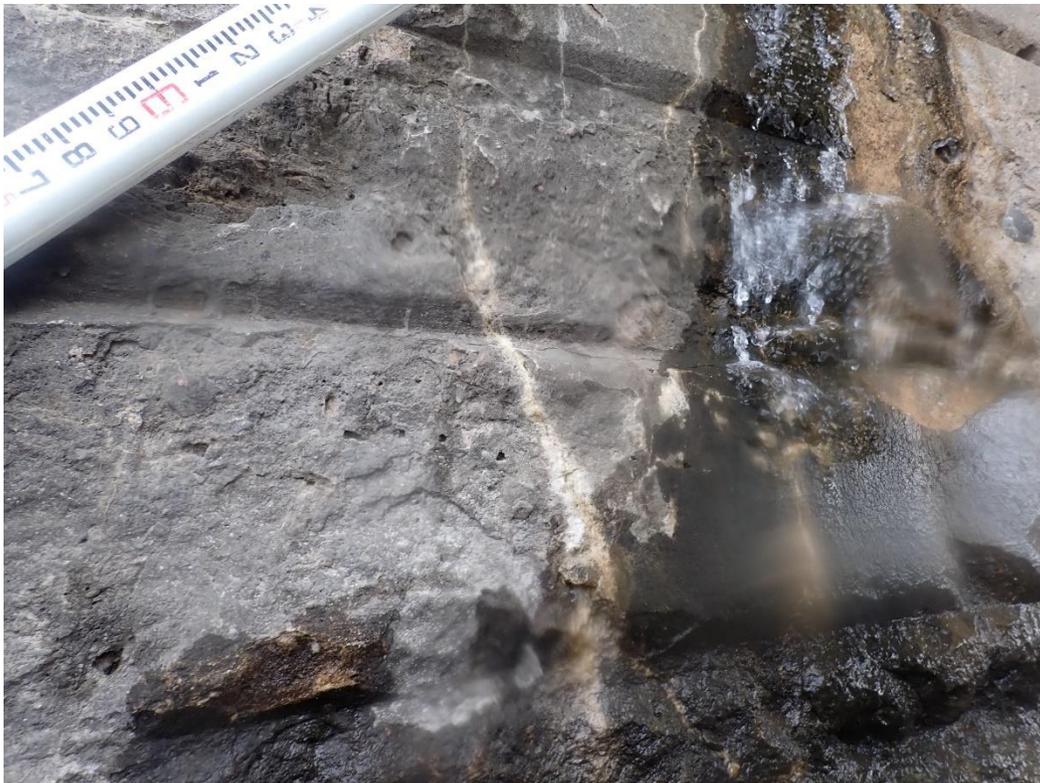
PHOTO 33. NORTH ABUTMENT TYPICAL HAIRLINE CRACKING WITH EFFLORESCENCE LOOKING NORTH

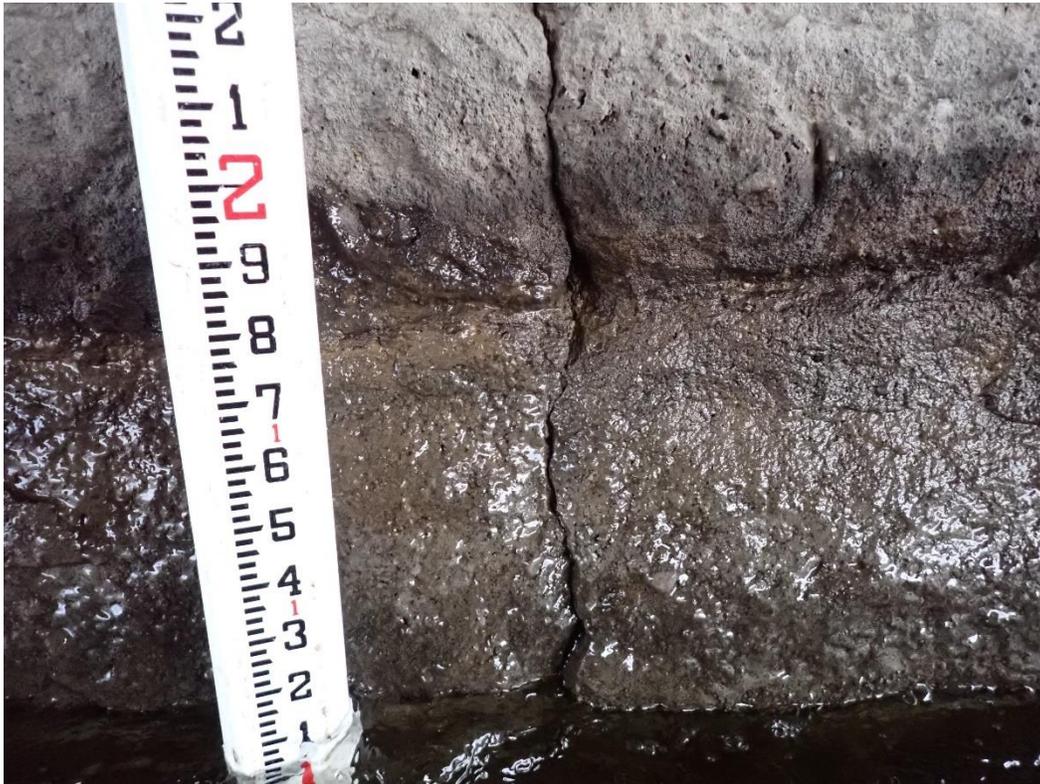
PHOTO 34. NORTH ABUTMENT VERTICAL CRACK LOOKING NORTH

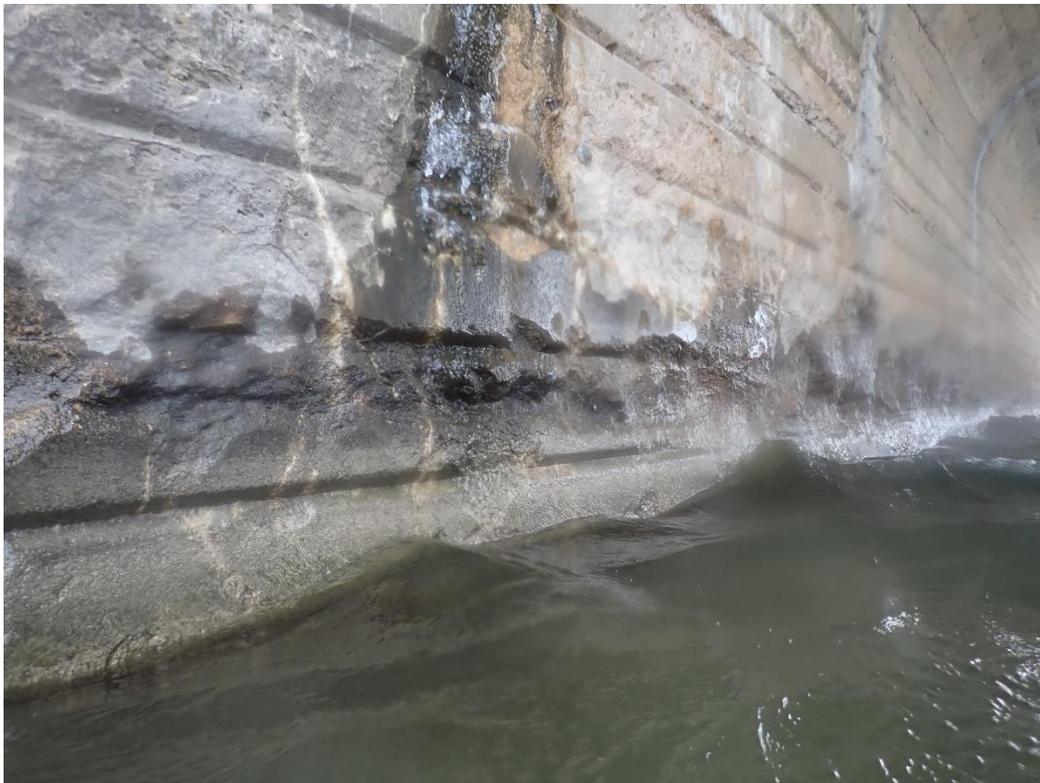
PHOTO 35. NORTH ABUTMENT WITH SCALING AT WATERLINE UP 2 FEET LOOKING NORTHEAST

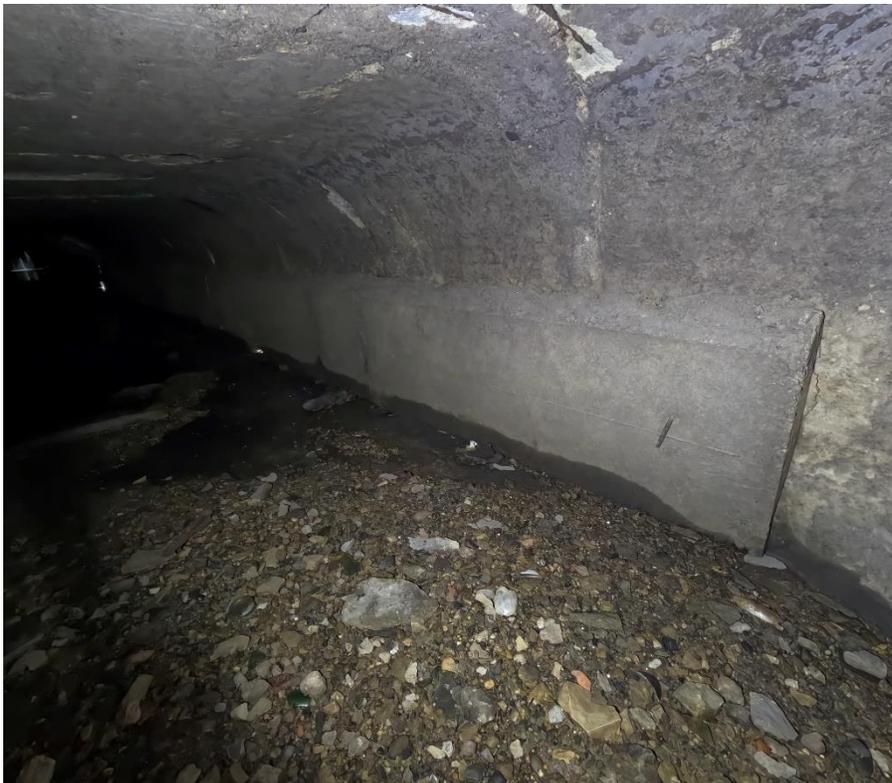
PHOTO 46. TYPICAL FLOOR TO WALL REPAIR LOOKING NORTHWEST

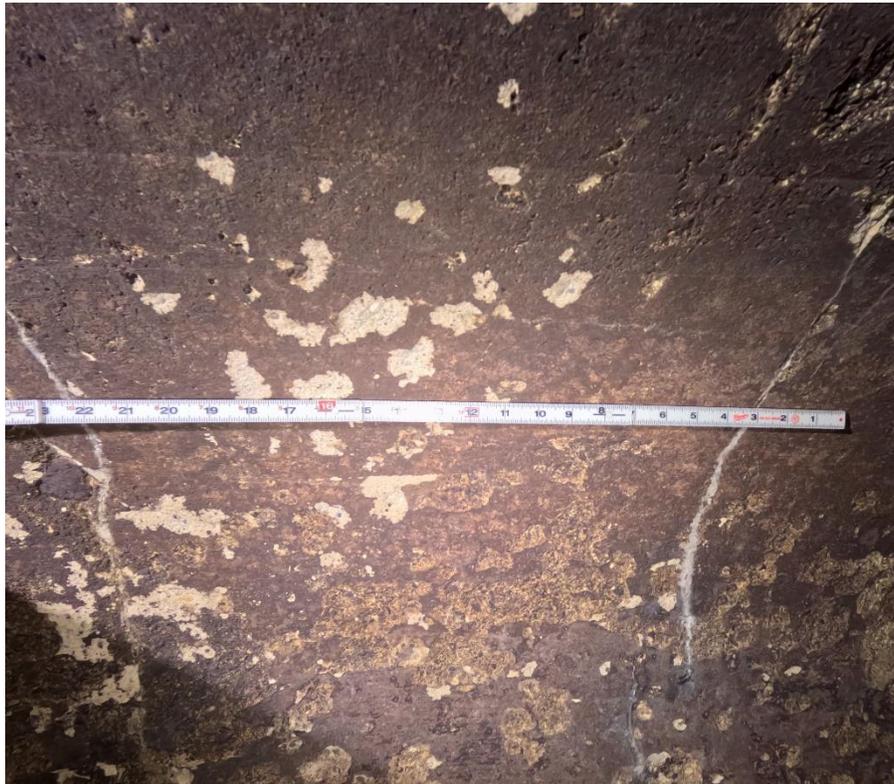
PHOTO 47. TYPICAL CRACKING WITH EFFLORESCENCE LOOKING SOUTH

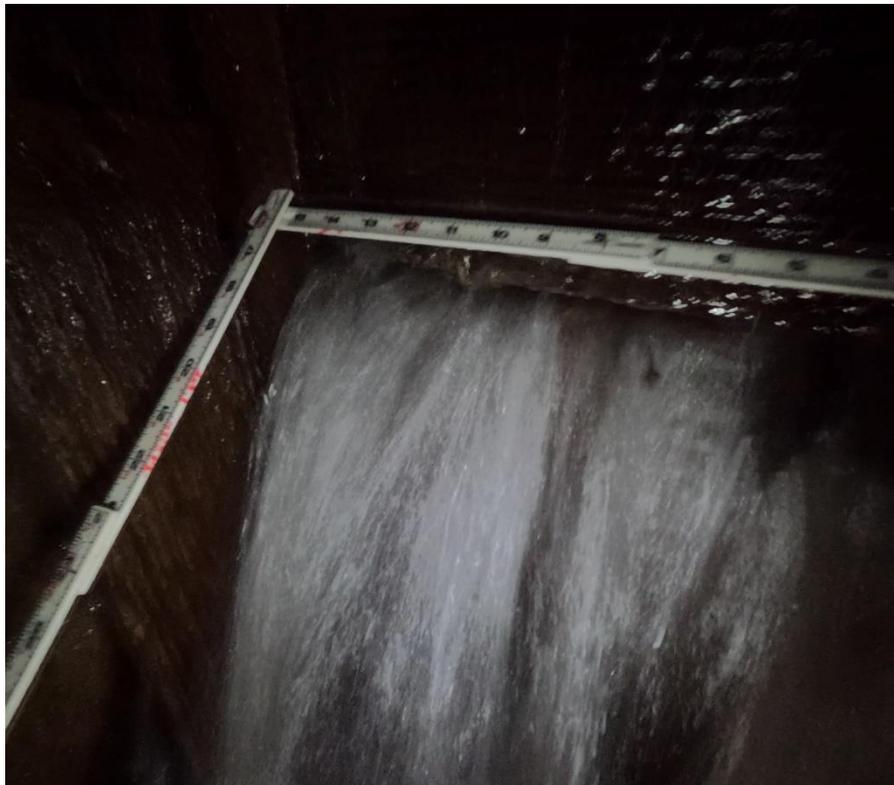
PHOTO 50. TYPICAL SEEPAGE THROUGH INLET GATE LOOKING WEST

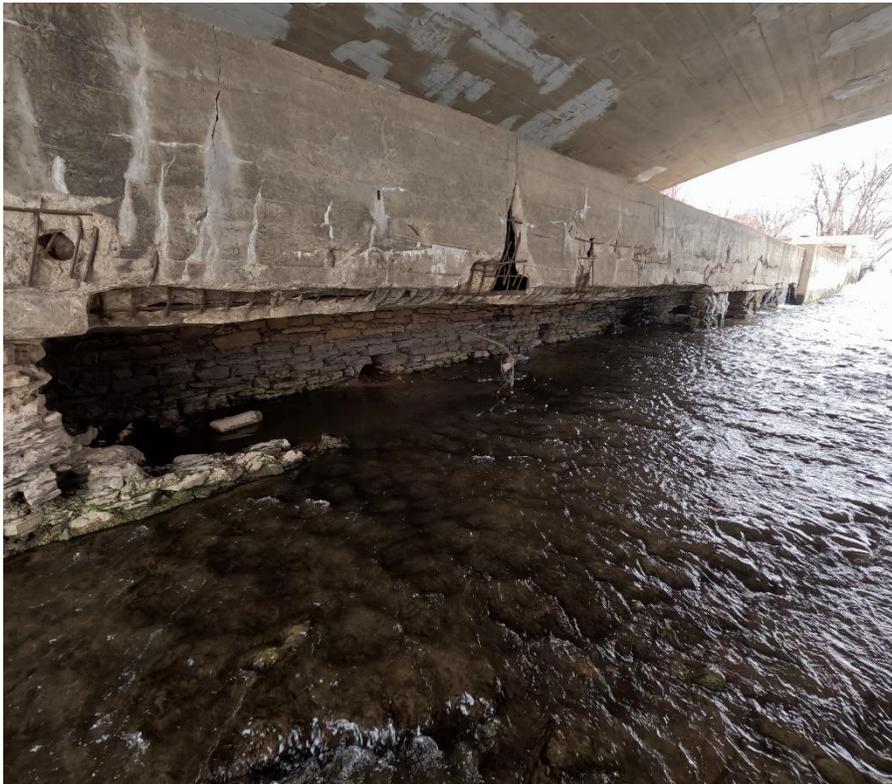
PHOTO 57. NORTH WALL DETERIORATION AND FLUME UNDERMINING LOOKING SOUTHWEST

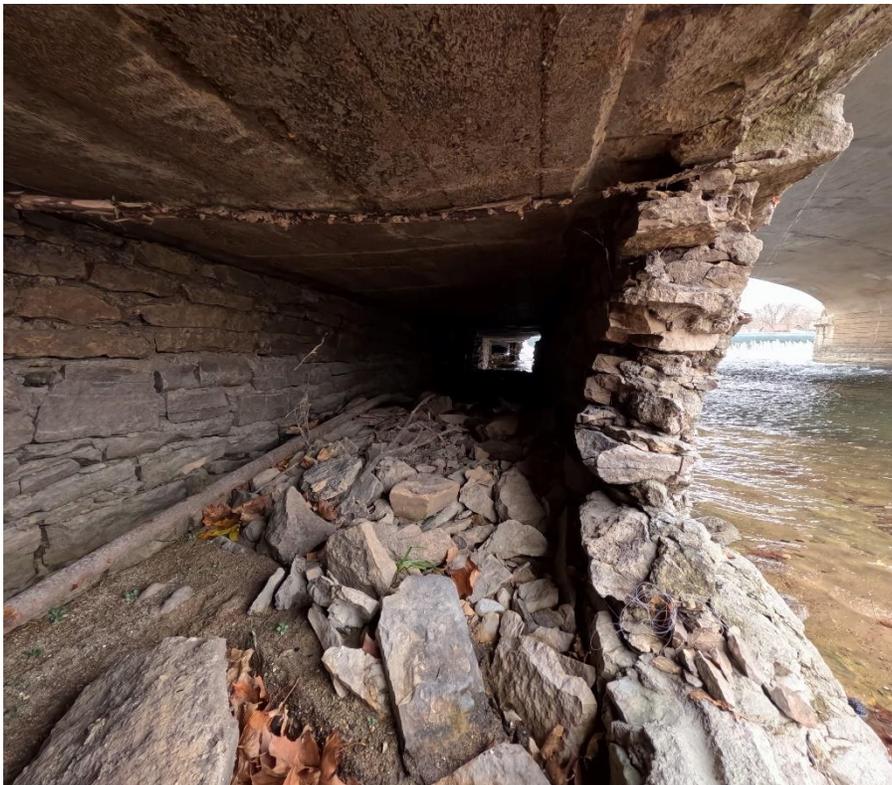
PHOTO 58. NORTH MASONRY WALL DETERIORATION AND FLUME UNDERMINING LOOKING WEST

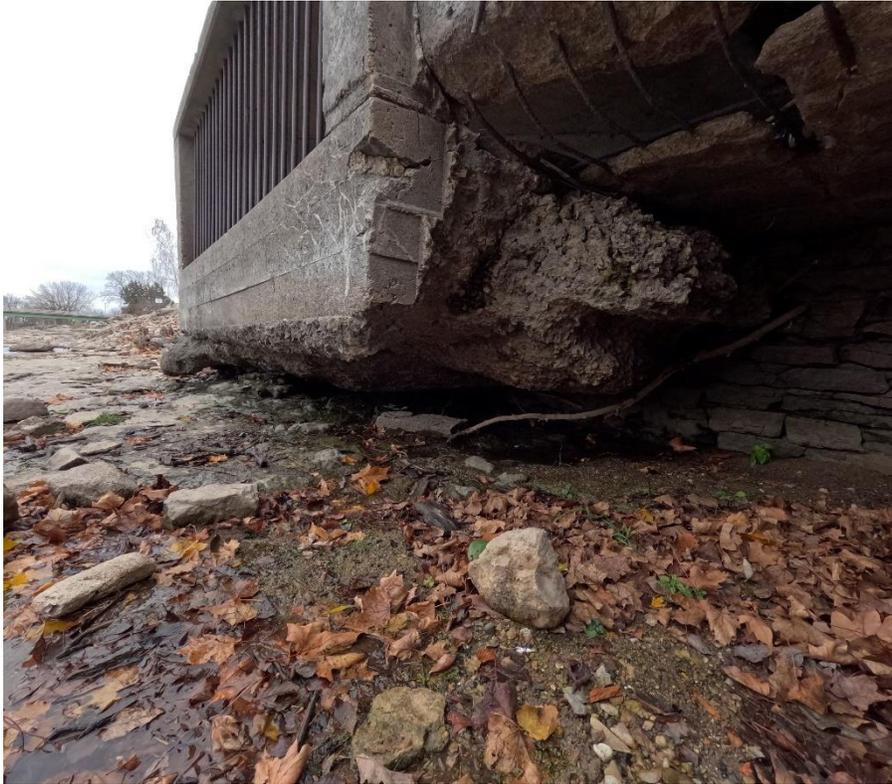
PHOTO 59. UNDERMINING OF OUTLET LOOKING SOUTHEAST

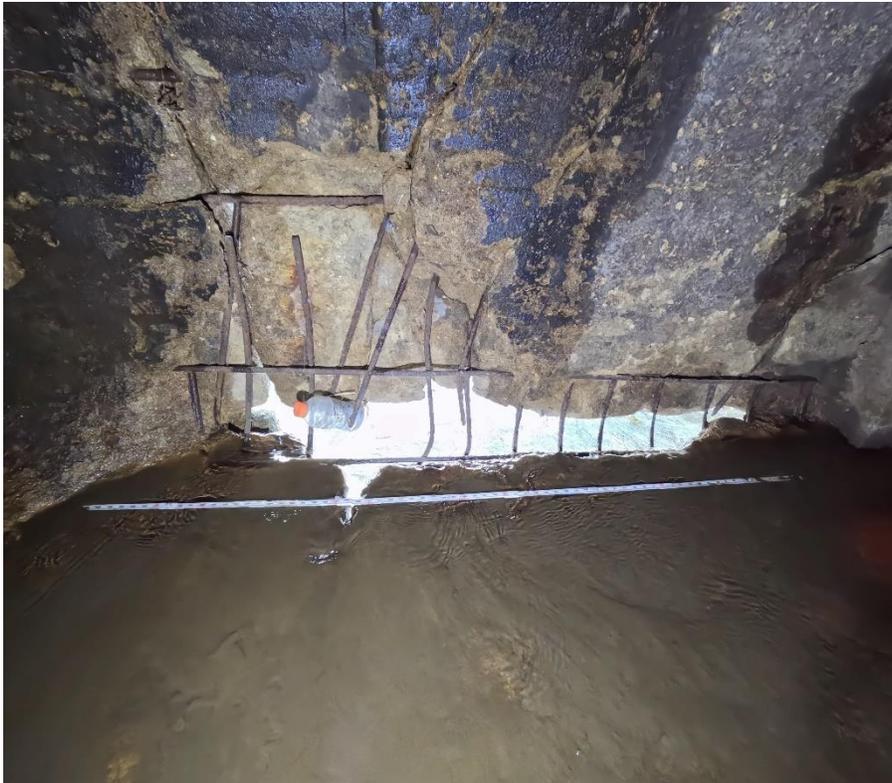
PHOTO 60. SPALL IN NORTH WALL AT FLOOR INTERFACE 85 FEET FROM INLET LOOKING NORTH

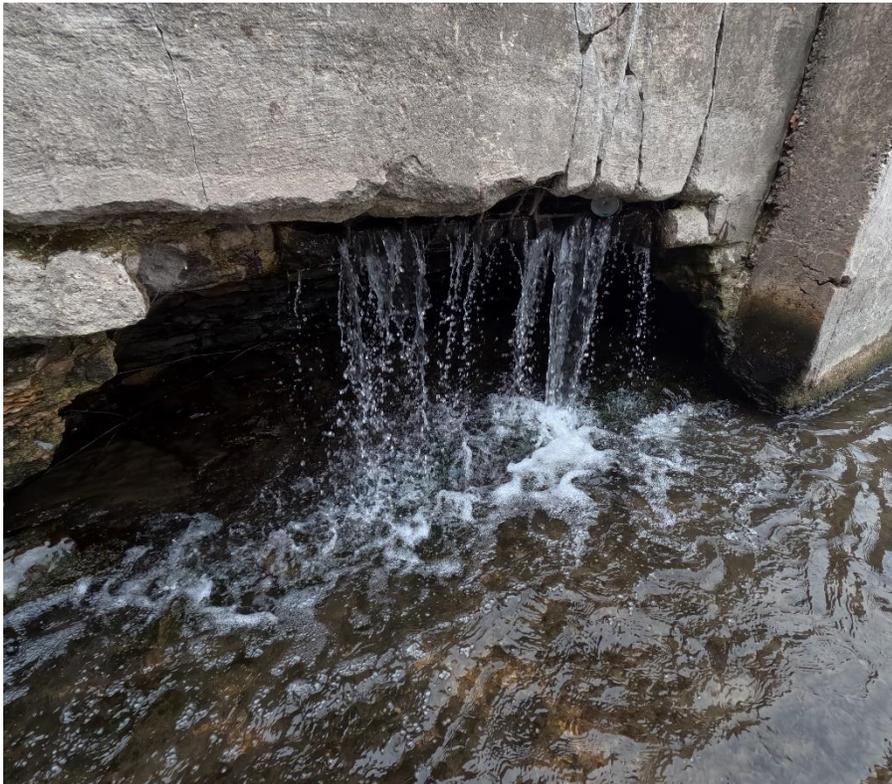
PHOTO 61. SEEPAGE THROUGH SPALL 85 FEET FROM INLET LOOKING SOUTH

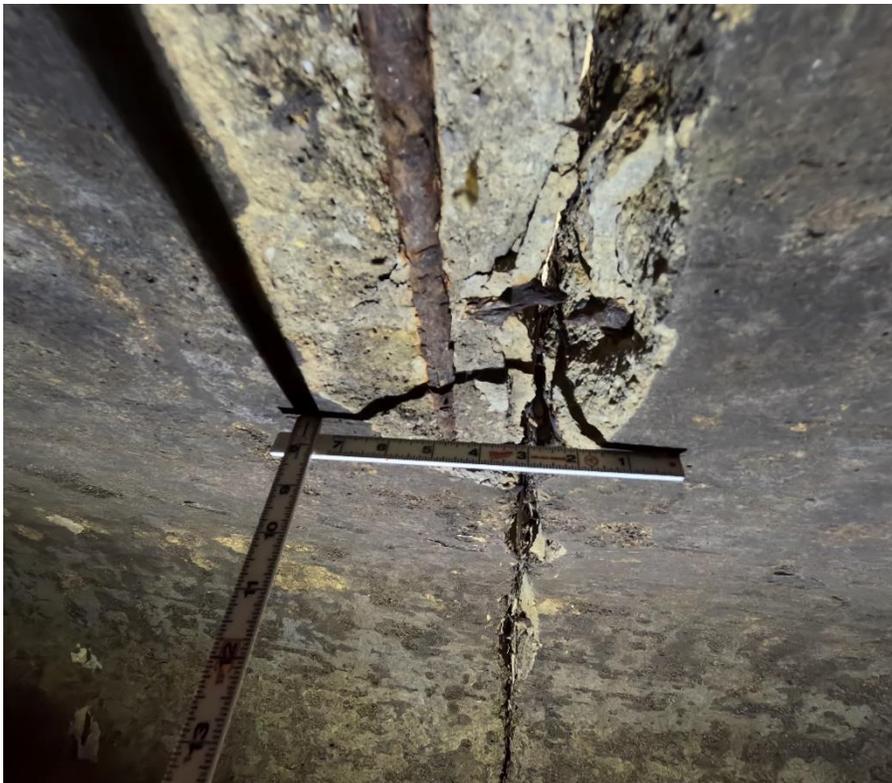
PHOTO 62. CEILING FRACTURED REBAR LOCATED 85 FEET FROM OUTLET LOOKING SOUTH

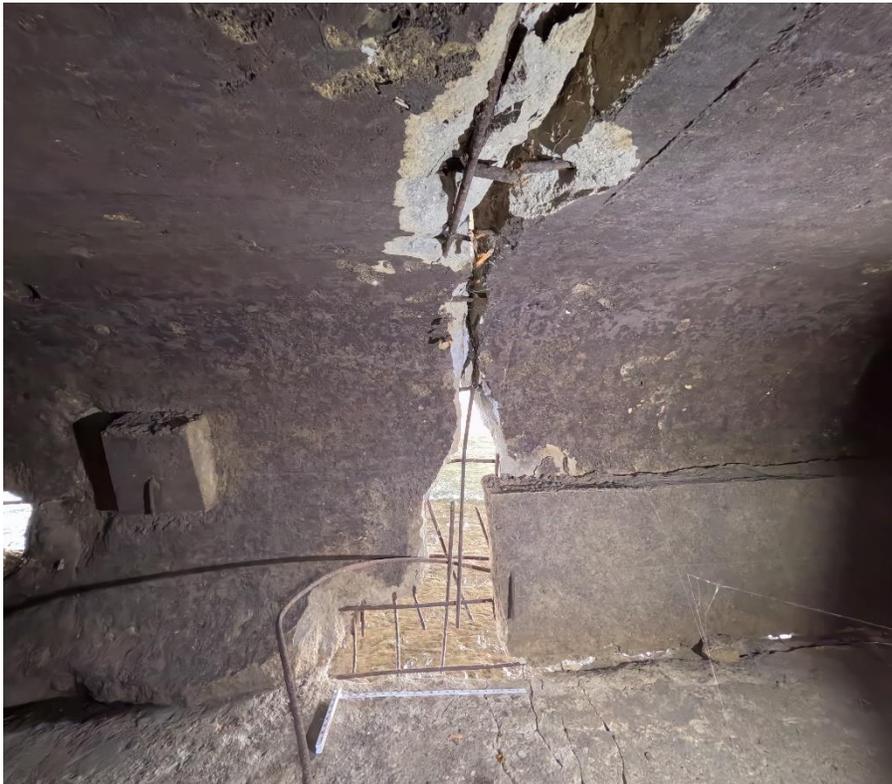
PHOTO 63. SPALL IN NORTH WALL AT FRACTURE 50 FEET FROM OUTLET LOOKING NORTH

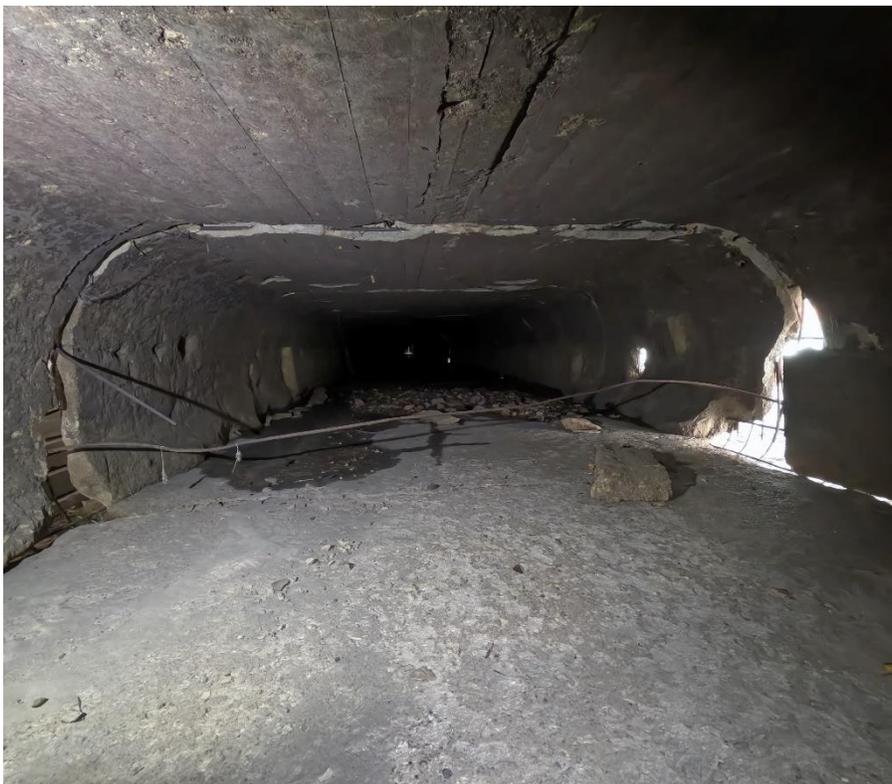
PHOTO 64. FRACTURE 50 FEET FROM OUTLET LOOKING WEST

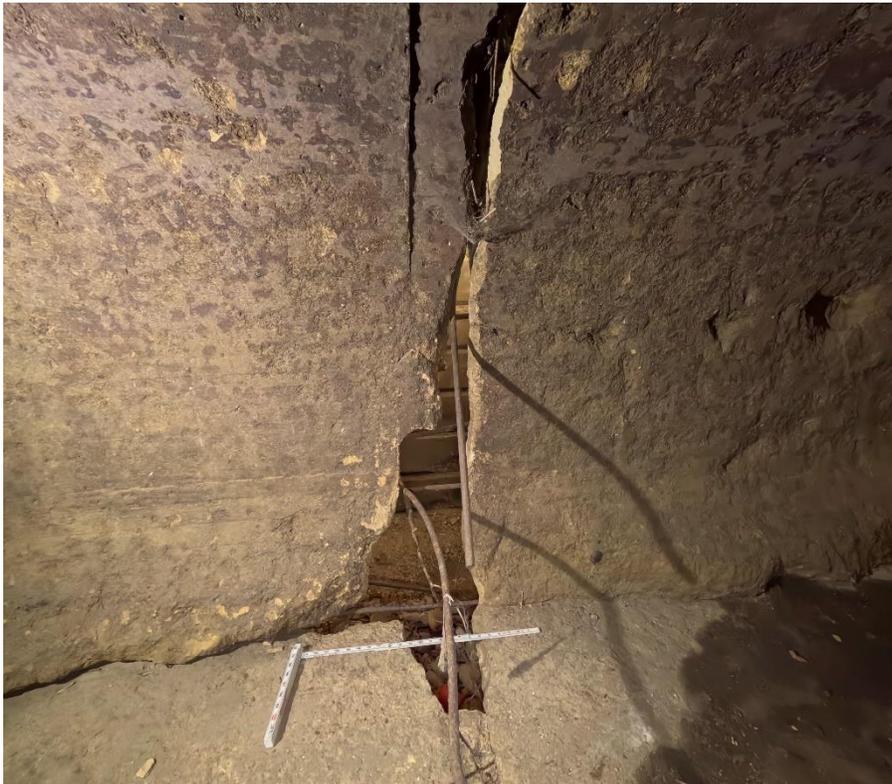
PHOTO 67. SPALL IN SOUTH WALL AT FRACTURE 50 FEET FROM OUTLET LOOKING SOUTH

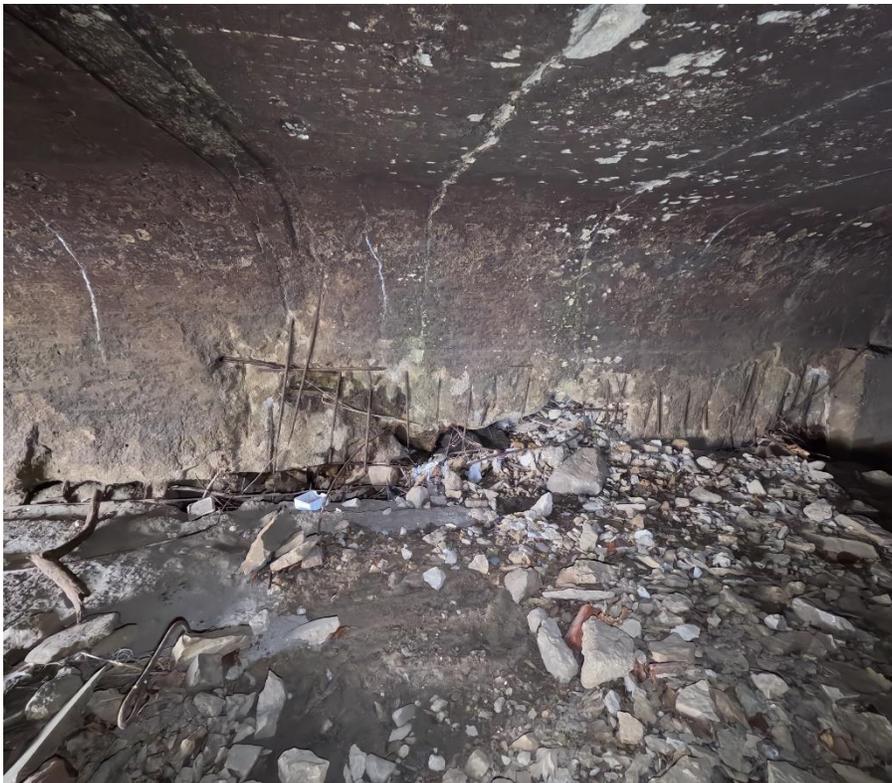
PHOTO 68. SPALL IN SOUTH WALL 15 FEET FROM OUTLET LOOKING SOUTH

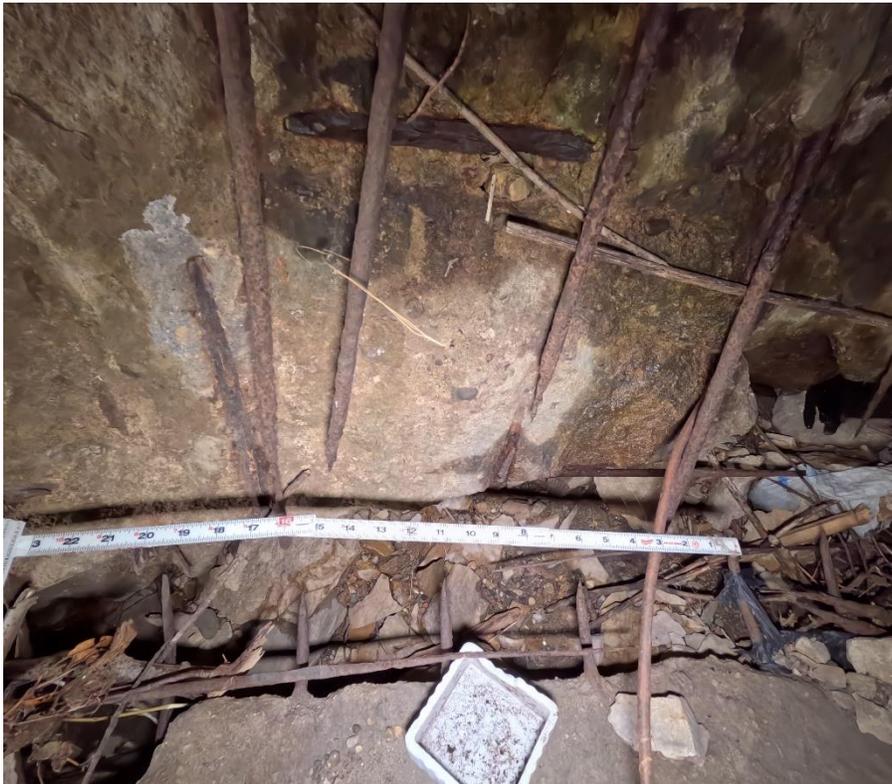
*PHOTO 69. SPALL IN SOUTH WALL AT FLOOR INTERFACE WITH FRACTURED REBAR 15 FEET FROM OUTLET
LOOKING SOUTH*

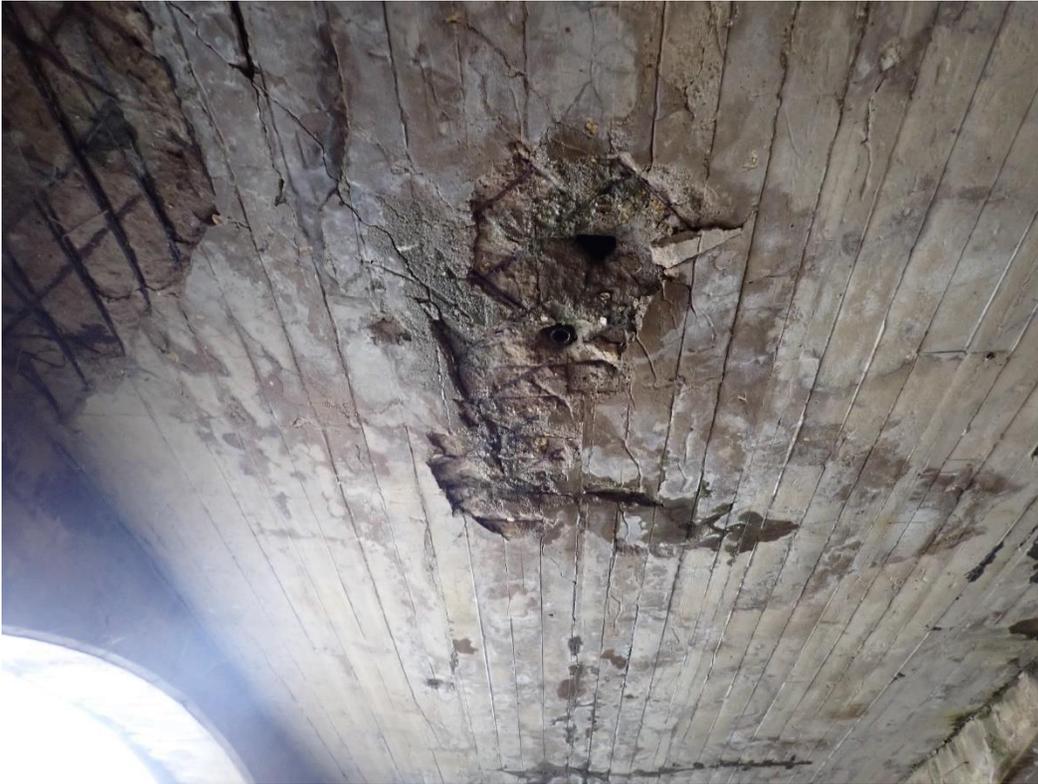
PHOTO 79. FLOUR MILL CEILING SOUTH BAY NEAR EAST WALL SPALL LOOKING WEST

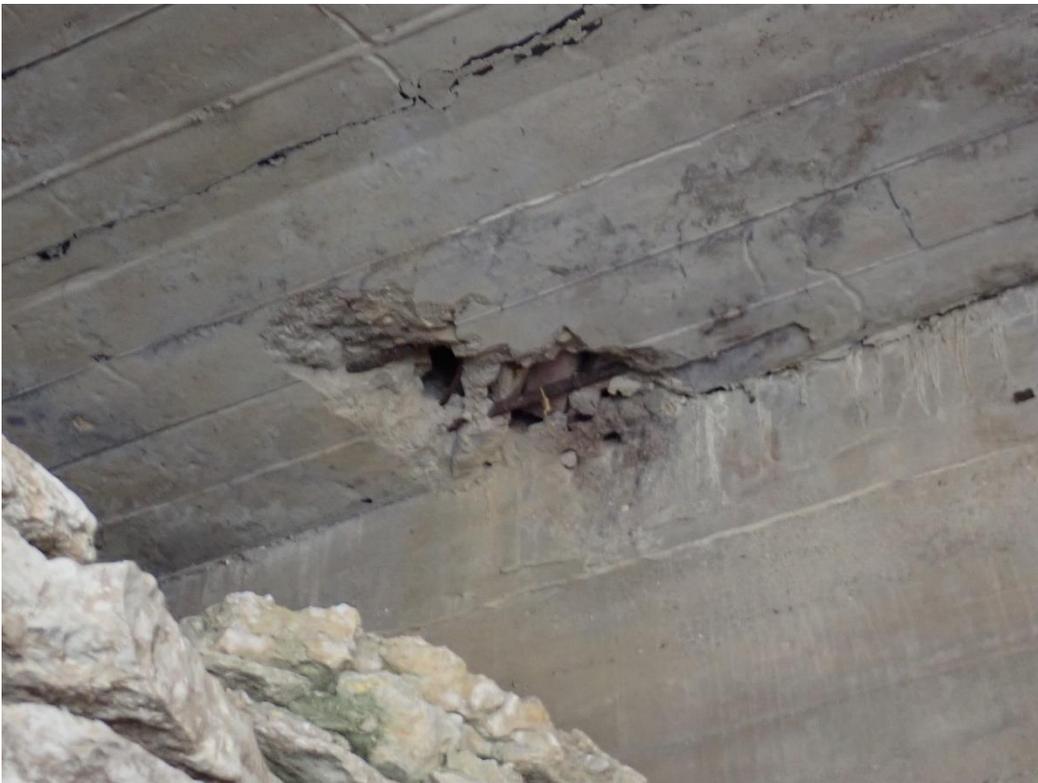
PHOTO 80. FLOUR MILL CEILING SOUTH BAY NEAR WEST WALL SPALL LOOKING NORTHWEST

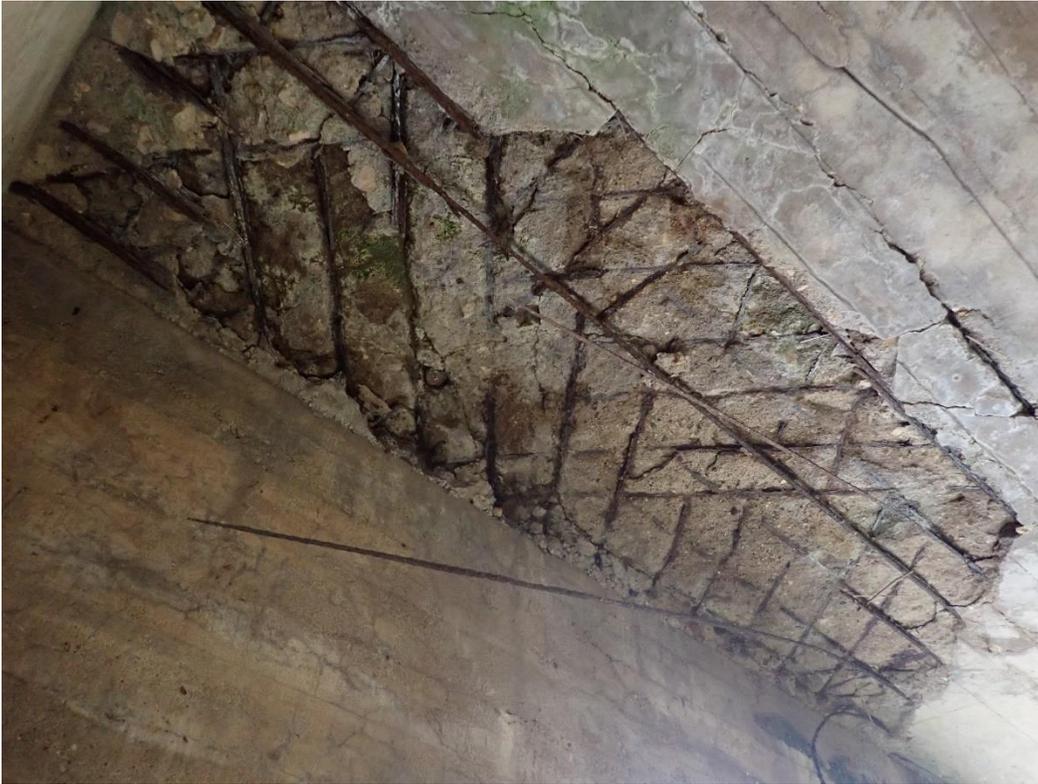
PHOTO 81. FLOUR MILL CEILING SOUTH BAY SOUTHEAST CORNER SPALL LOOKING SOUTHWEST
