**MAIN STREET BRIDGE FEASIBILITY
FHWA NO. 001820**

**RE: FEASIBILITY STUDY
MAIN STREET BRIDGE IN CHARLES CITY
OVER CEDAR RIVER
FHWA No. 001820
CB&A No. 2022192**

STRUCTURE CONDITION REPORT
BRIDGE (001820), DAM, FLUME AND
FLOUR MILL FOUNDATION
MAIN STREET over CEDAR RIVER

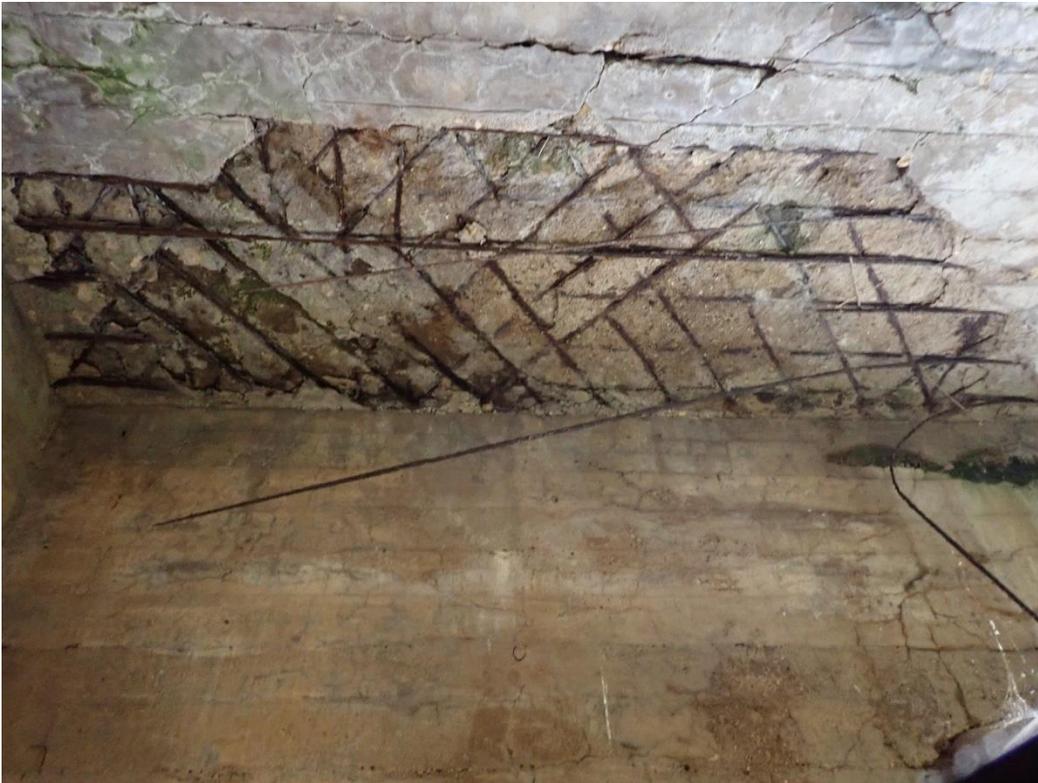
PHOTO 82. FLOUR MILL CEILING SOUTH BAY SOUTHEAST CORNER SPALL LOOKING SOUTH

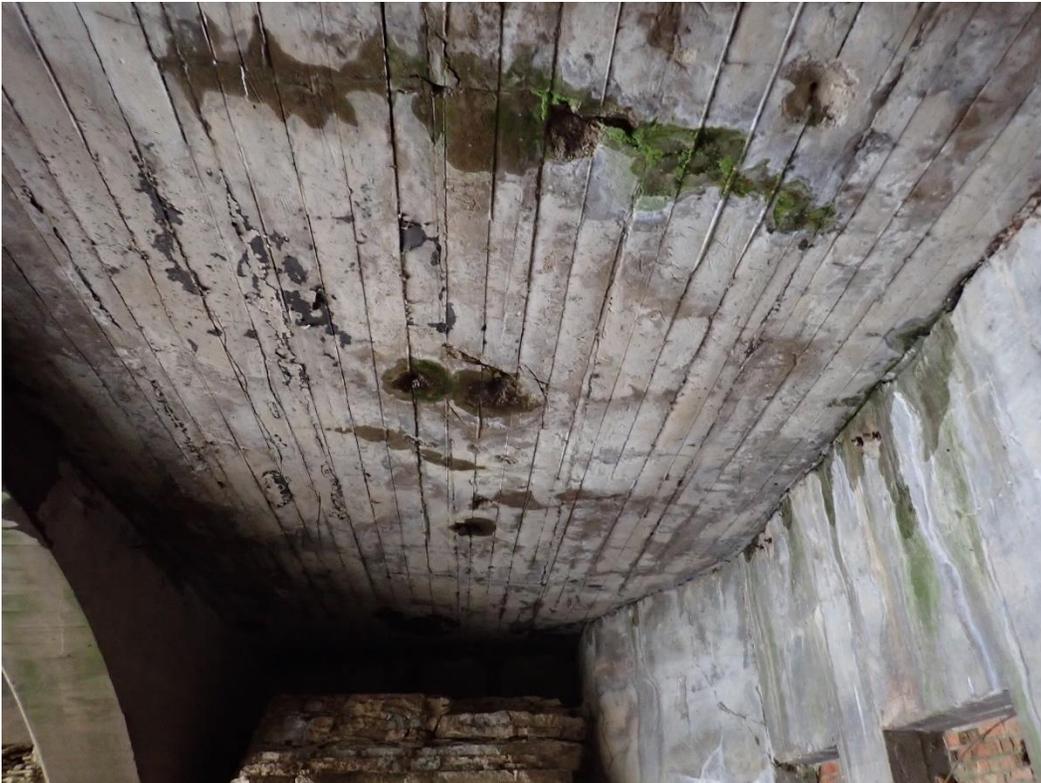
PHOTO 84. FLOUR MILL NORTH BAY CEILING TYPICAL SPALL LOOKING WEST

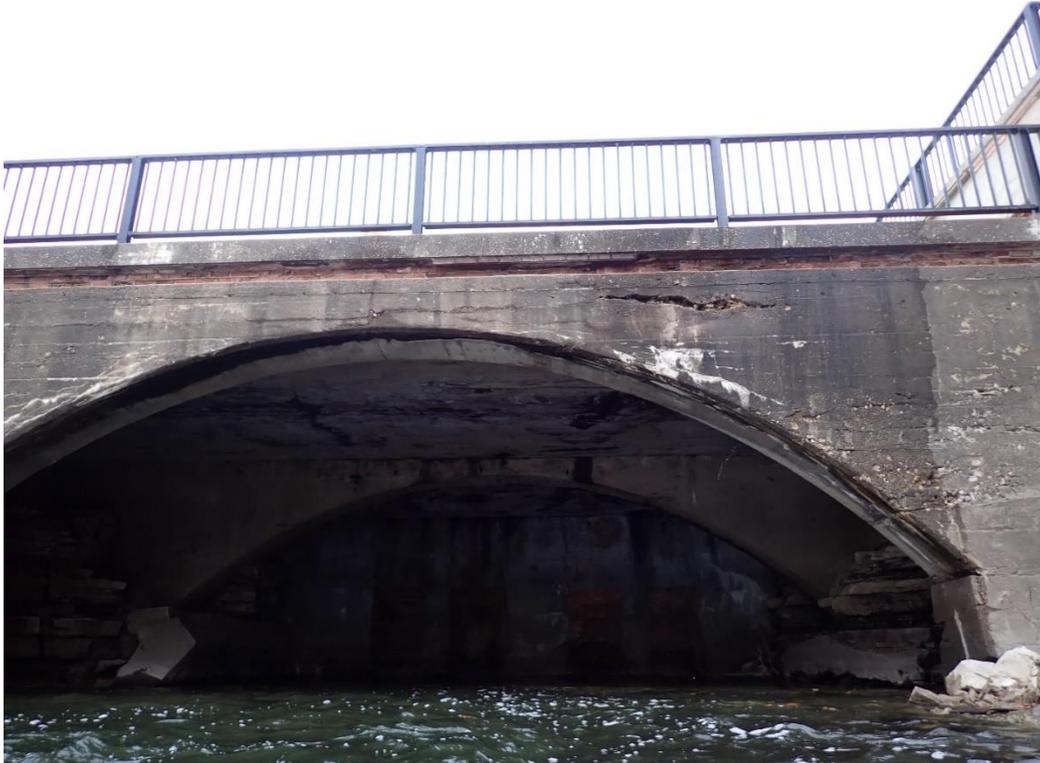
PHOTO 85. FLOUR MILL SOUTH FACE CRACKING AND SECTION LOSS LOOKING NORTH

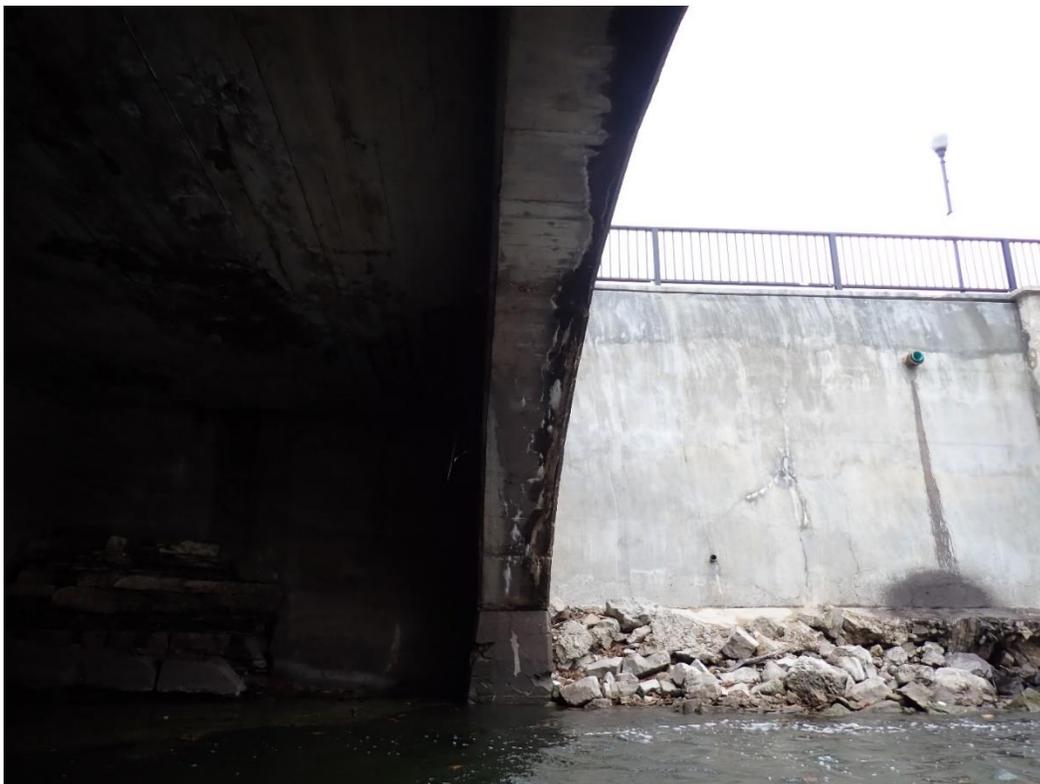
PHOTO 86. FLOUR MILL SOUTH ARCH CRACKING WITH EFFLORESCENCE LOOKING EAST

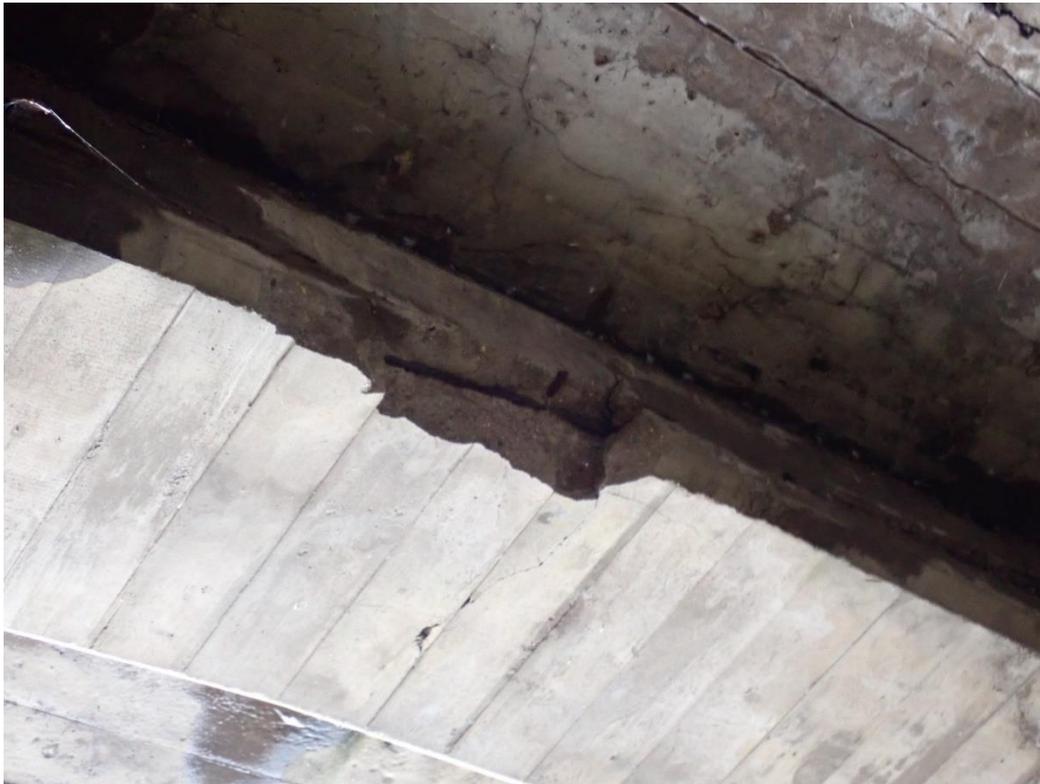
PHOTO 87. FLOUR MILL NORTH ARCH NORTH FACE MIDPOINT SPALL LOOKING SOUTHWEST

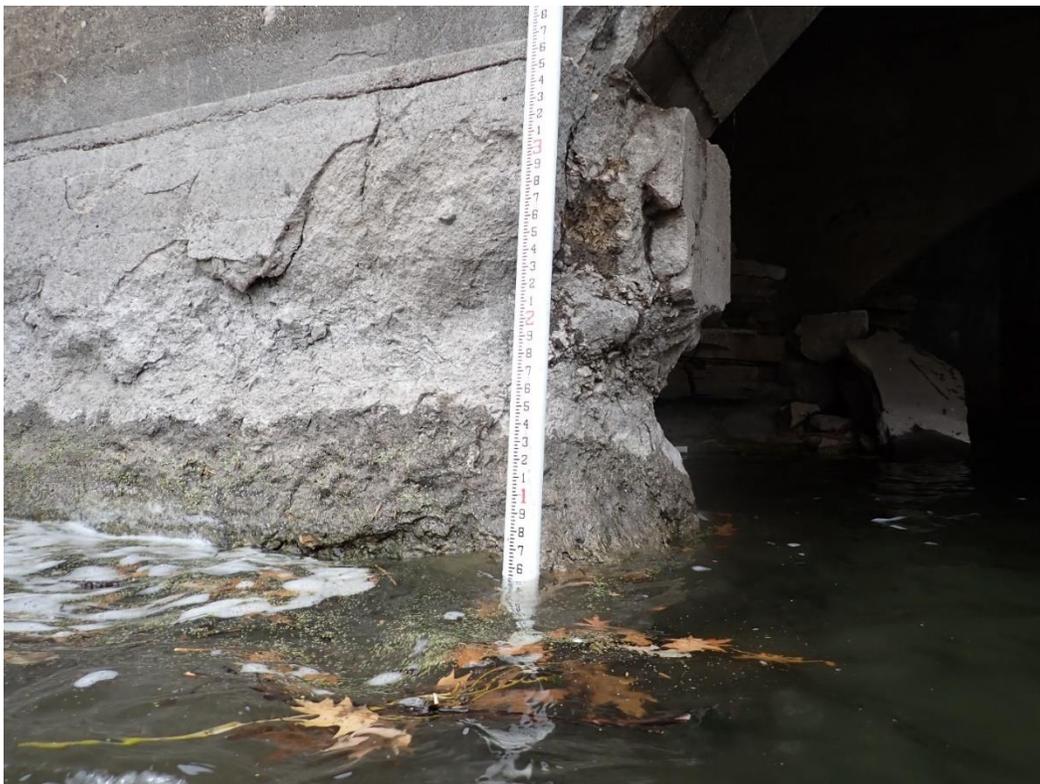
PHOTO 88. FLOUR MILL SOUTH ARCH WEST END SECTION LOSS AT WATERLINE LOOKING NORTHWEST

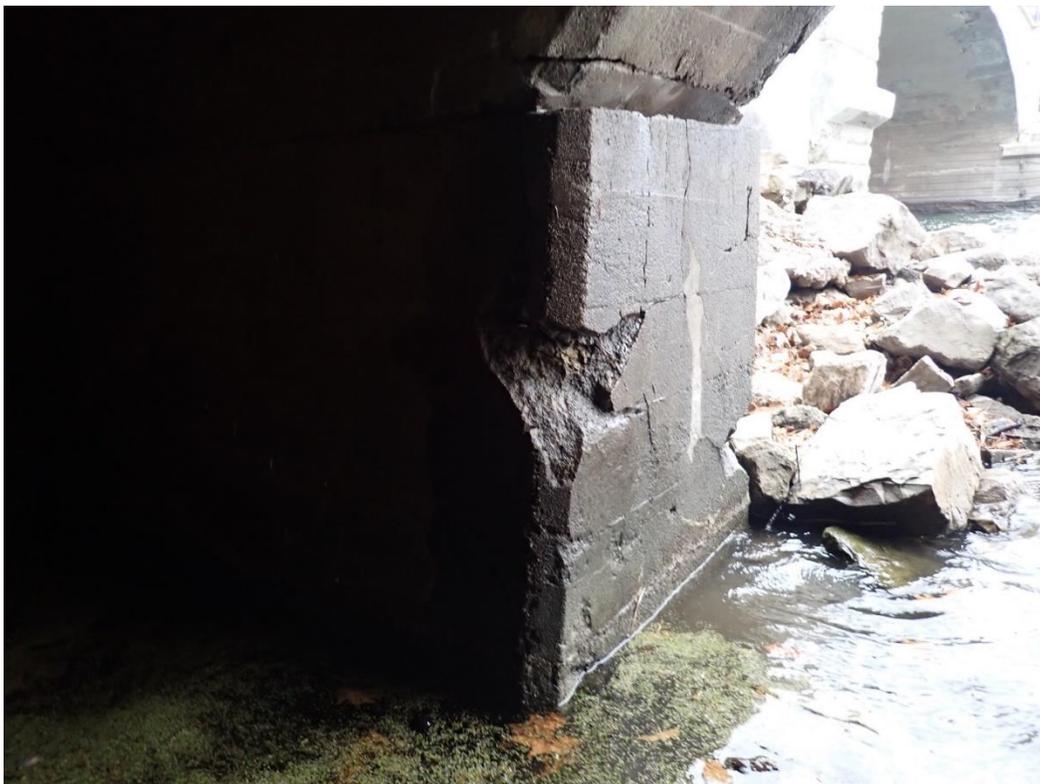
PHOTO 90. FLOUR MILL SOUTH ARCH EAST END SPALL AND DELAMINATION LOOKING SOUTHEAST

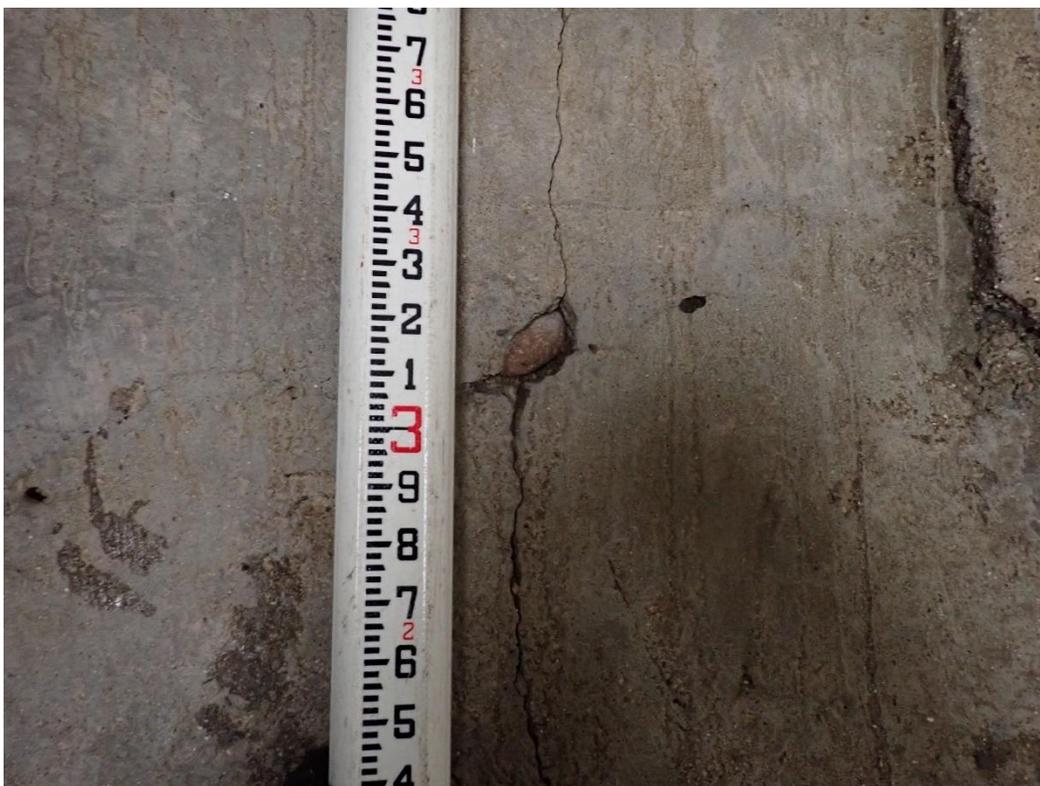
PHOTO 92. FLOUR MILL WEST WALL VERTICAL CRACK LOOKING WEST

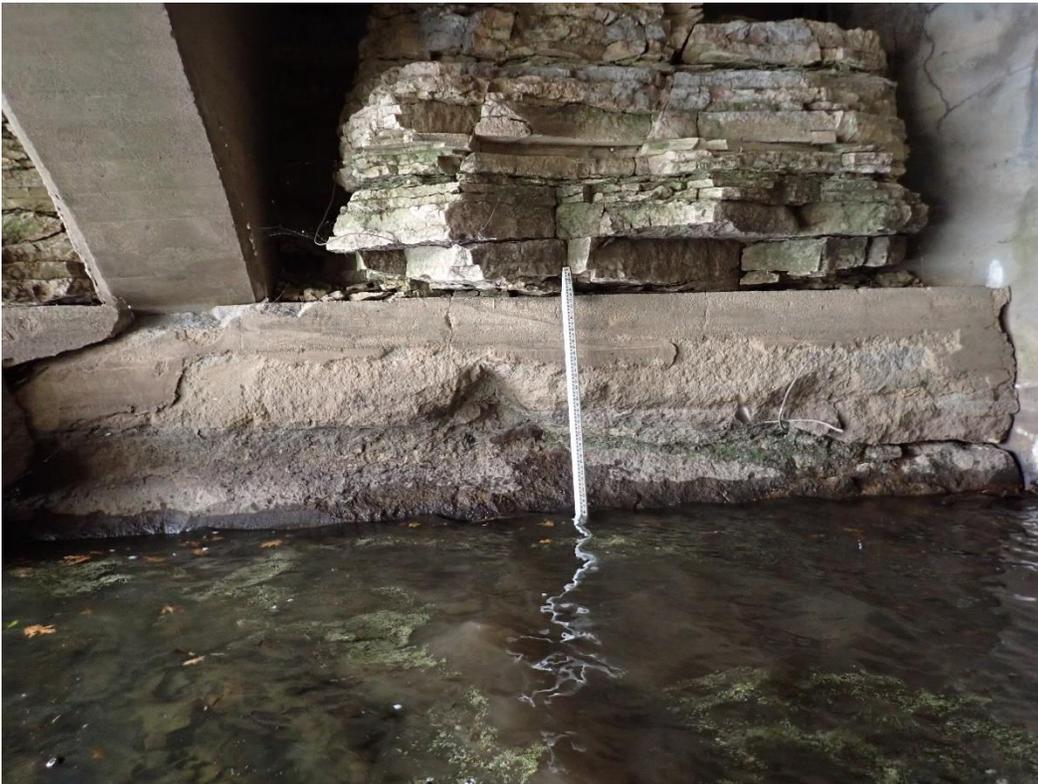
PHOTO 93. FLOUR MILL NORTH ARCH WEST END FOUNDATION SECTION LOSS LOOKING WEST

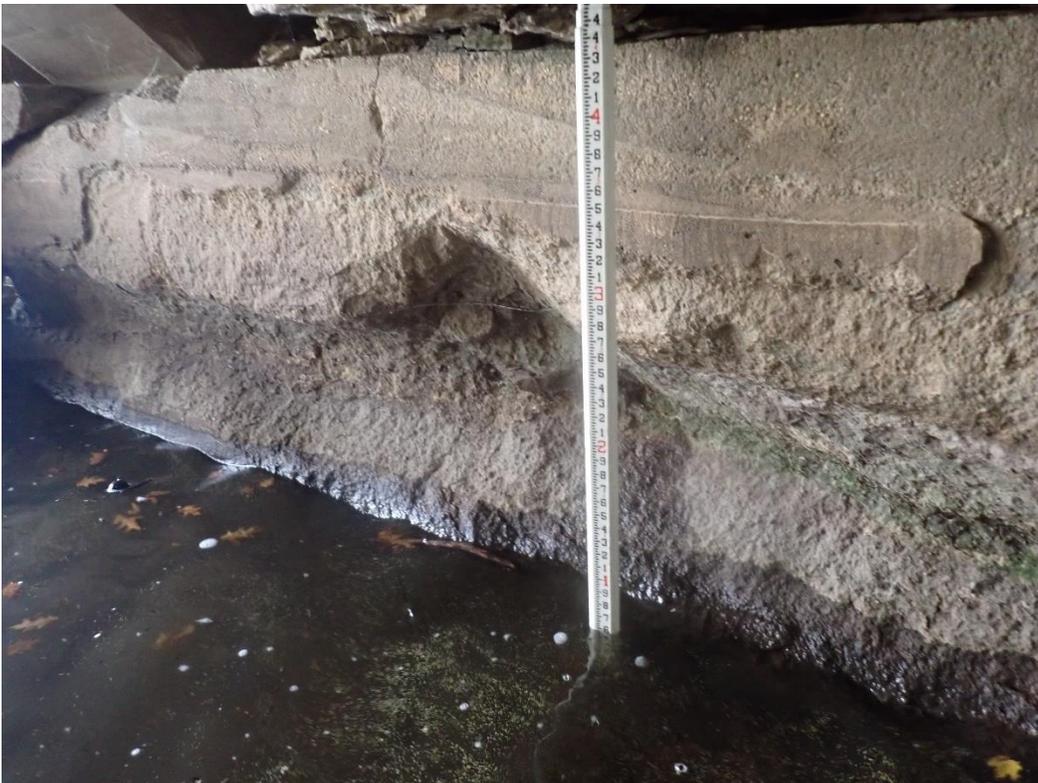
PHOTO 94. FLOUR MILL NORTH ARCH WEST END SECTION LOSS AT WATERLINE UP 2 FEET LOOKING SOUTHWEST

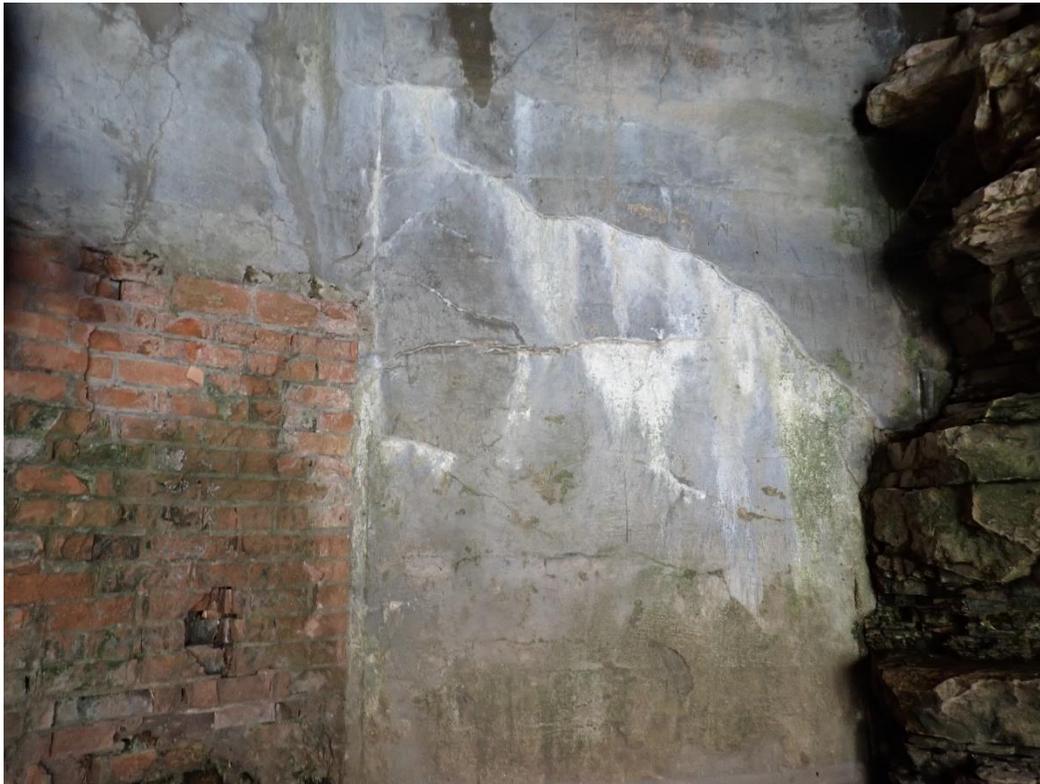
PHOTO 95. FLOUR MILL NORTH WALL TYPICAL CRACKING WITH EFFLORESCENCE LOOKING NORTH

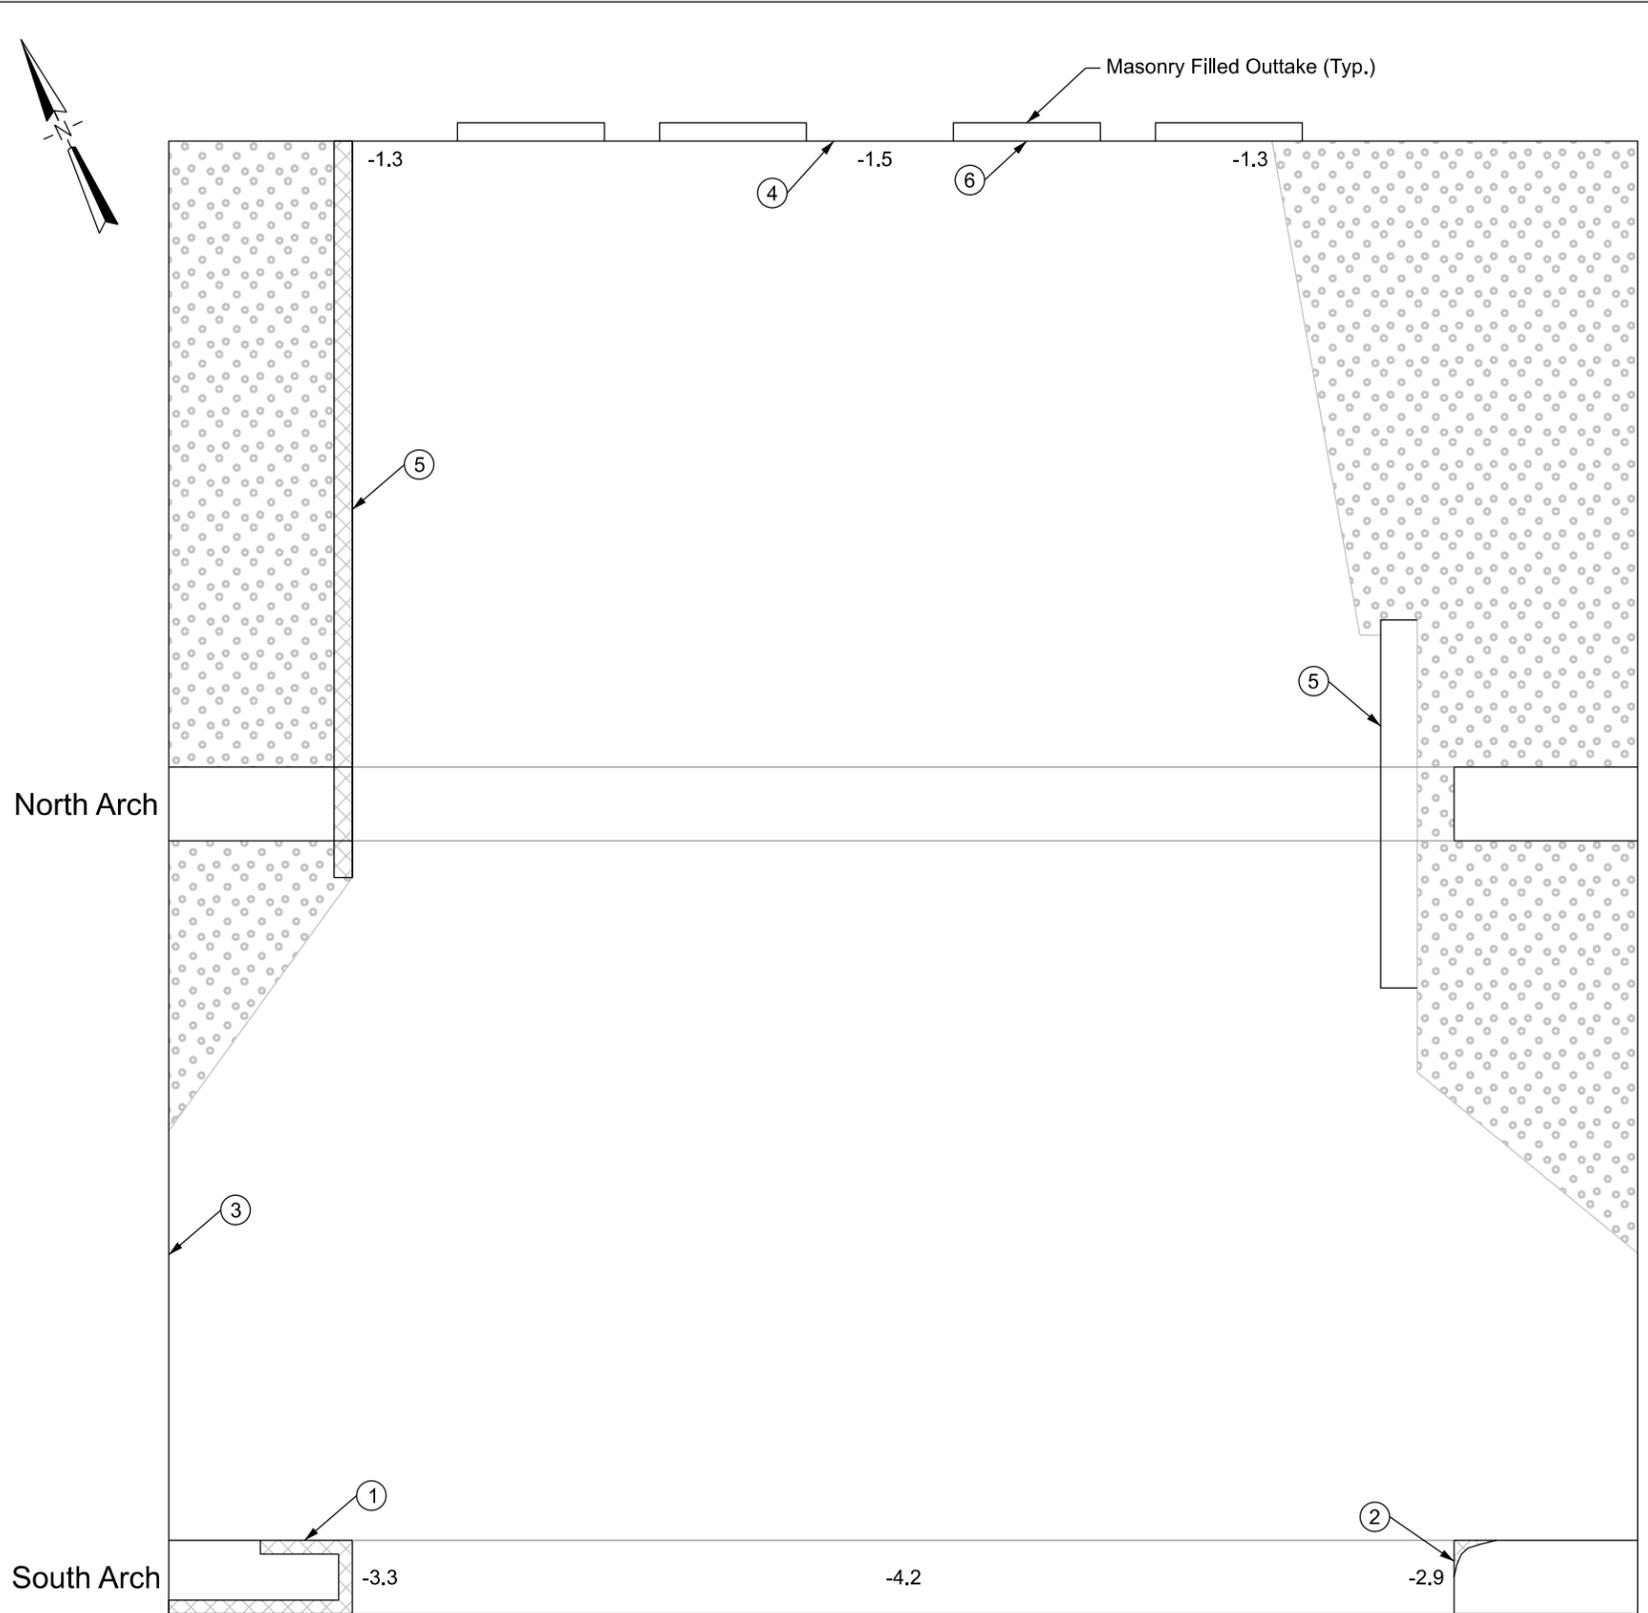
- 1 Section loss around the perimeter of the South Arch west base measuring up to 9 inches deep with unsound substrate from the waterline up 3 feet.
- 2 Spall with associated delamination in the South Arch east base on the northwest corner, up to 1 foot wide by 2 feet high and 4 inches deep, located approximately 2 feet above the waterline.

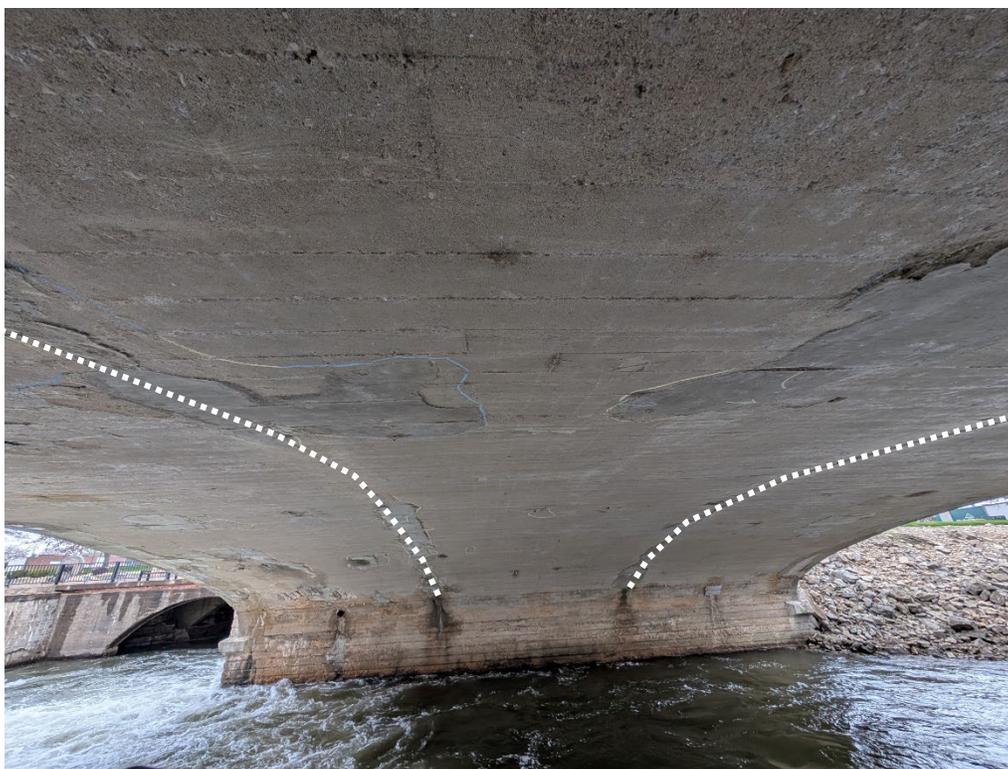
In general, AET observed larger delaminated regions in the vicinity of construction joints running parallel to the direction of the bridge in each of the arches (Figure 2).

Figure 2: West Arch (general) – Large delaminated regions were observed in proximity of construction joints (white lines) – Similar areas were observed in other arches
