**MAIN STREET BRIDGE FEASIBILITY
FHWA NO. 001820**

**RE: FEASIBILITY STUDY
MAIN STREET BRIDGE IN CHARLES CITY
OVER CEDAR RIVER
FHWA No. 001820
CB&A No. 2022192**

STRUCTURE CONDITION REPORT
BRIDGE (001820), DAM, FLUME AND
FLOUR MILL FOUNDATION
MAIN STREET over CEDAR RIVER

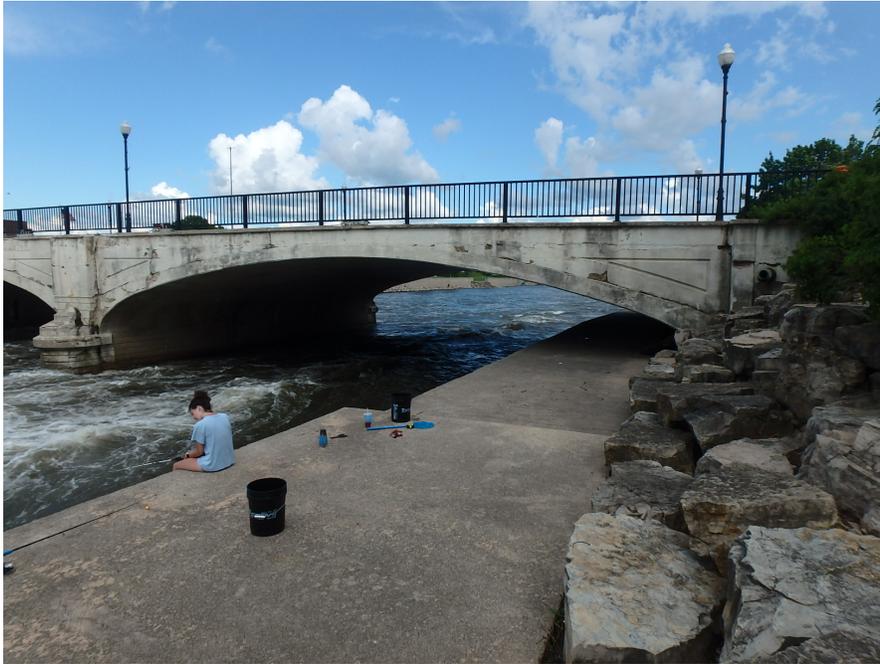
Photo Number: 1

SIDE VIEW LOOKING EAST

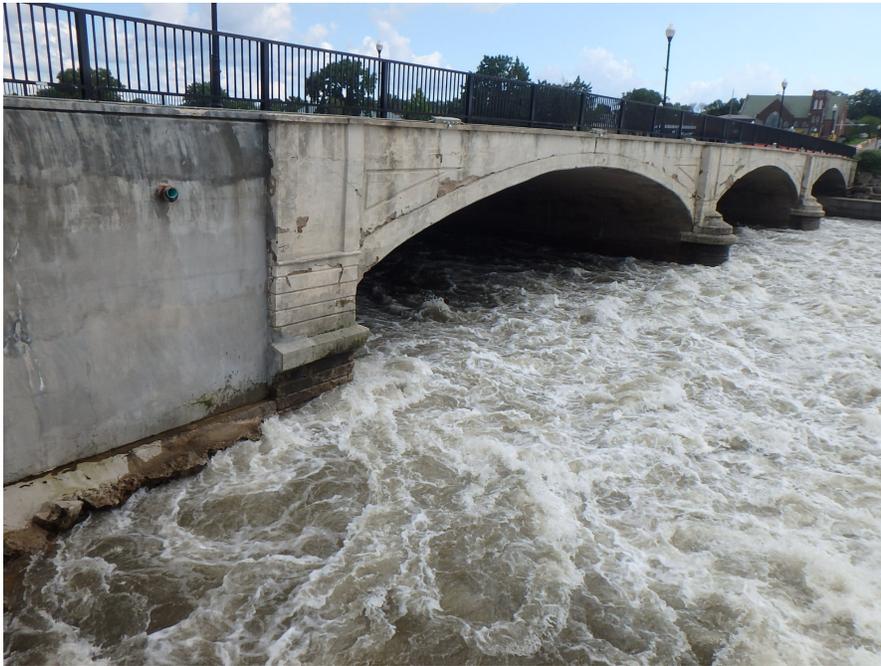
Photo Number: 3

LOOKING SOUTHEAST

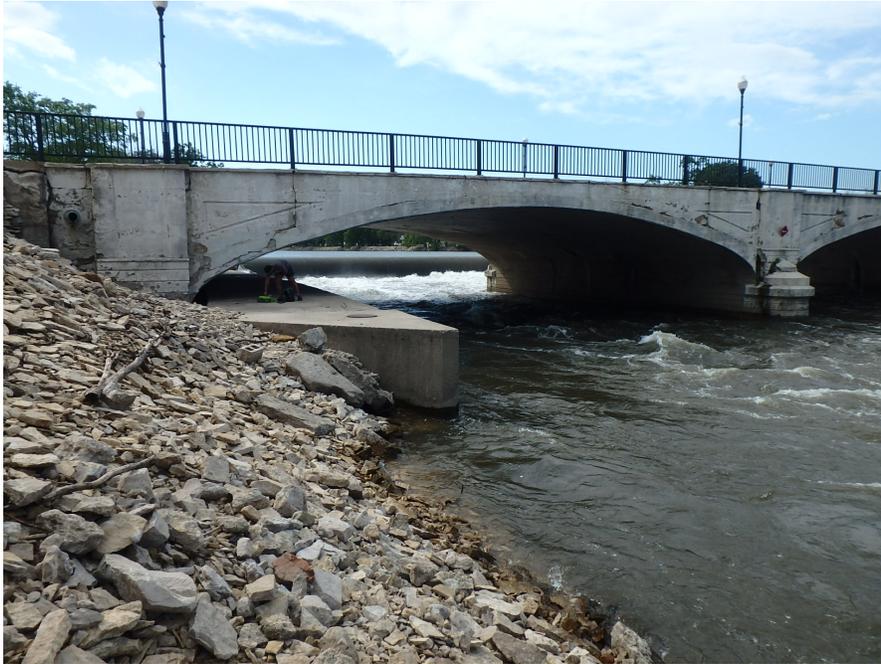
Photo Number: 5

LOOKING WEST

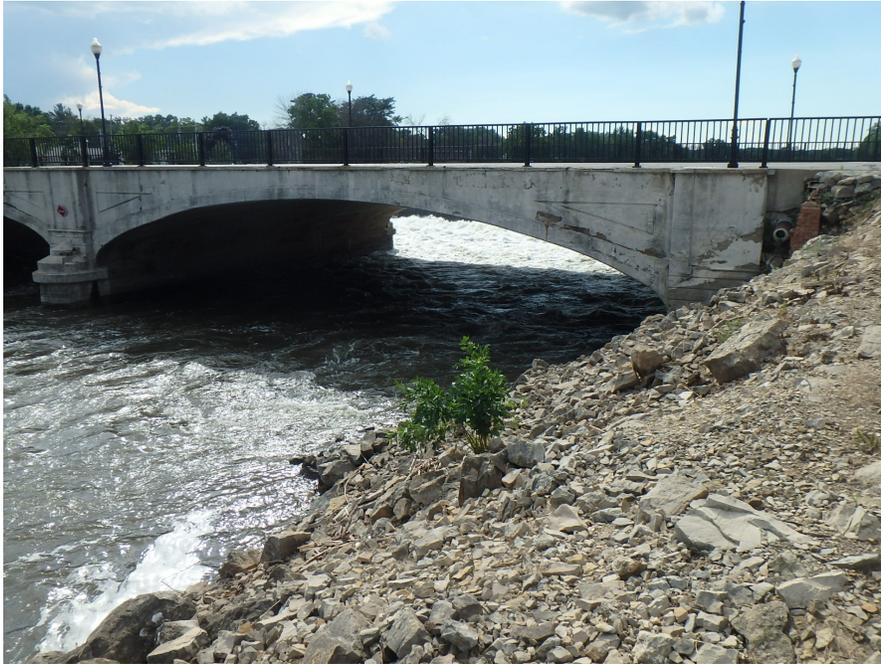
Photo Number: 7

LOOKING WEST

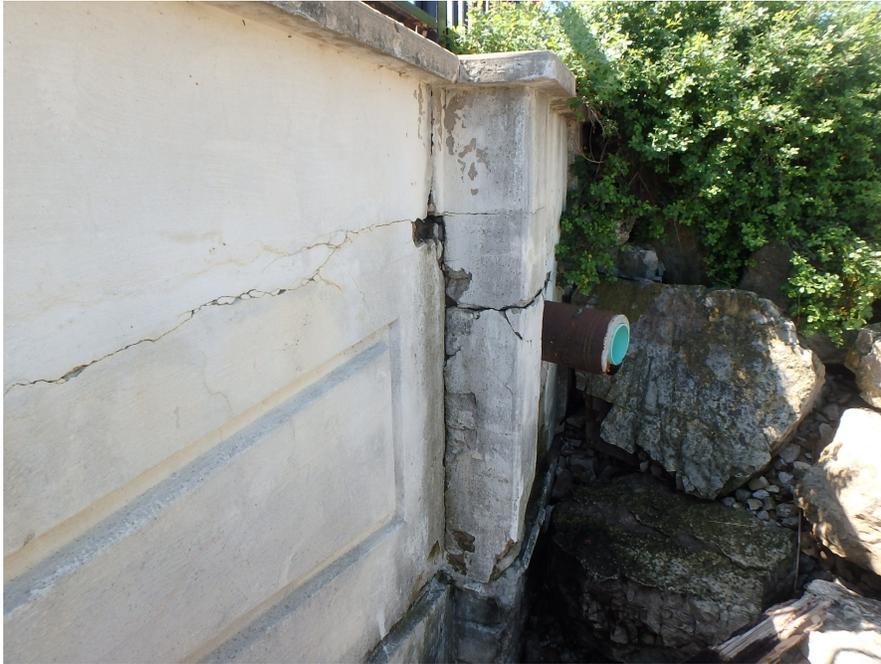
Photo Number: 9

LOOKING SOUTHEAST AT WEST FACE OF SOUTH ABUTMENT

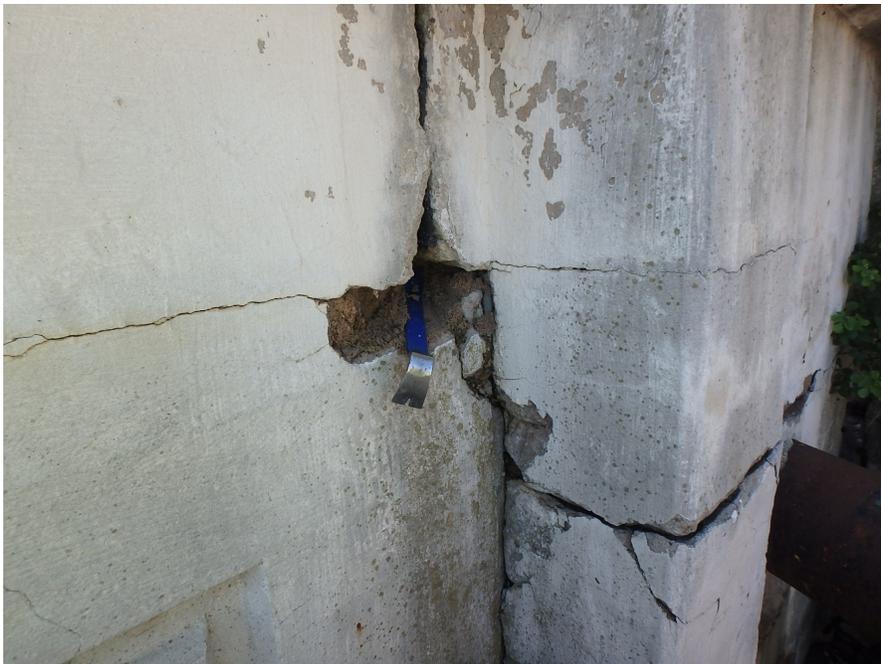
Photo Number: 10

SPALL AT SOUTH ABUTMENT, WEST FACE

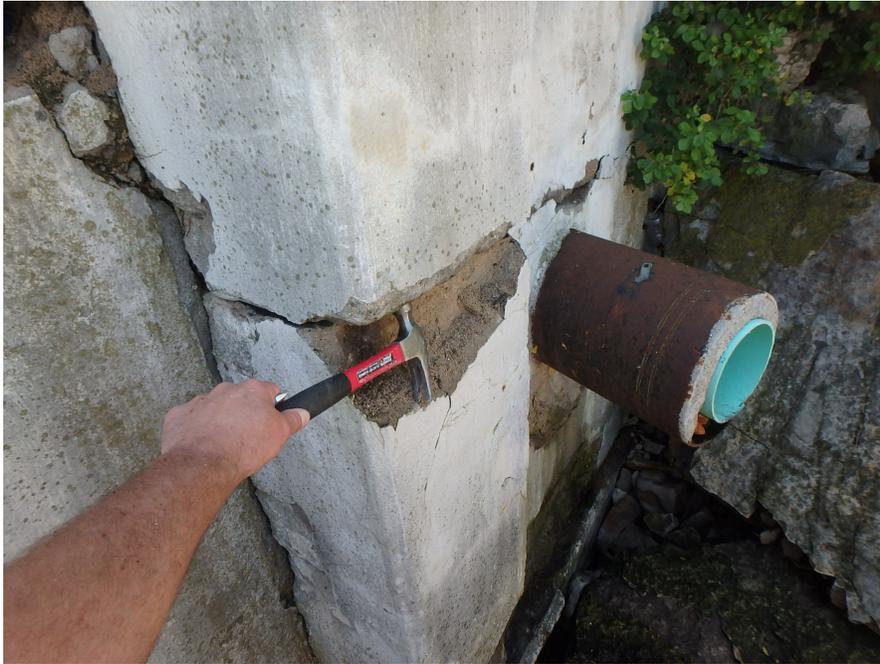
Photo Number: 11

SPALL AT SOUTH ABUTMENT, WEST FACE

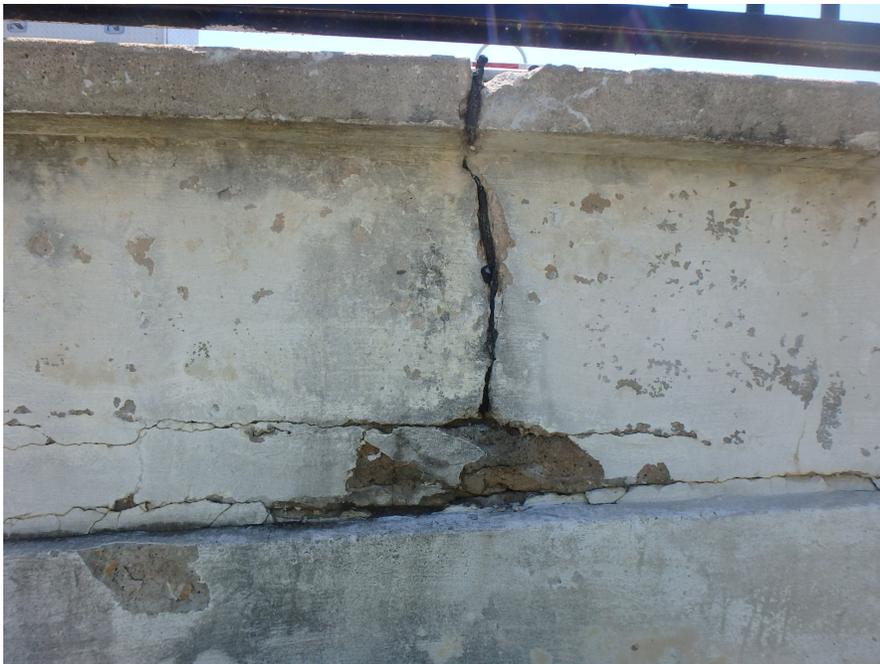
Photo Number: 12

SPALL AT WEST FASCIA, NEAR MIDSPAN OF SOUTH SPAN

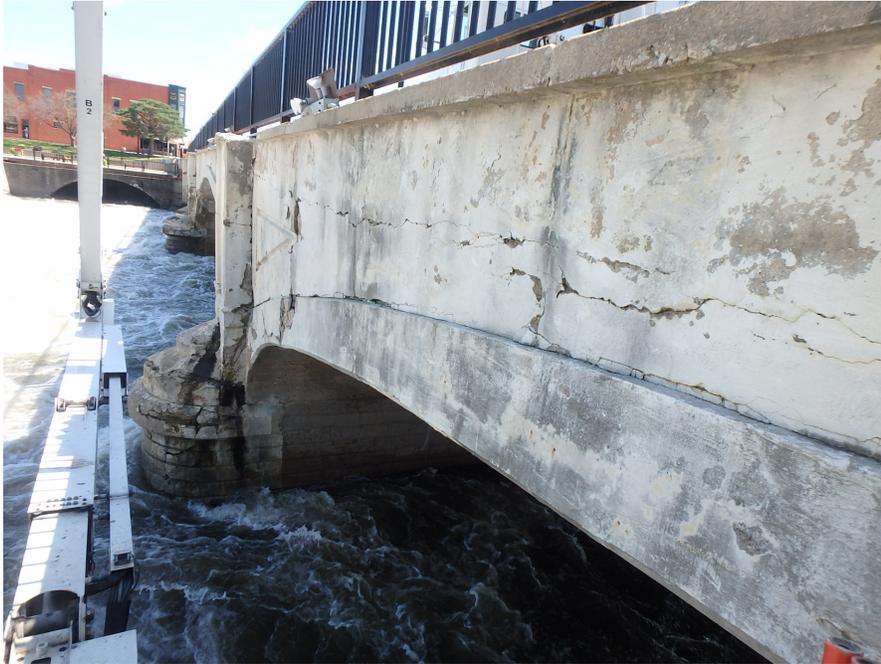
Photo Number: 13

LOOKING NORTH ALONG WEST FASCIA, SOUTH SPAN

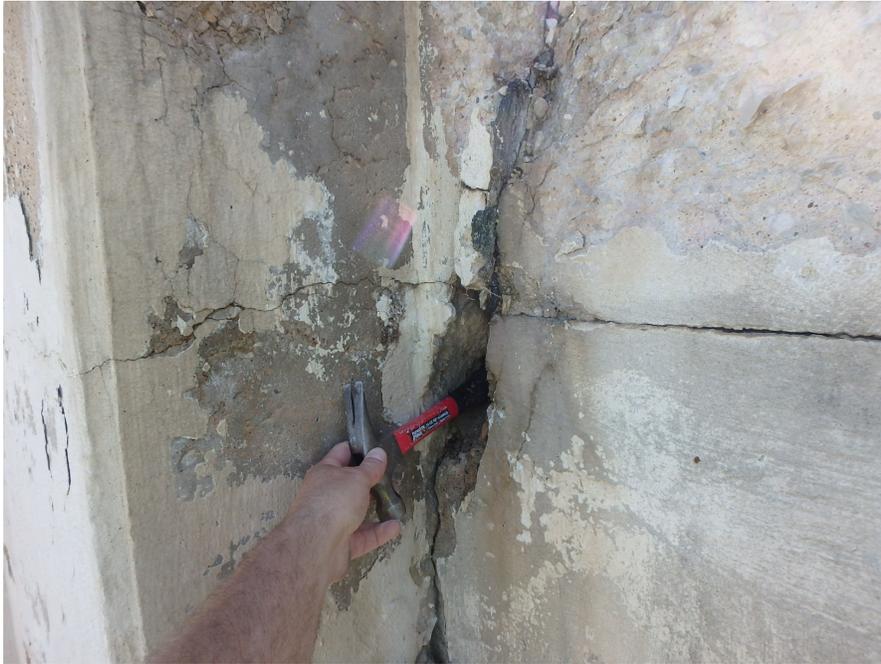
Photo Number: 15

SPALLED WEST FASCIA, SOUTH PIER

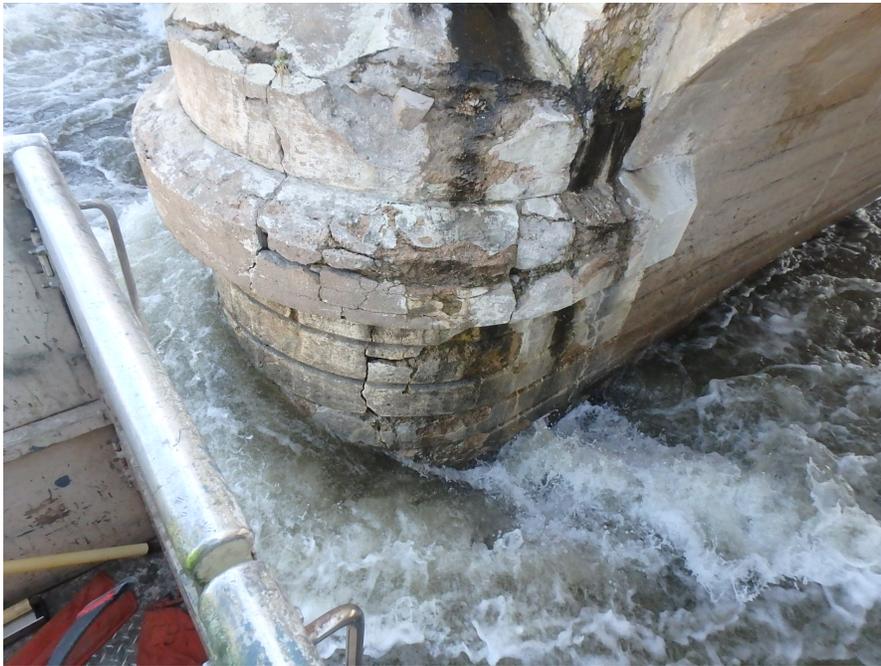
Photo Number: 17

WEST END OF SOUTH PIER NOSE

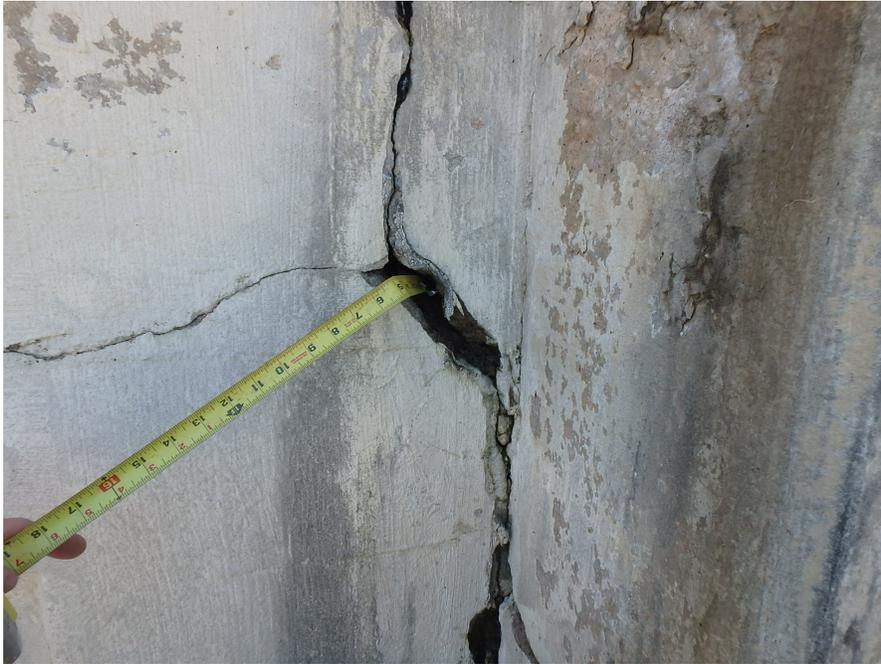
Photo Number: 19

SPALLED WEST FASCIA, SOUTH PIER

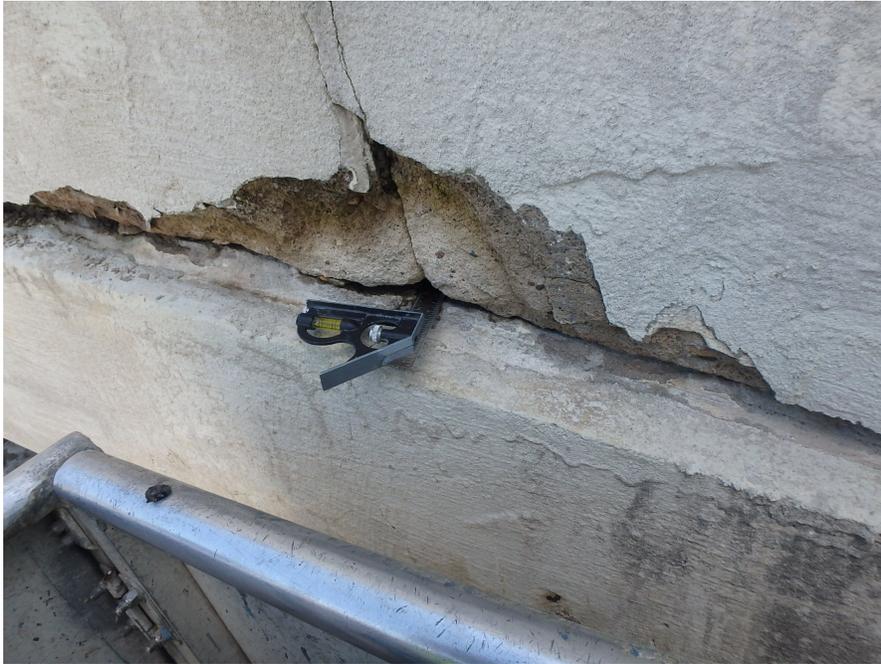
Photo Number: 21

SPALLED WEST FASCIA, NORTH OF SOUTH PIER

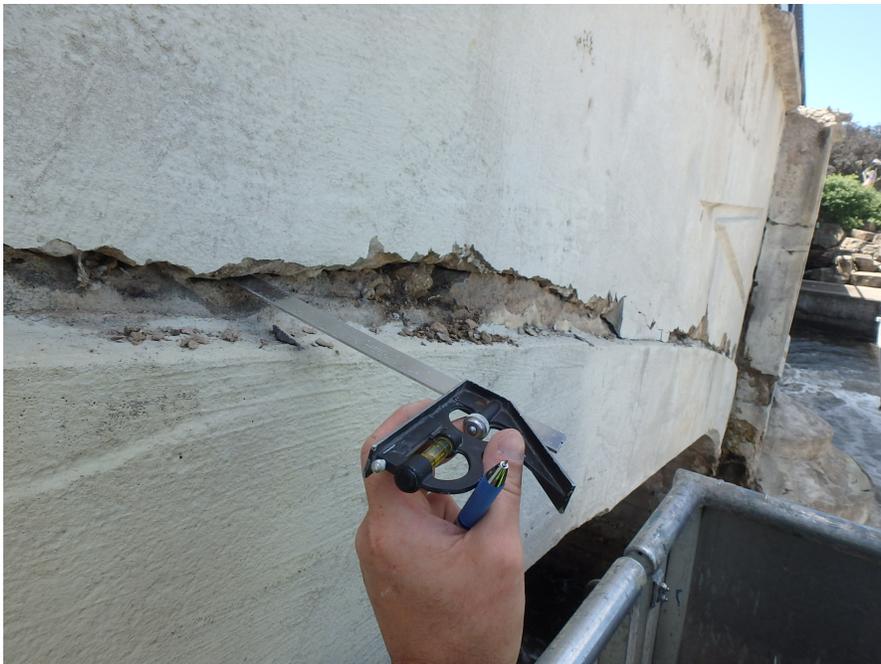
Photo Number: 22

SPALLED WEST FASCIA, NORTH OF SOUTH PIER

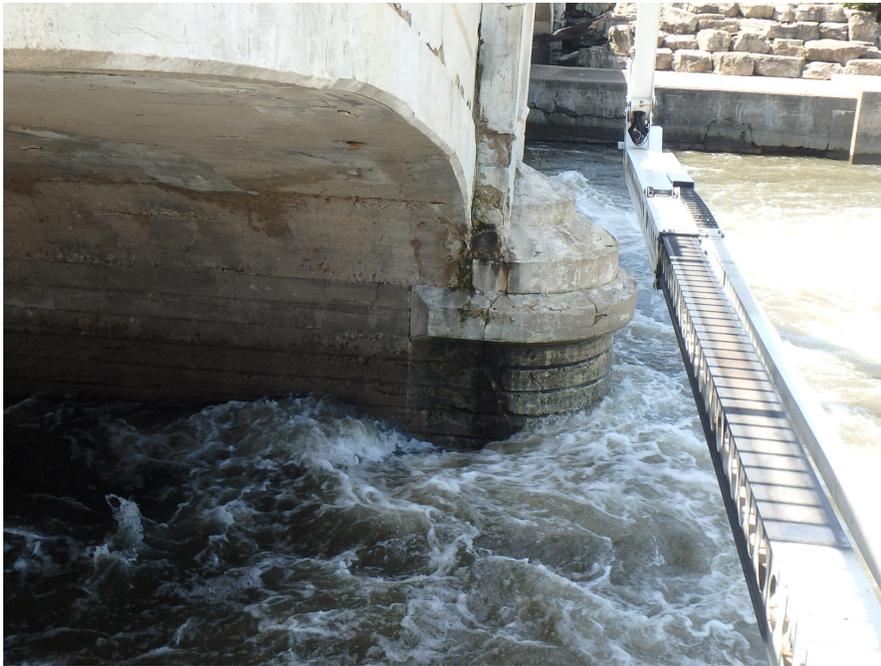
Photo Number: 23

LOOKING SOUTH AT SOUTH PIER, WEST SIDE

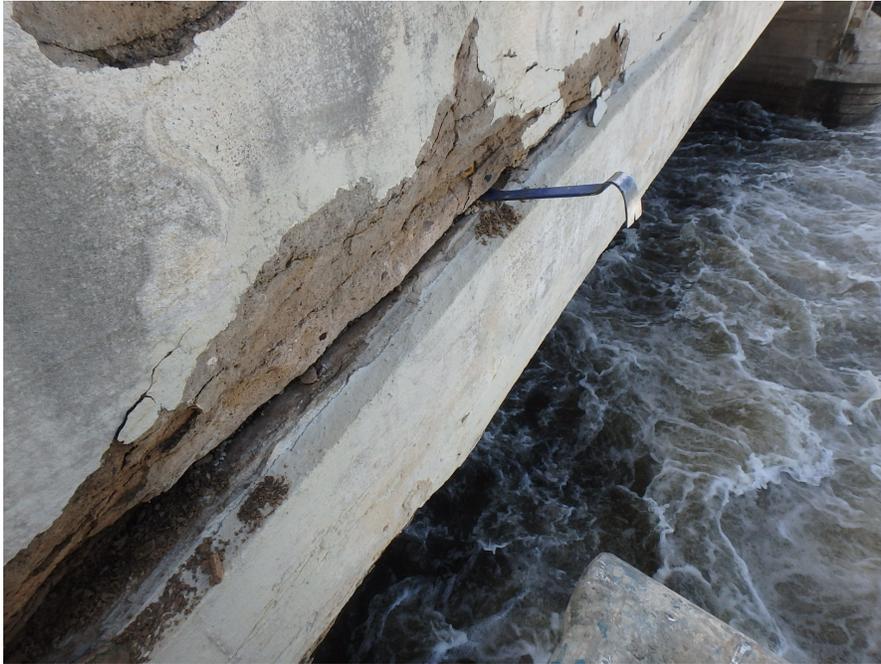
Photo Number: 25

SPALLED FASCIA, SOUTH OF NORTH PIER

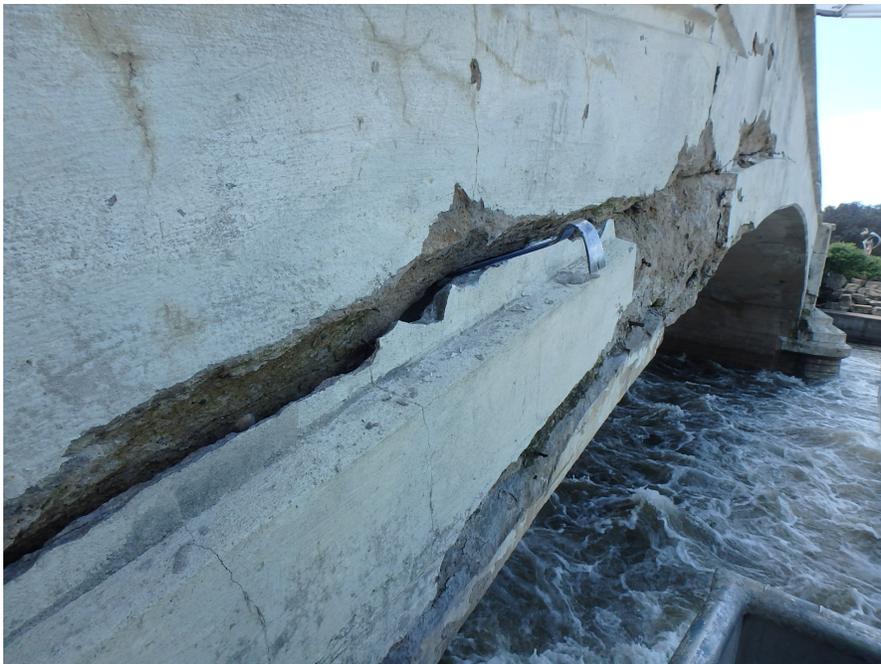
Photo Number: 26

SPALLED ARCH, LOOKING SOUTH FROM NORTH PIER

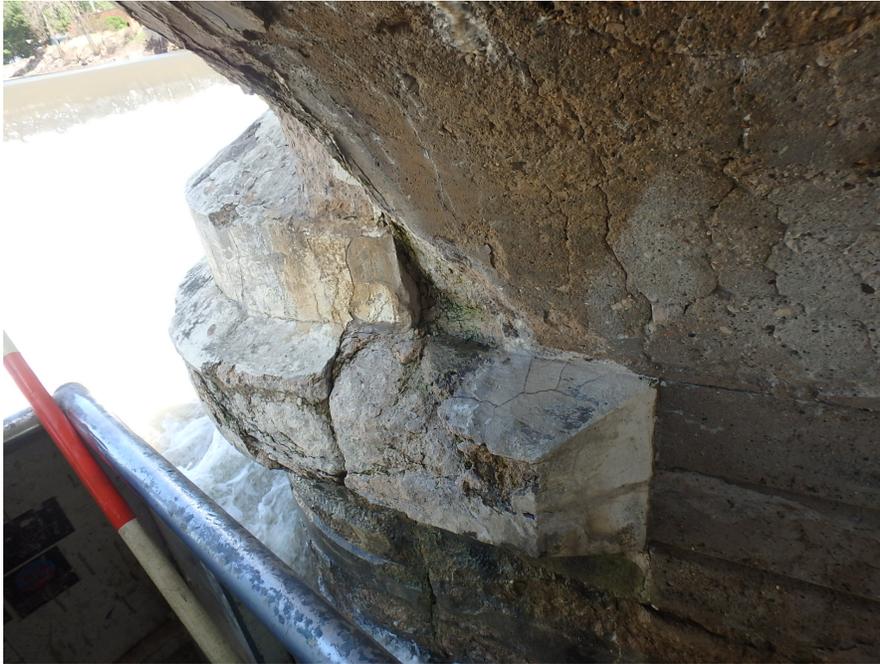
Photo Number: 27

SPALLED NORTH PIER, WEST END

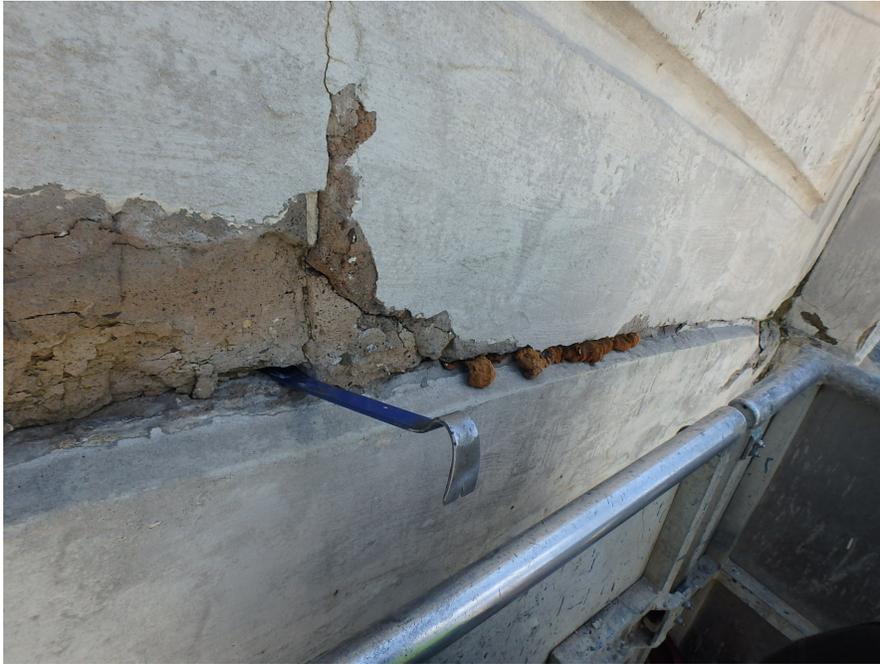
Photo Number: 29

SPALLED WEST FASCIA, NORTH OF NORTH PIER

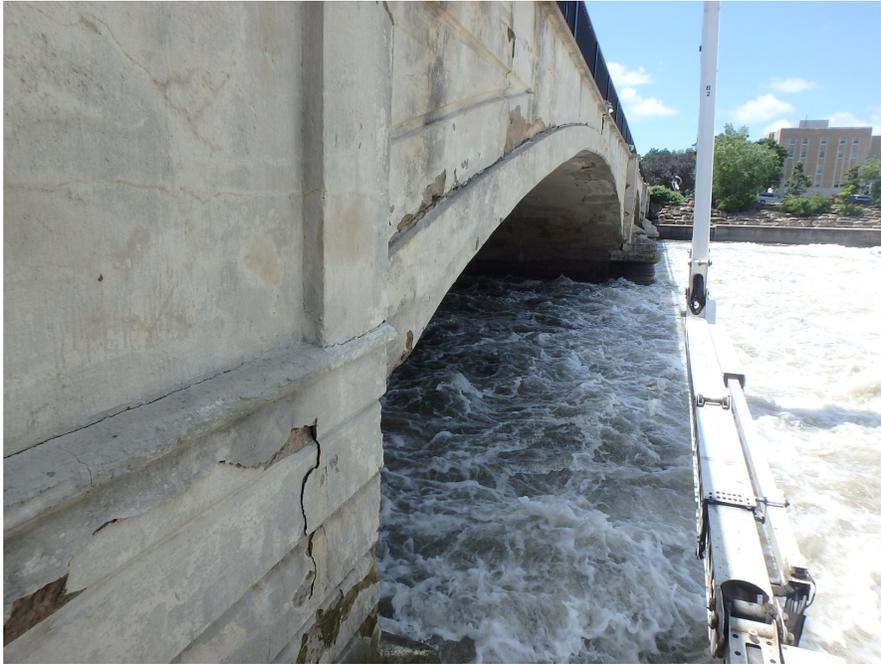
Photo Number: 31

LOOKING SOUTH AT WEST FACE, NORTH SPAN

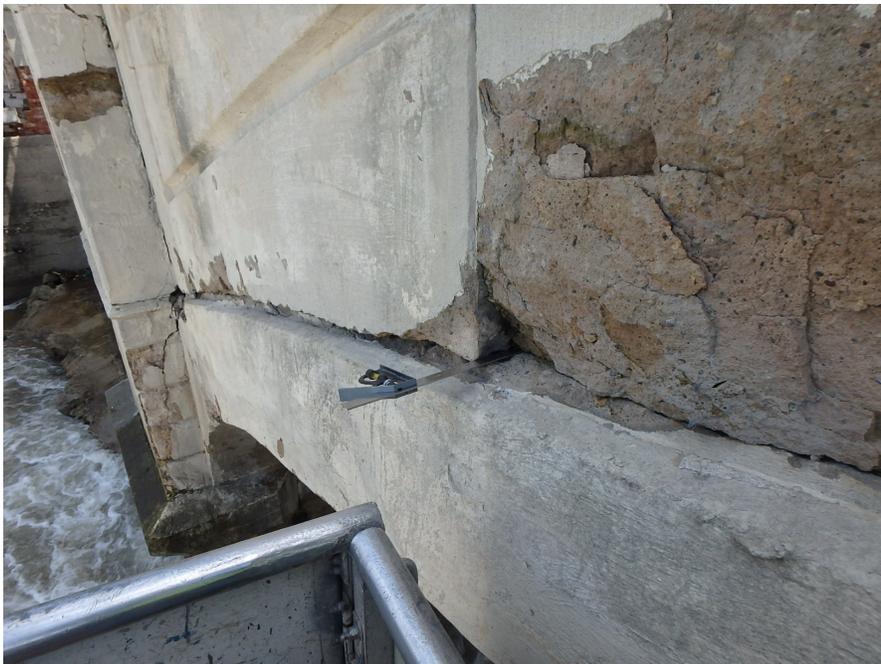
Photo Number: 32

SPALLED WEST FASCIA, SOUTH OF NORTH ABUTMENT

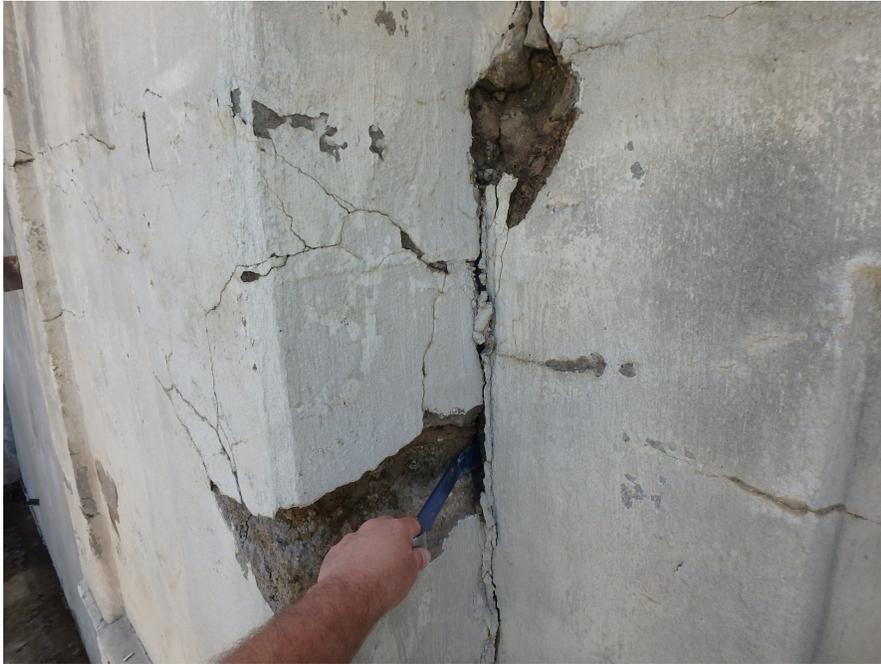
Photo Number: 33

SPALLED WEST FASCIA, NORTH ABUTMENT

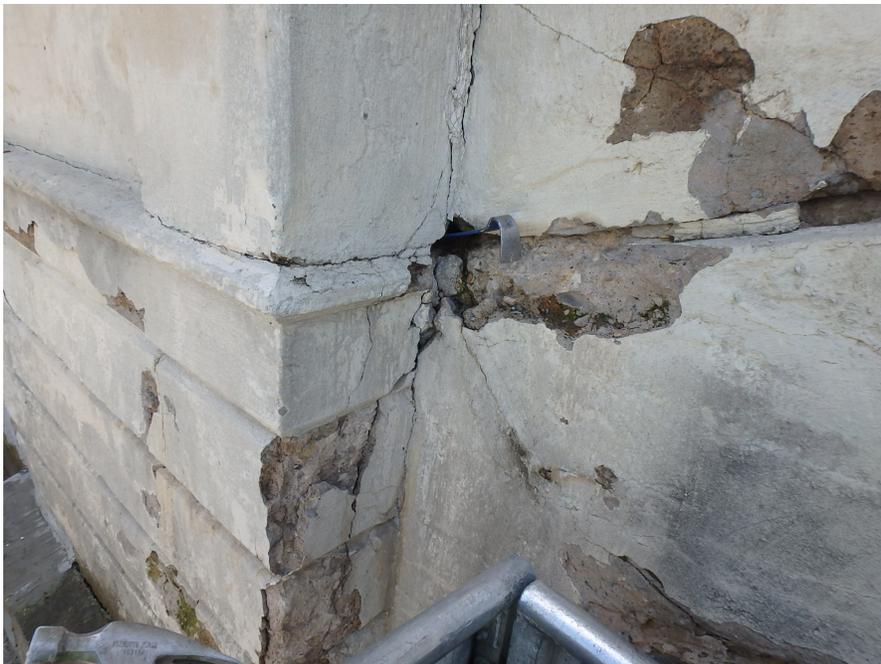
Photo Number: 34

SPALLED WEST FASCIA, NORTH ABUTMENT

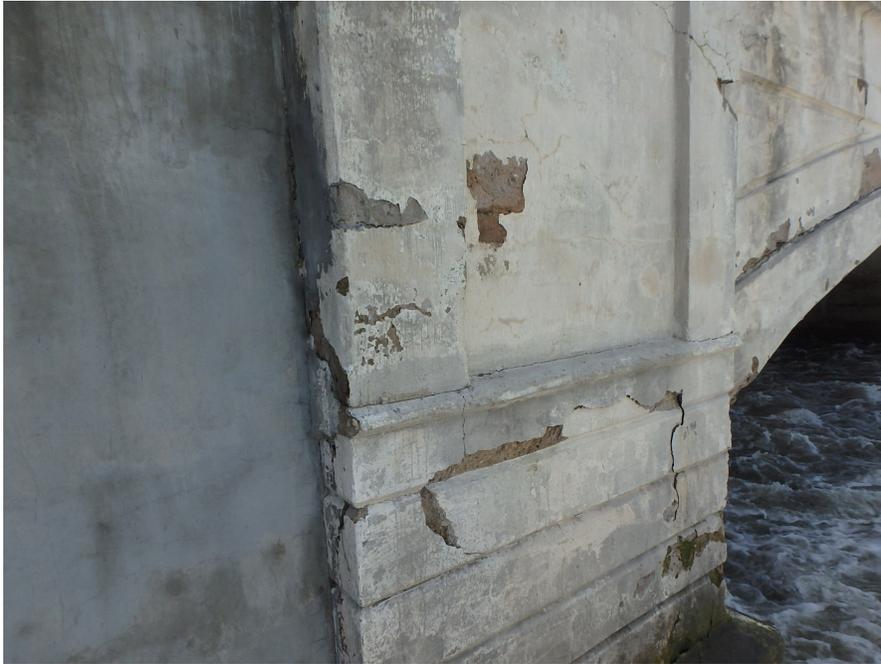
Photo Number: 35

WEST FACE OF NORTH ABUTMENT

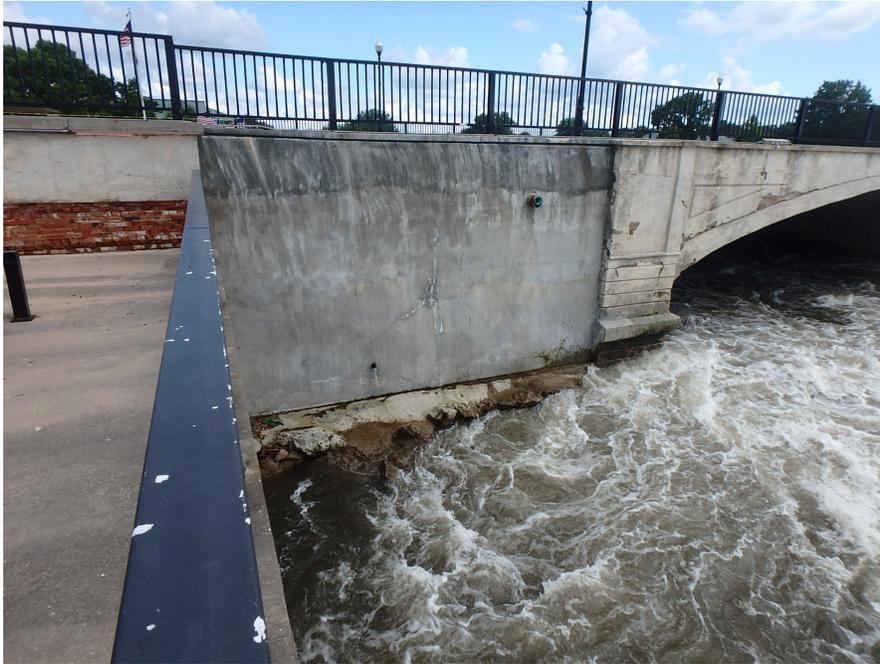
Photo Number: 37

LOOKING EAST AT NORTHWEST WING

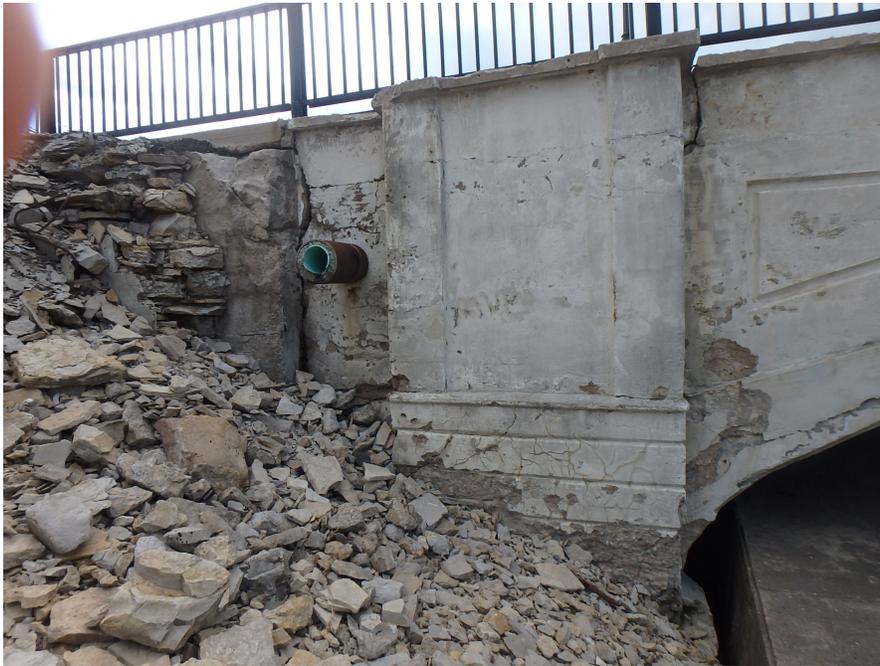
Photo Number: 39

SOUTHEAST WING

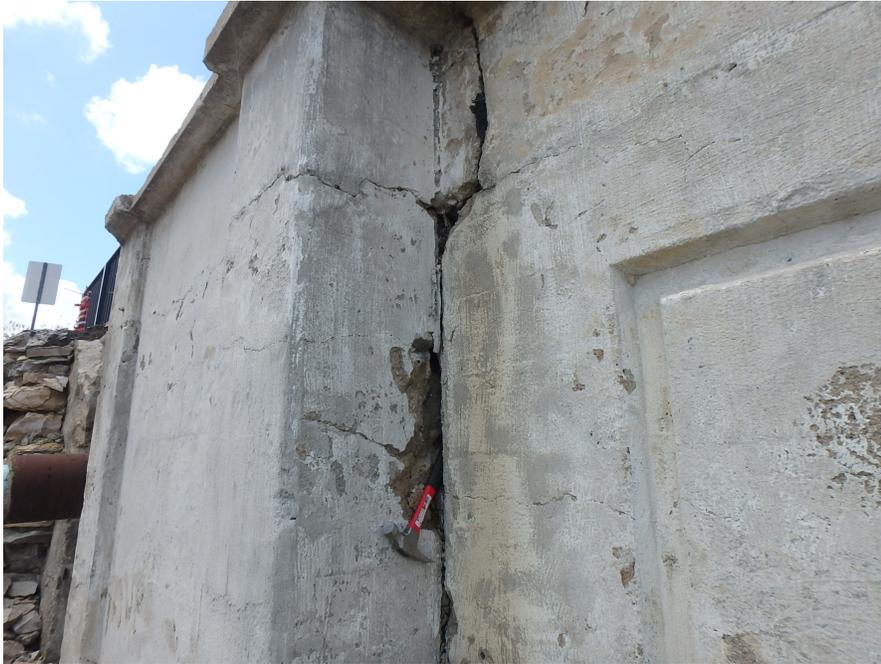
Photo Number: 41

SPALLED EAST FACE, SOUTH ABUTMENT

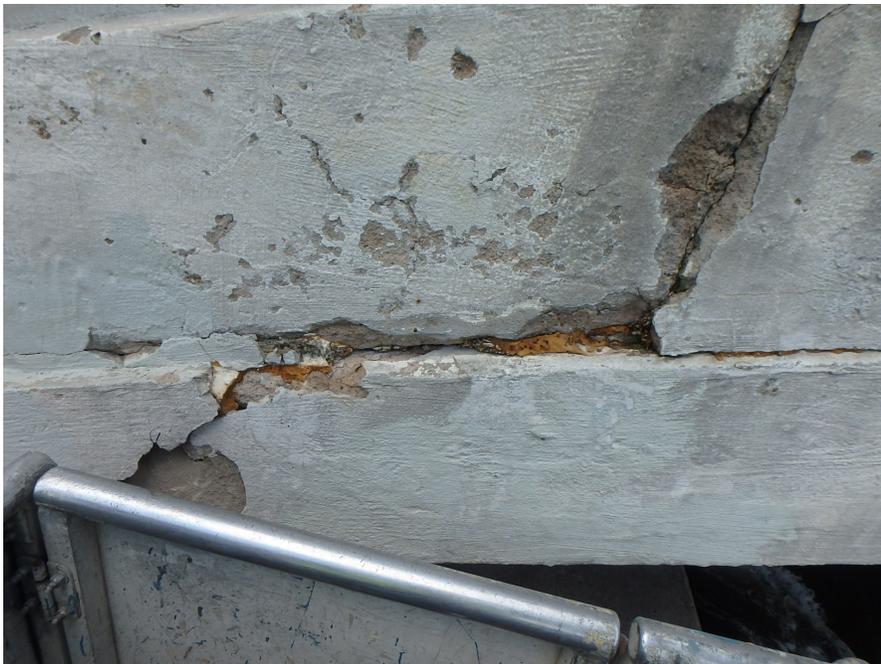
Photo Number: 42

SPALLED EAST FASCIA, NORTH OF SOUTH ABUTMENT

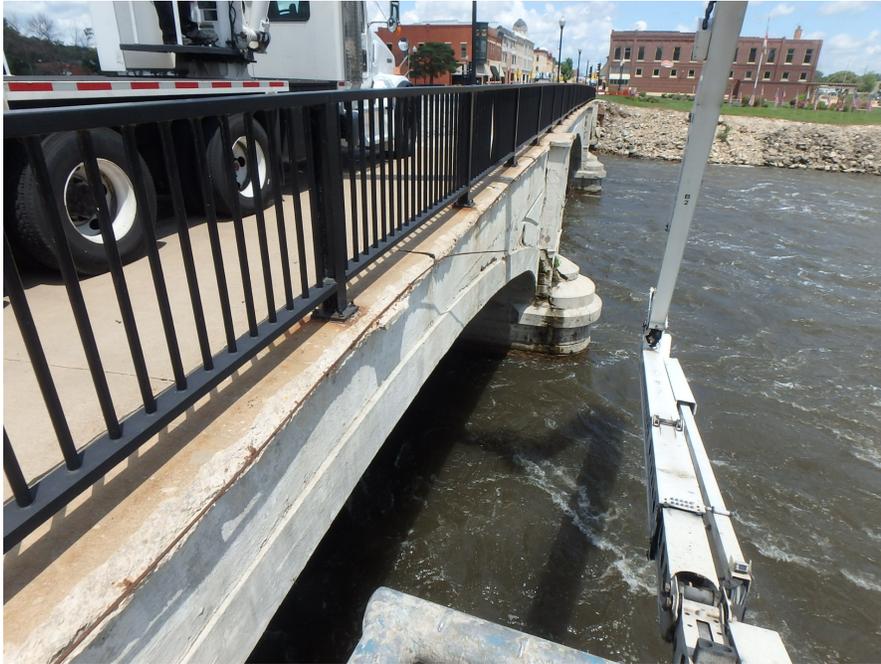
Photo Number: 43

LOOKING NORTH AT SPALLED TOP OF EAST FASCIA

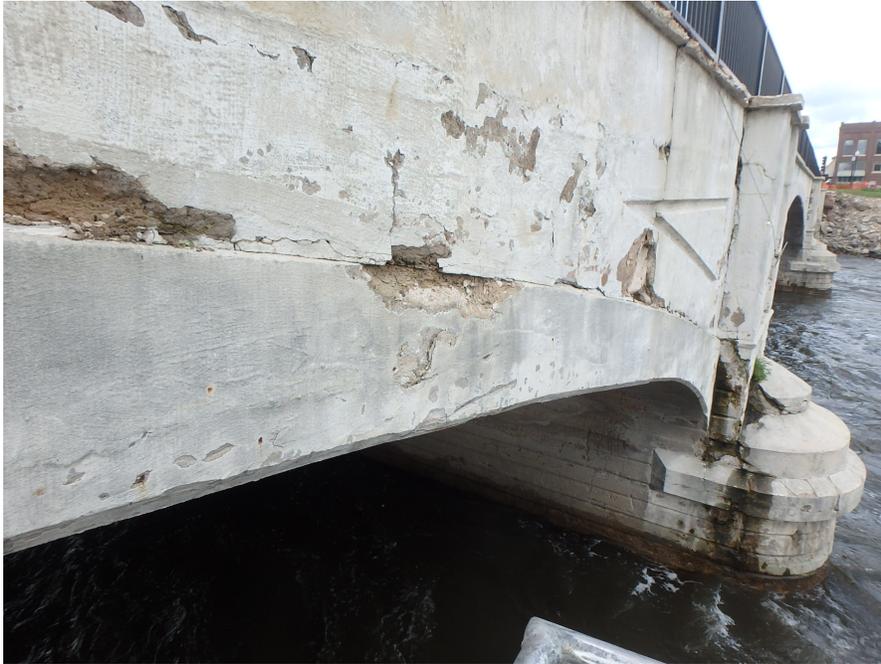
Photo Number: 45

LOOKING NORTH, EAST FASCIA, SOUTH OF SOUTH PIER

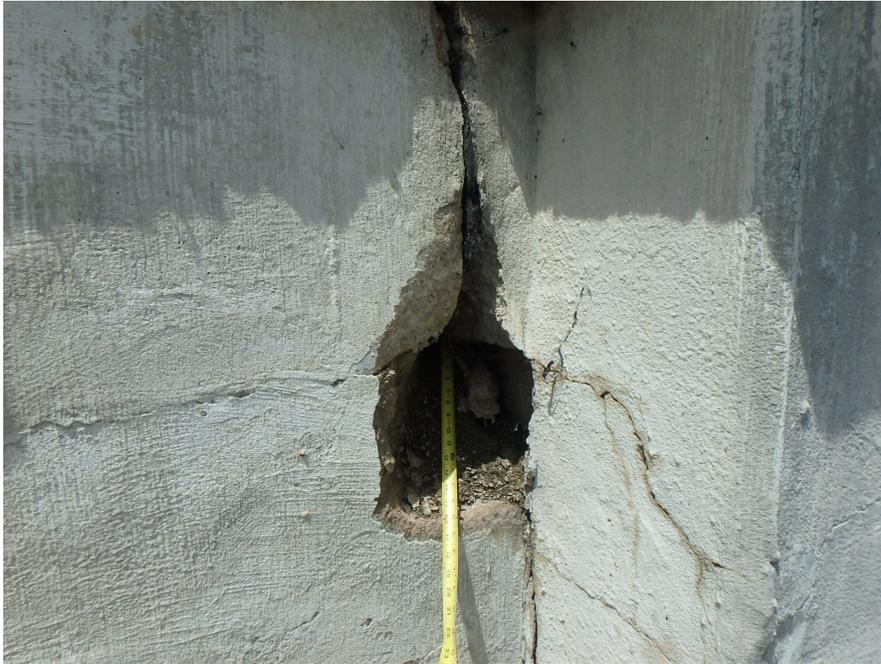
Photo Number: 47

SPALLED EAST FASCIA, SOUTH OF SOUTH PIER

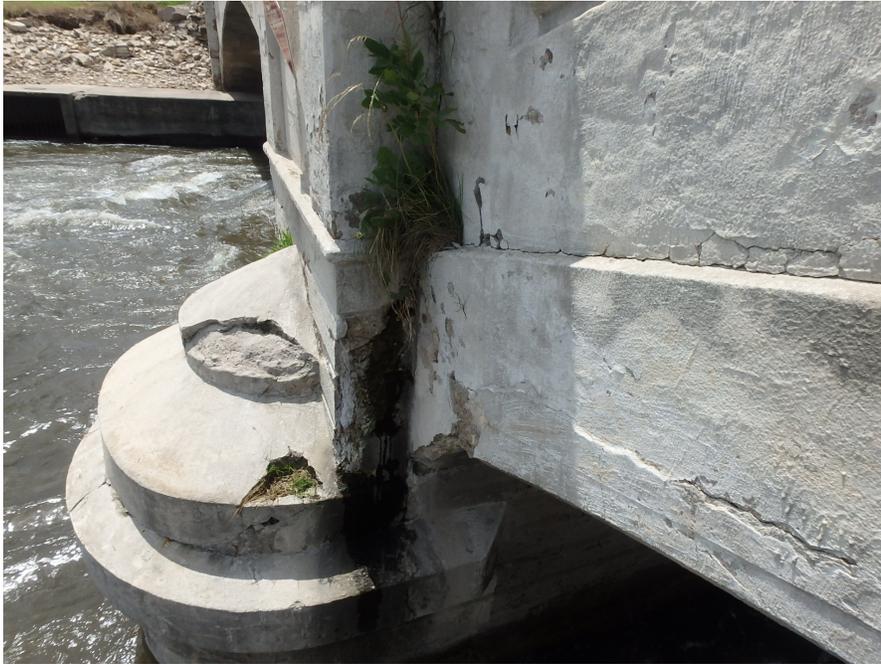
Photo Number: 49

LOOKING SOUTH AT EAST END OF SOUTH PIER

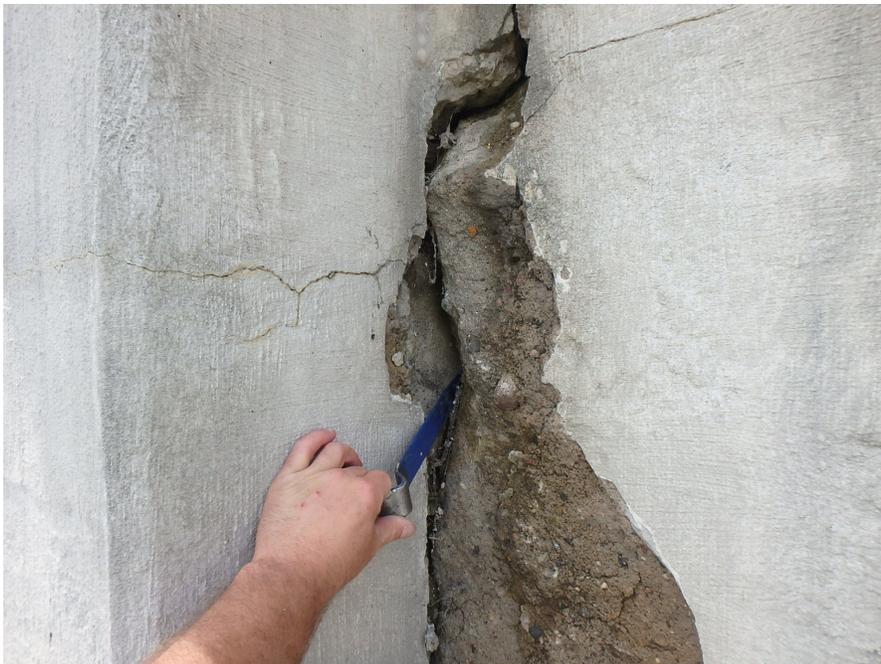
Photo Number: 50

SPALLED EAST FASCIA, SOUTH PIER

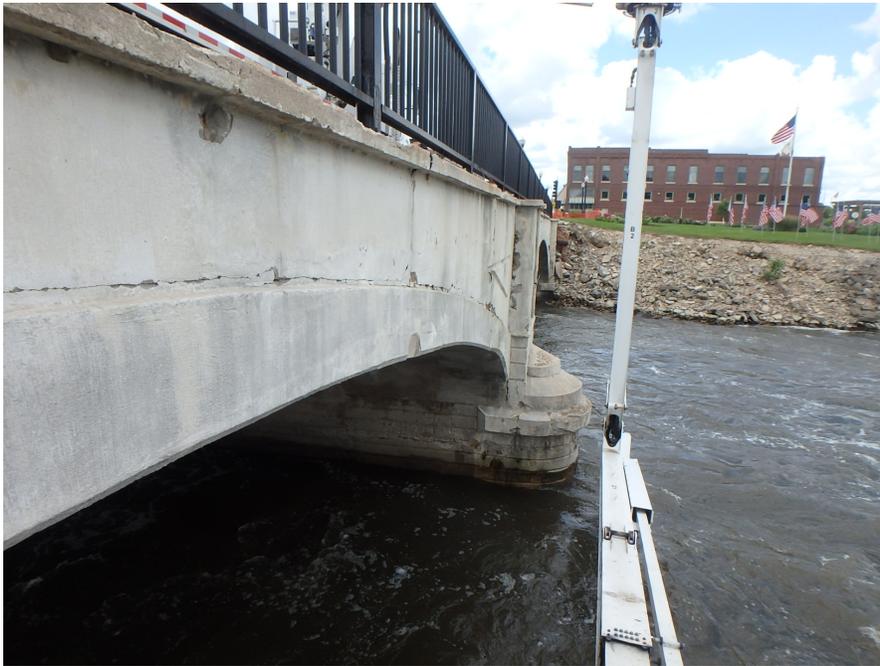
Photo Number: 51

LOOKING NORTH, EAST FACE, CENTER SPAN AND NORTH PIER

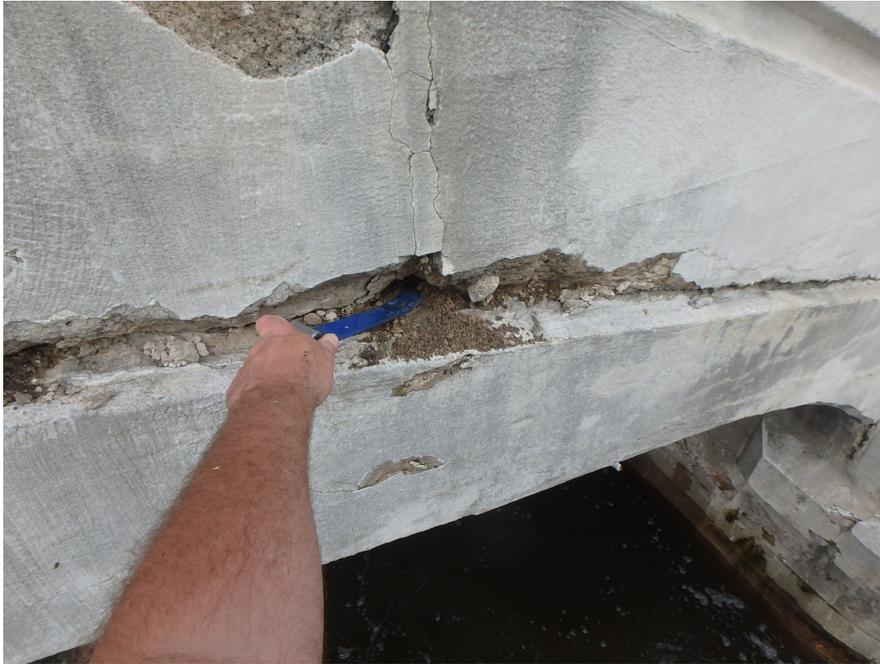
Photo Number: 53

SPALLED EAST FASCIA, SOUTH OF NORTH PIER

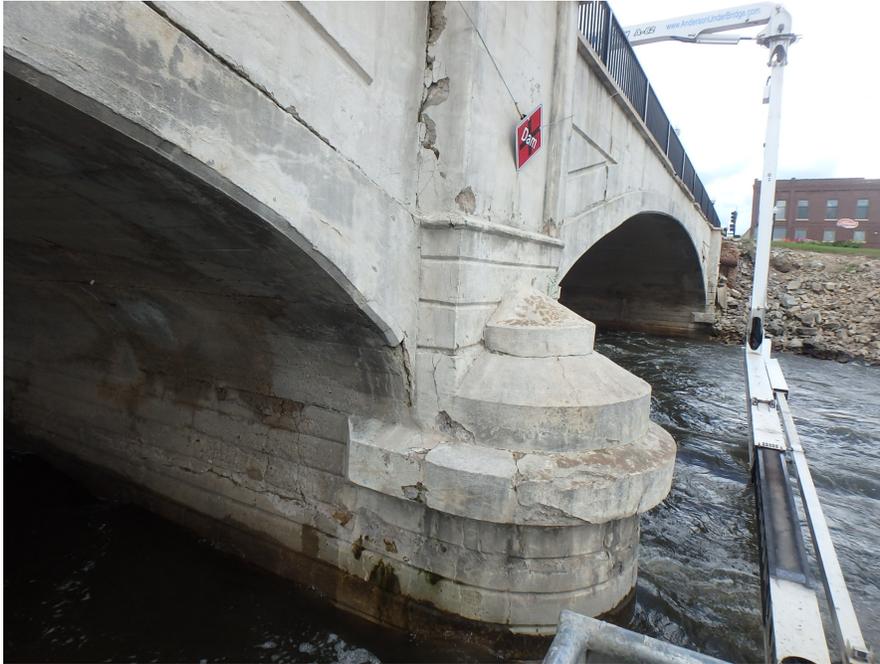
Photo Number: 55

LOOKING NORTH, EAST END OF NORTH PIER

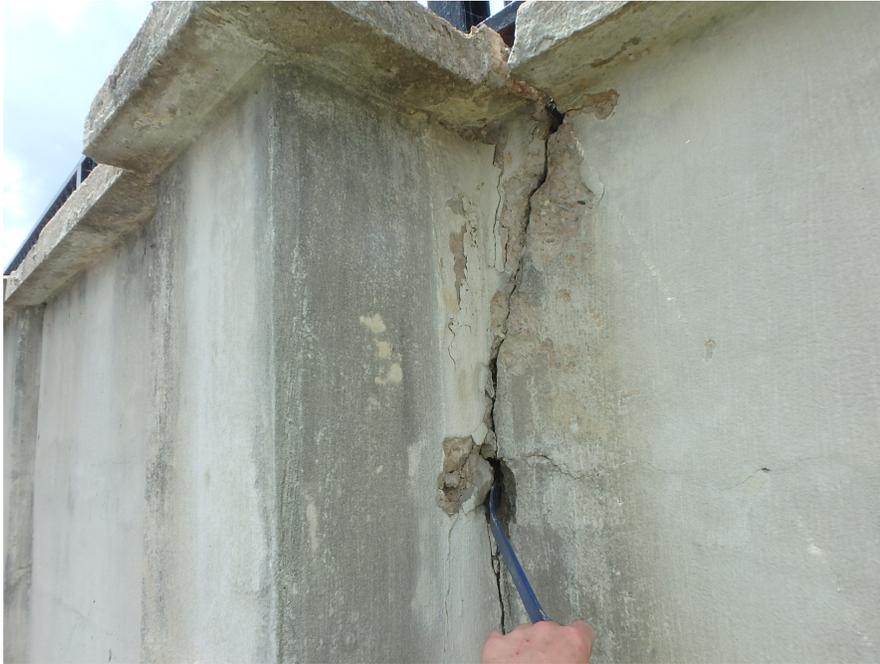
Photo Number: 57

SPALLED EAST FASCIA, NORTH PIER

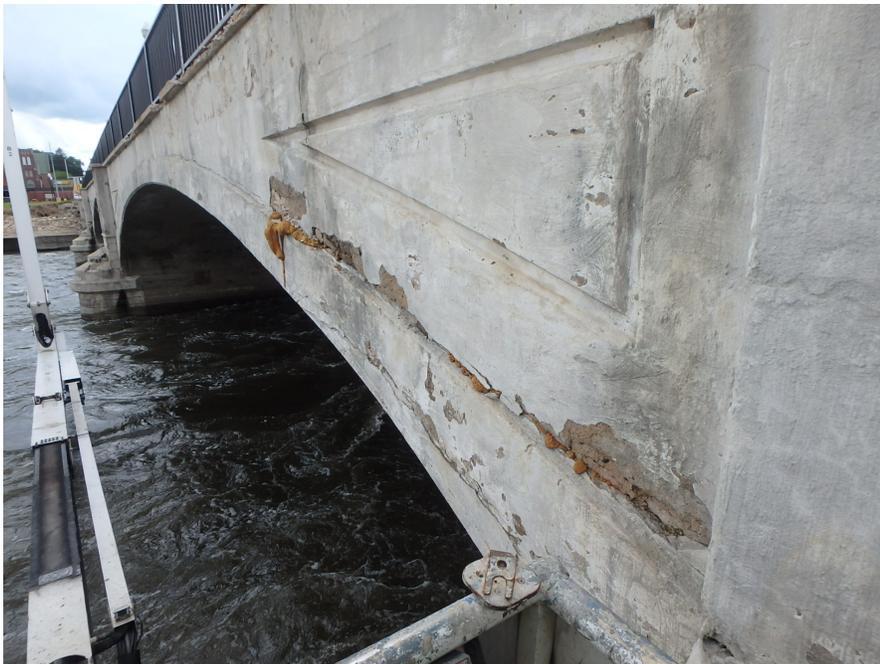
Photo Number: 58

LOOKING SOUTH, SPALLED EAST FASCIA, SOUTH OF NORTH ABUTMENT
