**MAIN STREET BRIDGE FEASIBILITY
FHWA NO. 001820**

**RE: FEASIBILITY STUDY
MAIN STREET BRIDGE IN CHARLES CITY
OVER CEDAR RIVER
FHWA No. 001820
CB&A No. 2022192**

STRUCTURE CONDITION REPORT
BRIDGE (001820), DAM, FLUME AND
FLOUR MILL FOUNDATION
MAIN STREET over CEDAR RIVER

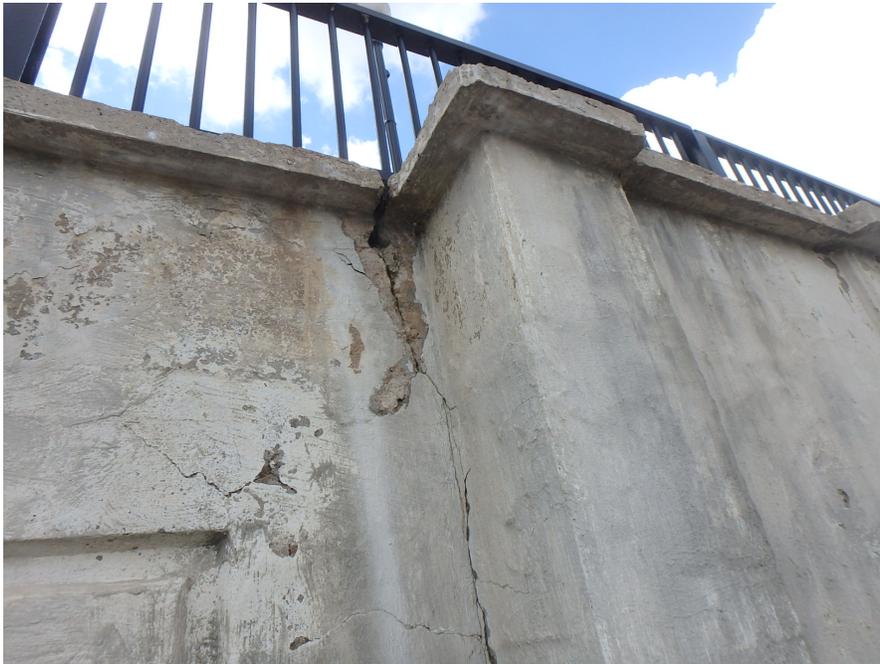
Photo Number: 59

LOOKING SOUTH, SPALLED EAST FASCIA, SOUTH OF NORTH ABUTMENT

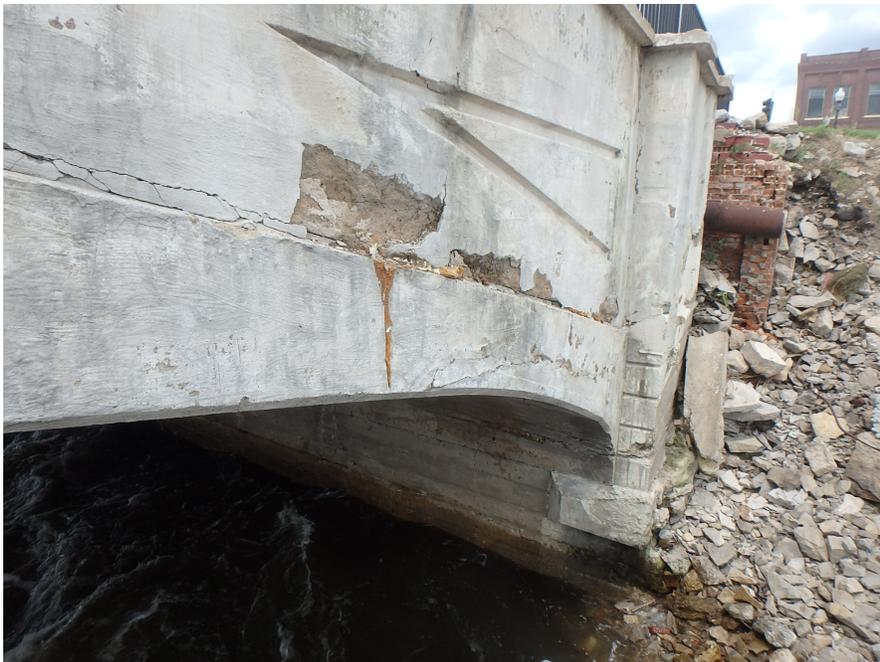
Photo Number: 60

LOOKING NORTH, SPALLED EAST FASCIA, SOUTH OF NORTH ABUTMENT

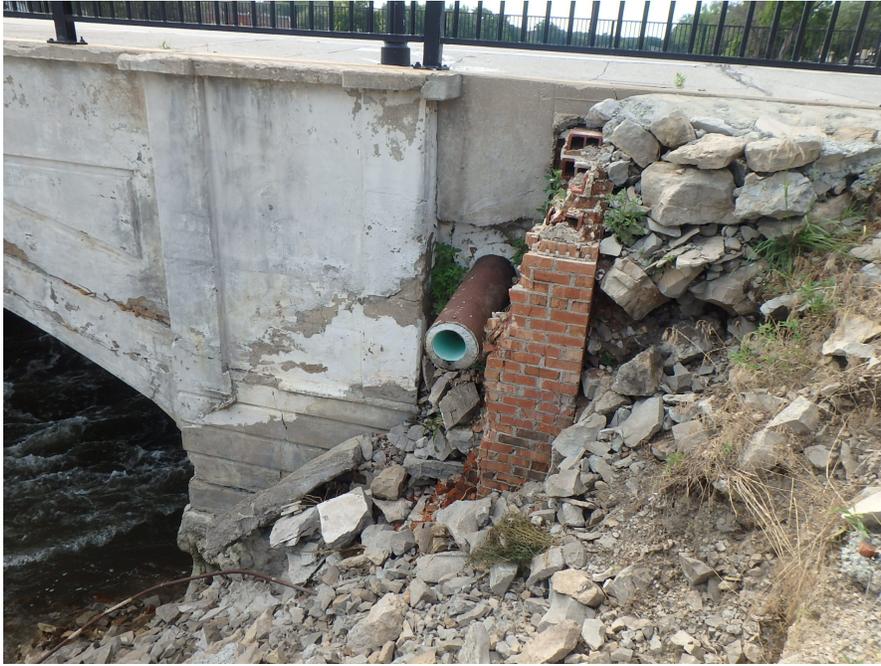
Photo Number: 61

NORTHEAST WING

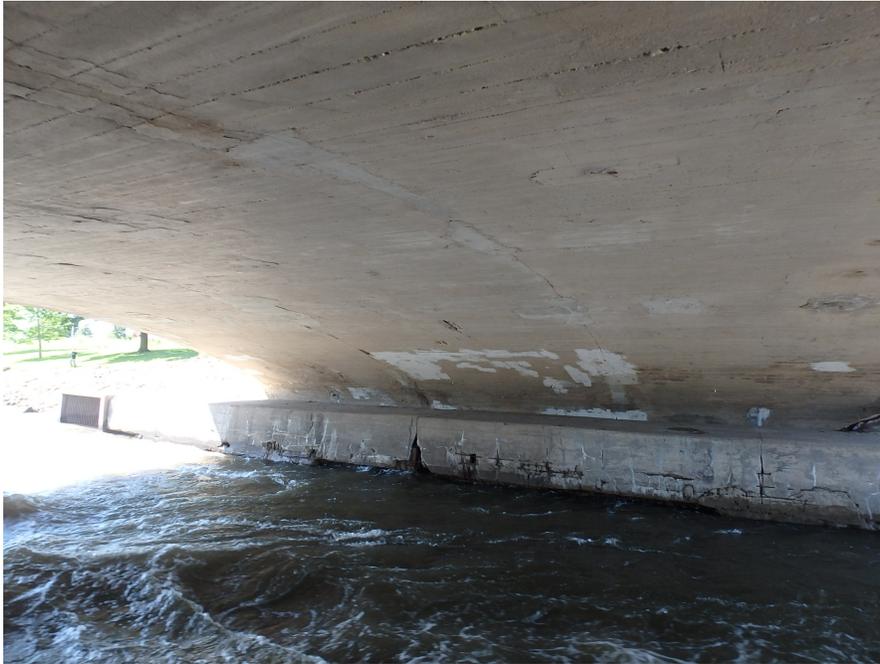
Photo Number: 63

LOOKING SOUTHEAST AT SOUTH SPAN

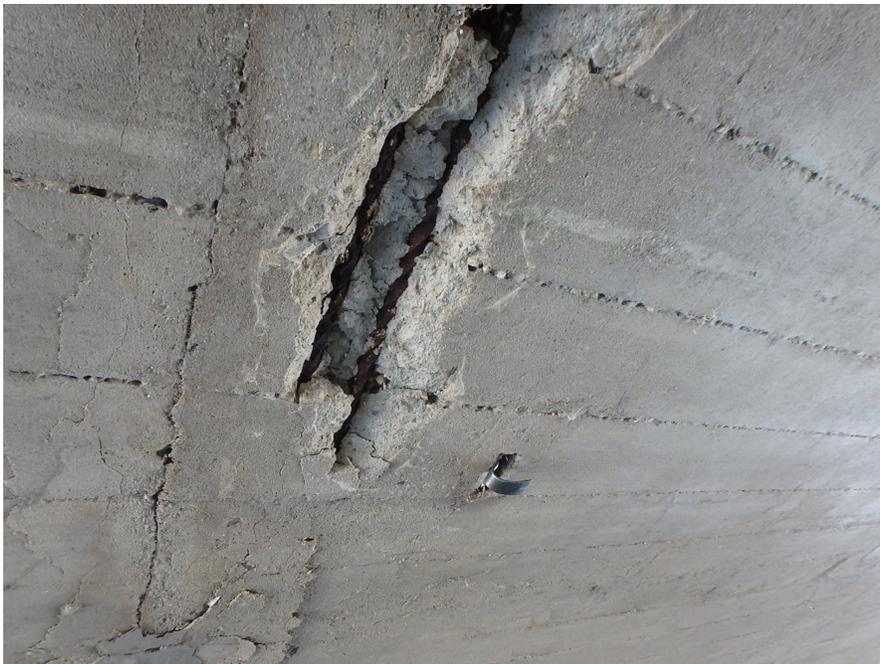
Photo Number: 64

SPALL WITH EXPOSED REBAR, SOUTH SPAN

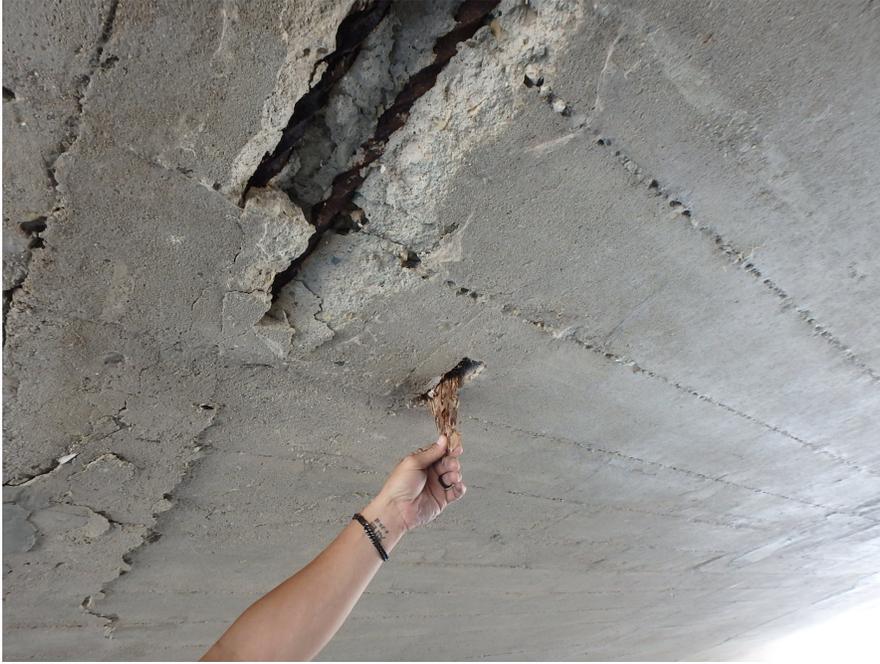
Photo Number: 65

WOOD FROM ORIGINAL FORM WORK

| <u>SUPERSTRUCTURE ITEMS</u> | <u>RATING</u> | <u>REMARKS</u> |
|---|---|---|
| 4. Floor Beams | _____ | <u>DECAYED FORM BOARDS ALLOWING LOSS OF FILL</u> |

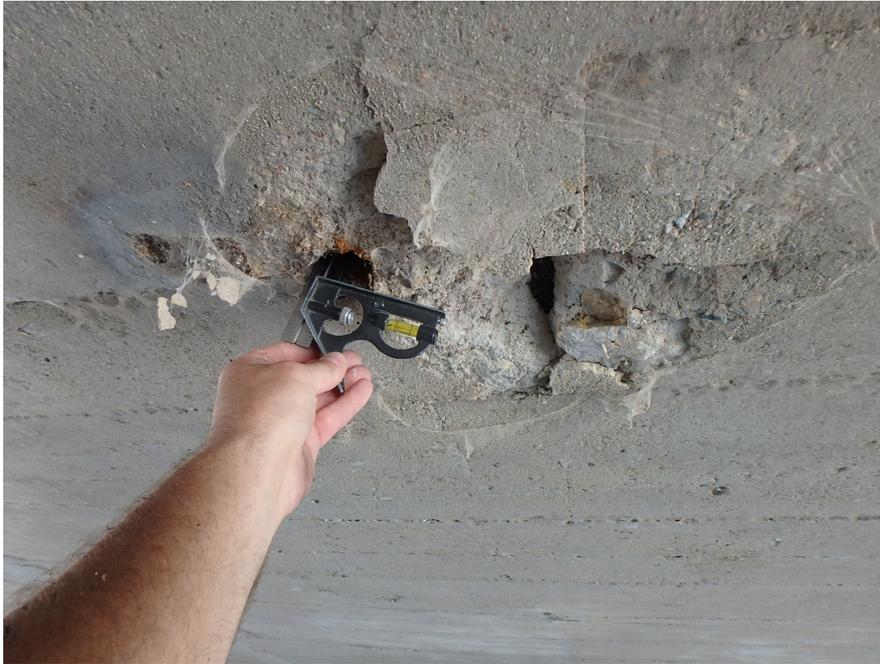
Photo Number: 67

HOLE THROUGH CONCRETE AT FORM WORK, SOUTH SPAN

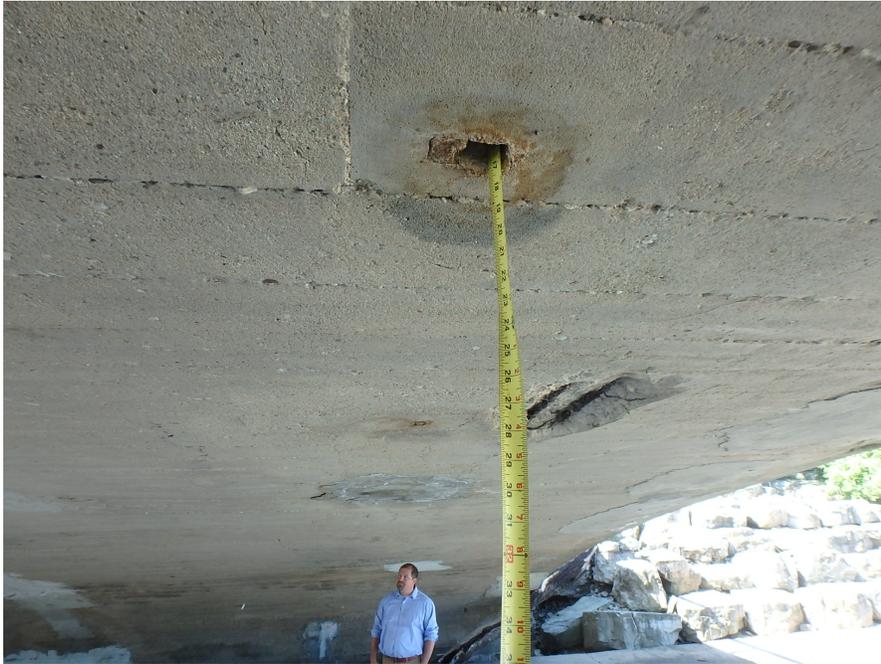
Photo Number: 69

HOLE THROUGH CONCRETE AT FORM WORK, SOUTH SPAN

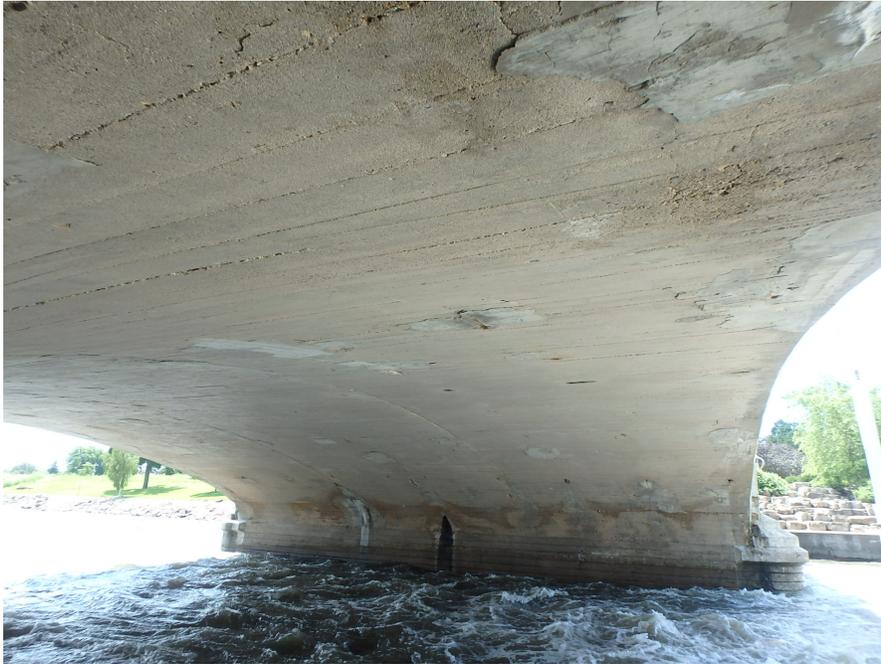
Photo Number: 71

LOOKING SOUTH AT CENTER SPAN

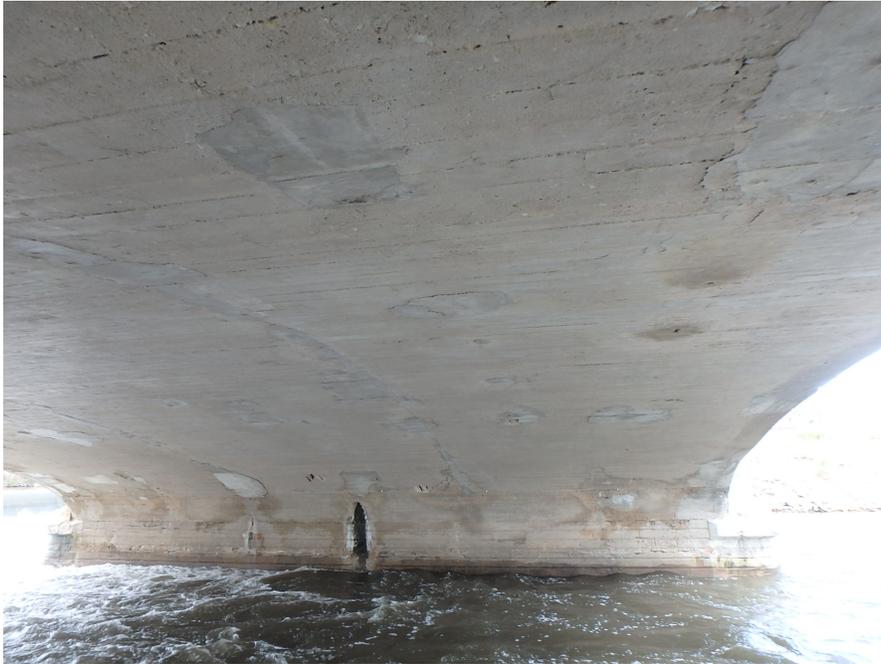
Photo Number: 73

LOOKING NORTH AT CENTER SPAN

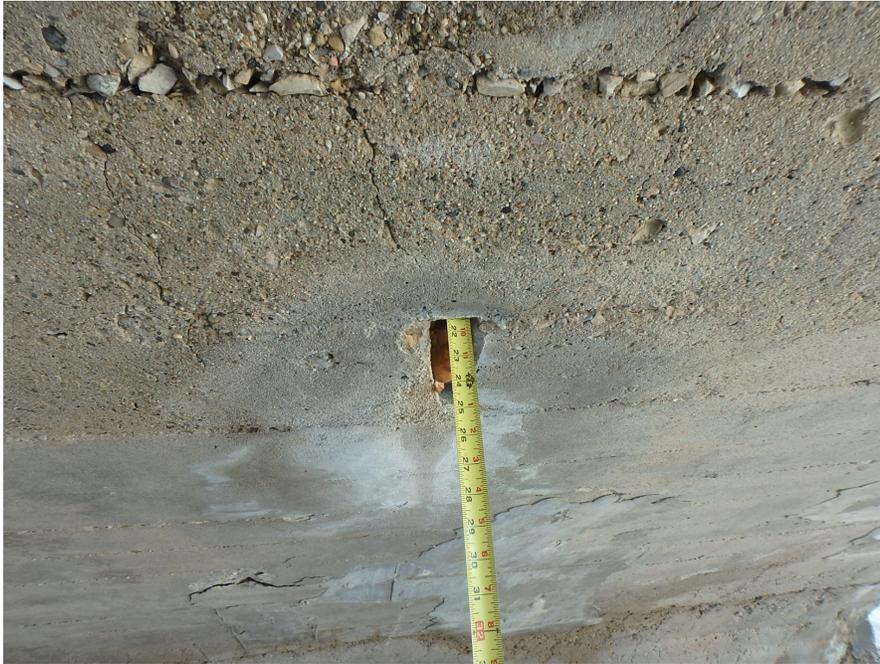
Photo Number: 75

HOLE THROUGH CONCRETE AT FORM WORK, CENTER SPAN,
APPROXIMATELY 10 FEET FROM WEST SIDE, SOUTH 1/4 POINT

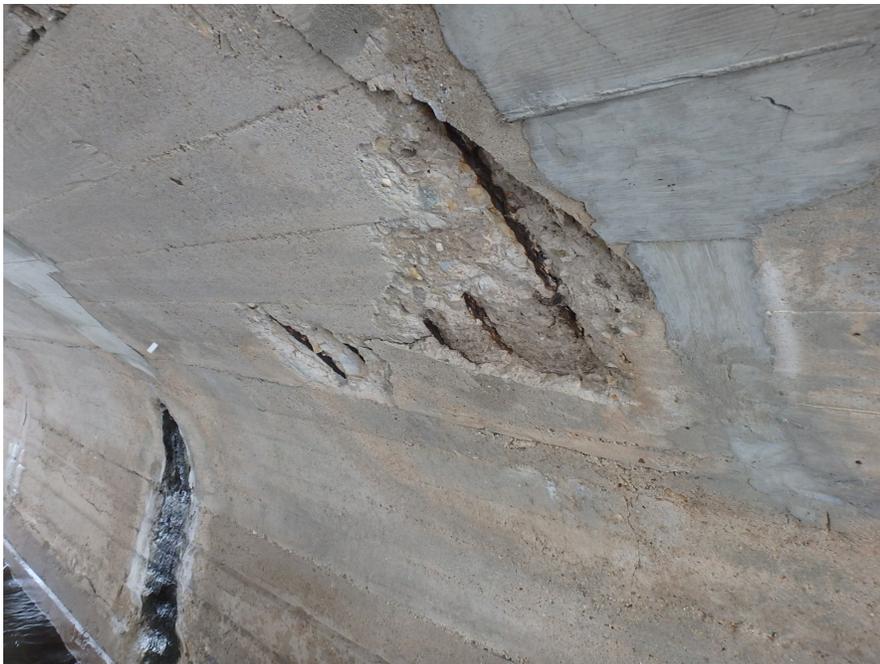
Photo Number: 76

SPALLED CENTER SPAN, NEAR NORTH PIER

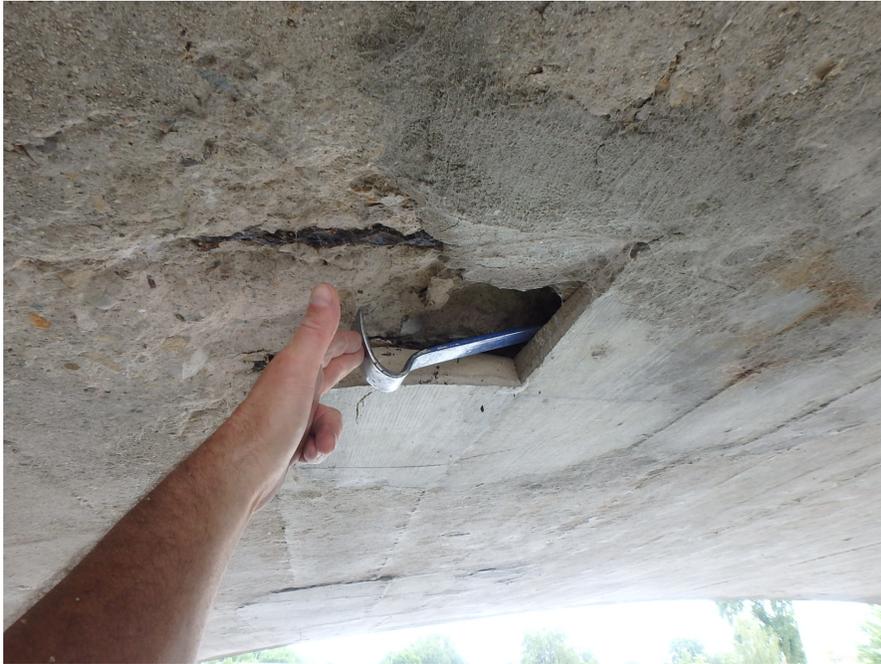
Photo Number: 77

VOID IN PATCH, CENTER SPAN, APPROXIMATELY NORTH 1/4 POINT

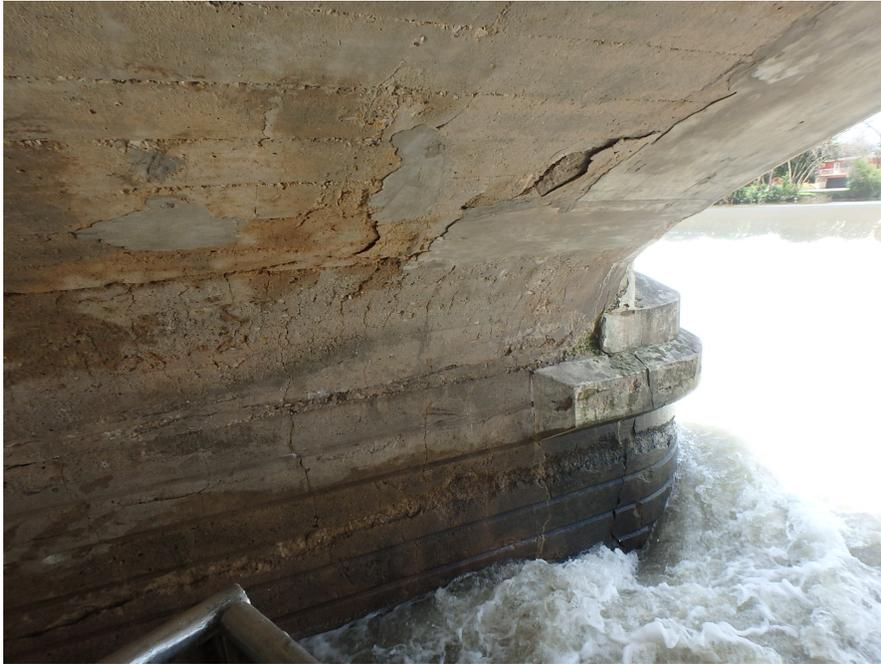
Photo Number: 79

LOOKING SOUTH, WEST END OF NORTH PIER

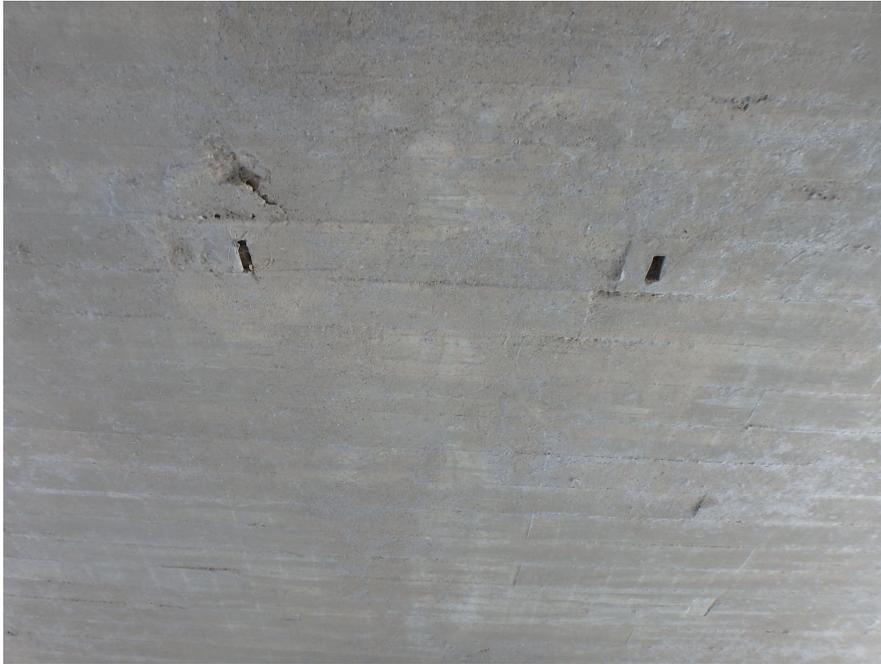
Photo Number: 81

TYPICAL FORM BOARD HOLES

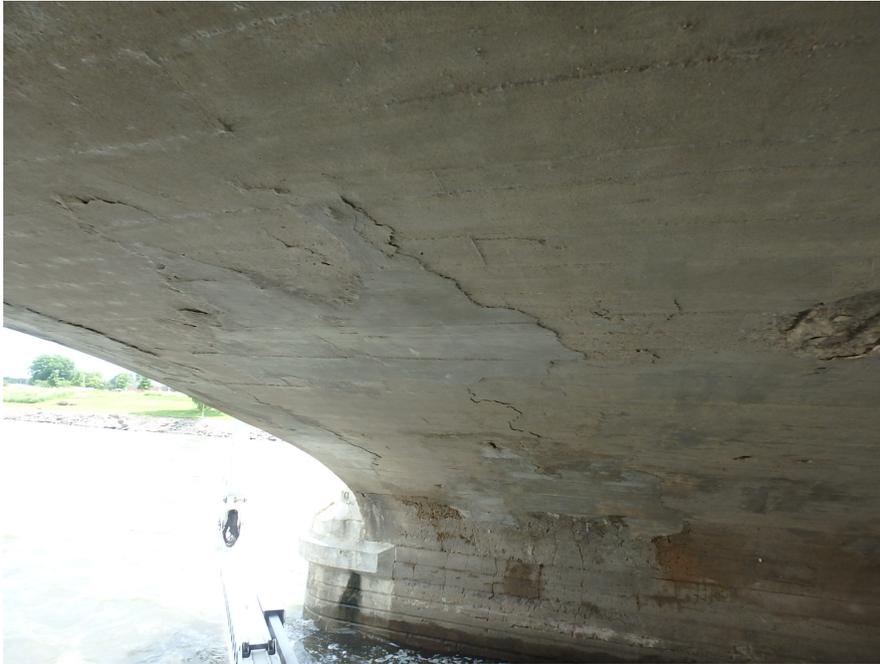
Photo Number: 85

FORM WORK HOLE, NORTH SPAN, EAST PORTION OF ARCH

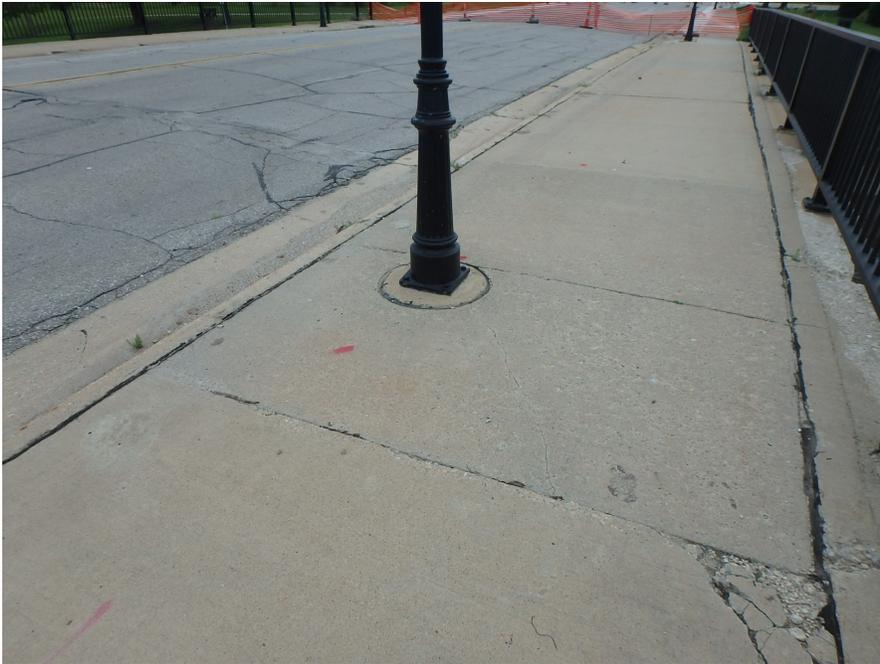
Photo Number: 96

CRACKED SIDEWALK OVER SOUTH PIER

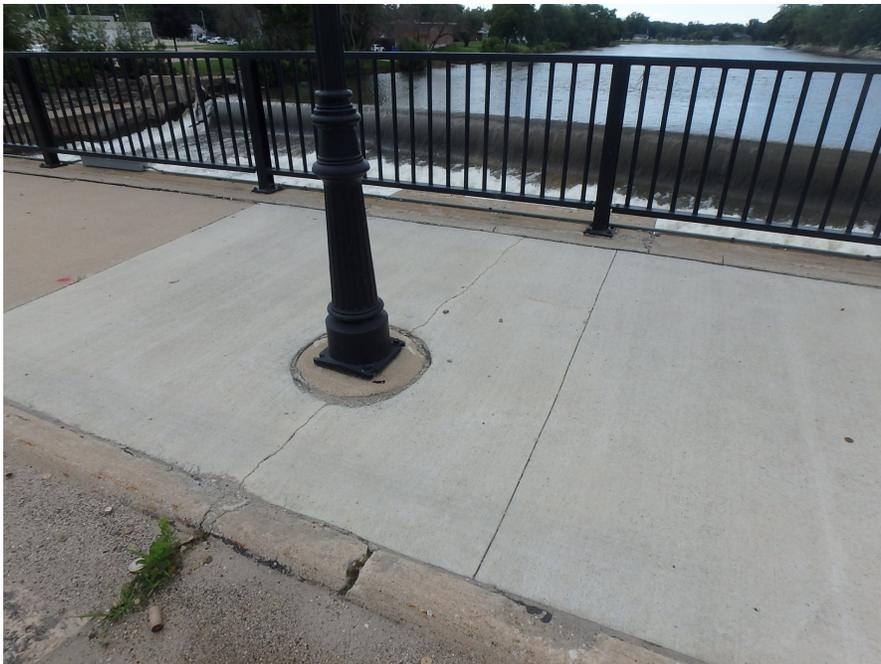
Photo Number: 98

CRACKED SIDEWALK OVER NORTH PIER

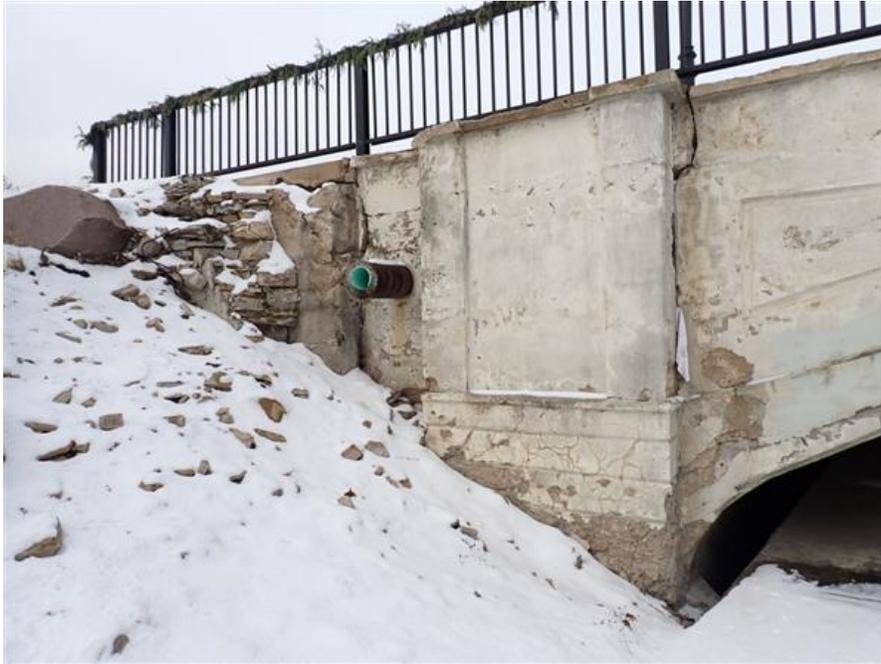
Photo Number: 5

DETERIORATED SOUTHEAST WING

| Wings | 3 | SPALLS SW.. SE. -- JACKET POURED AT NW.. CRACKS WITH EFFLORESCENCE |

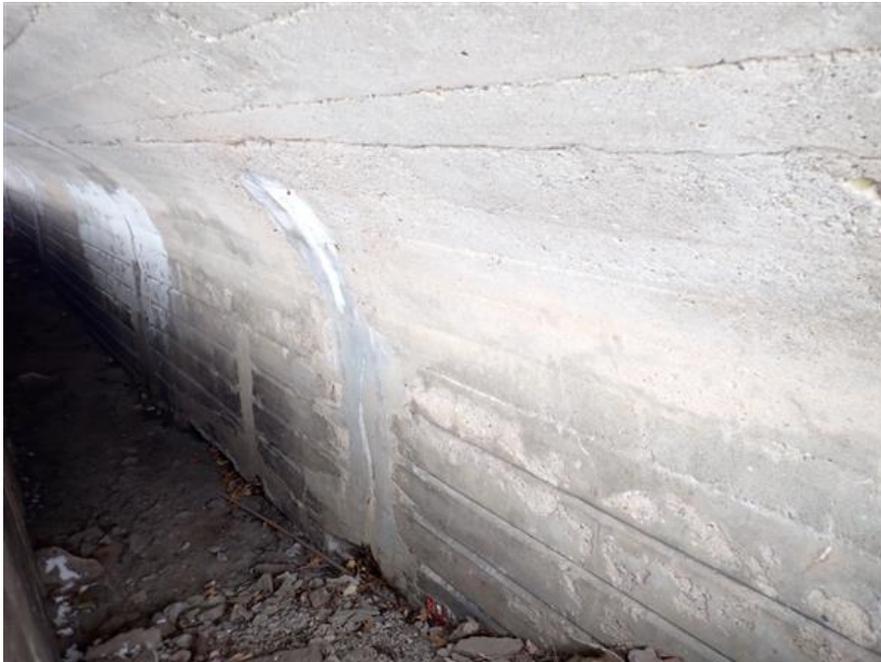
Photo Number: 6

SOUTH ABUTMENT SPRINGLINE DETERIORATION

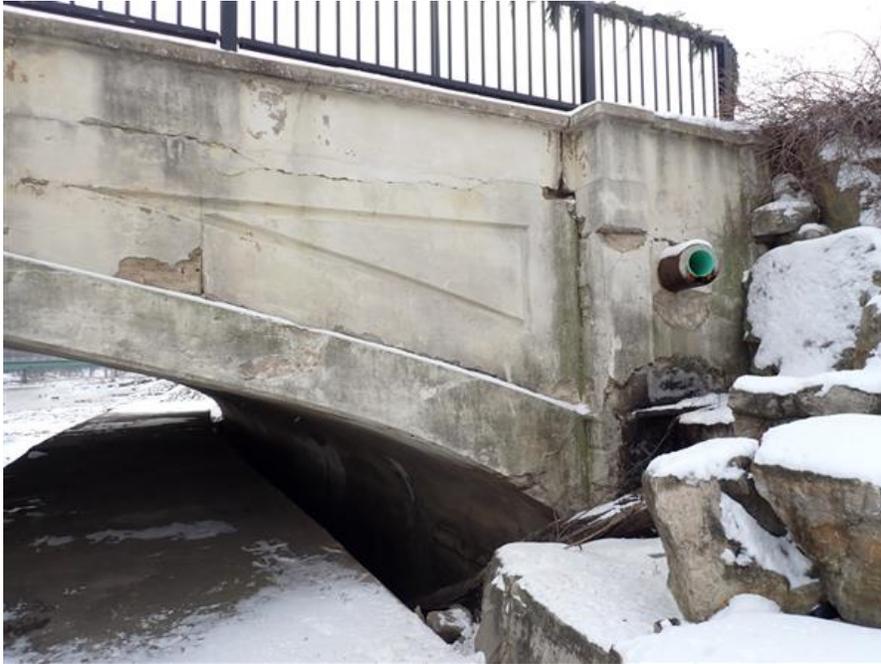
Photo Number: 7

DETERIORATED SOUTHWEST WING

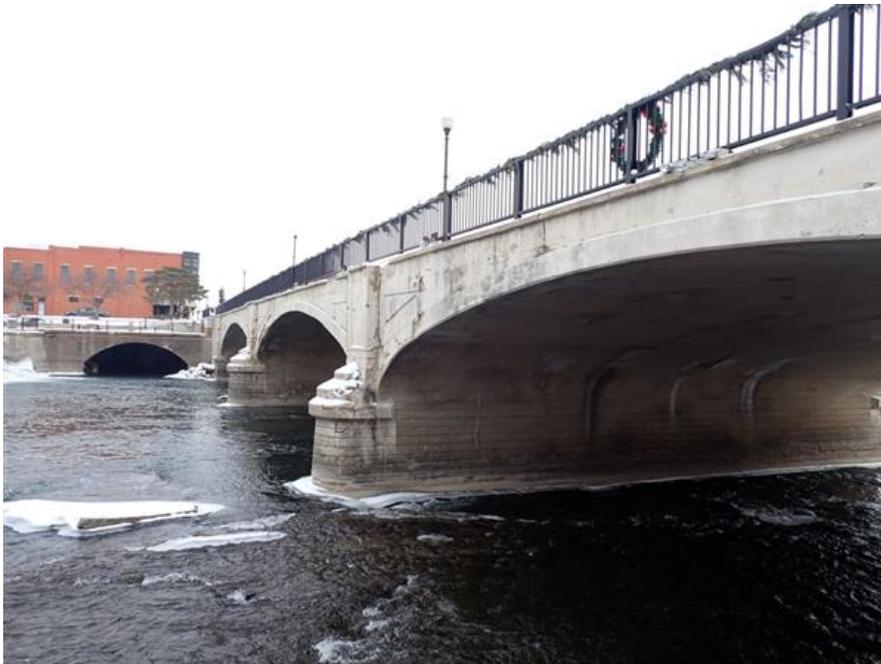
Photo Number: 8

DETERIORATED WEST FACIA

| <u>SUPERSTRUCTURE ITEMS</u> | <u>RATING</u> | <u>REMARKS</u> |
|---|---|---|
| 11. Concrete Cracking | <u>4</u> | <u>IN ARCHES. FASCIA WALLS SPALLING AND STARTING TO LOSE FILL</u> |

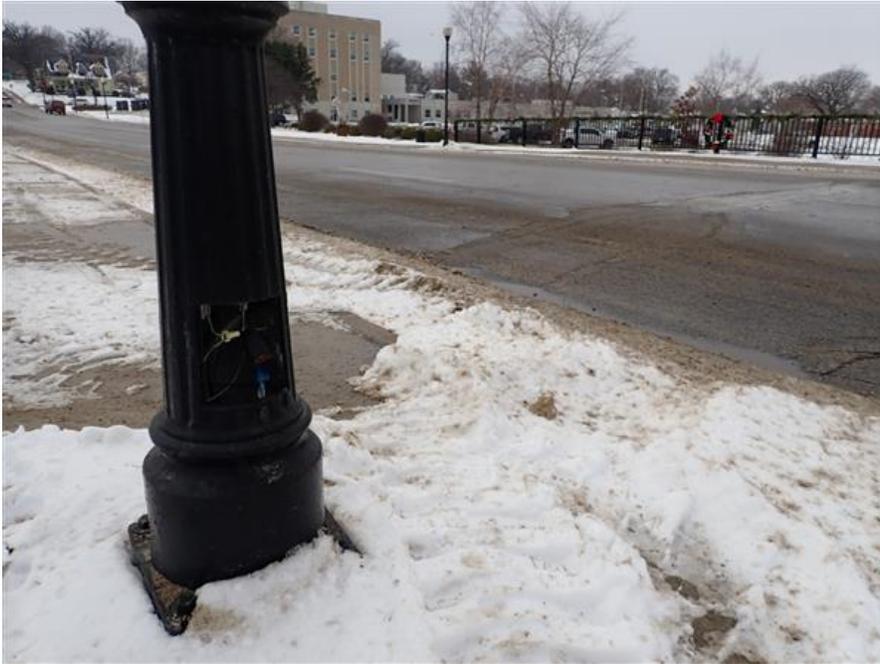
Photo Number: 9

MISSING COVER ON LIGHT STANDARD, 2ND FROM SOUTH AT EAST

| <u>DECK ITEMS</u> | <u>RATING</u> | <u>REMARKS</u> |
|---|---|---|
| 9. Utility Connections | <u>5</u> | <u>ALONG W. EDGE, MISSING COVER PLATE 2ND F.S. AT E.</u> |

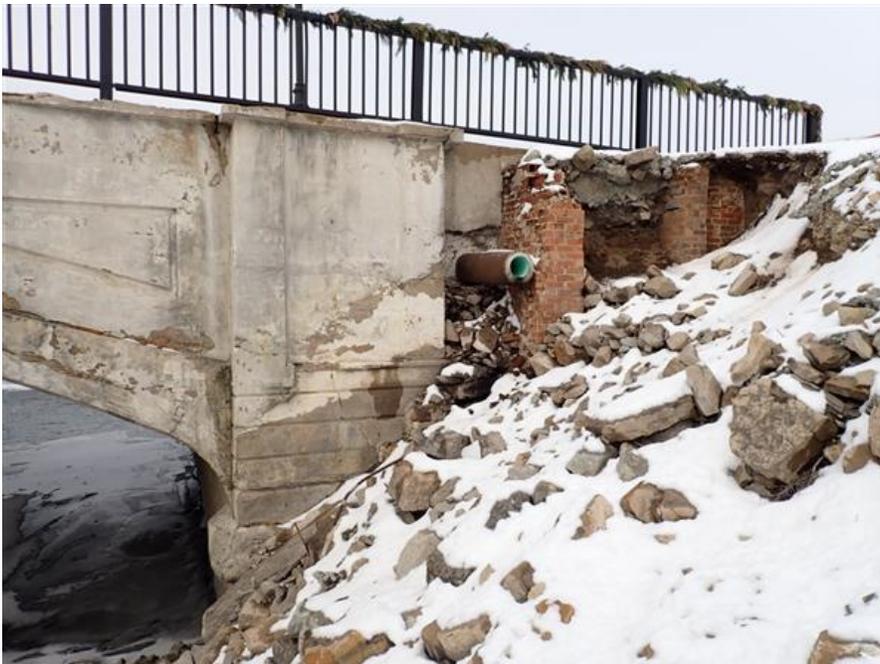
Photo Number: 10

DETERIORATED NORTHEAST WING

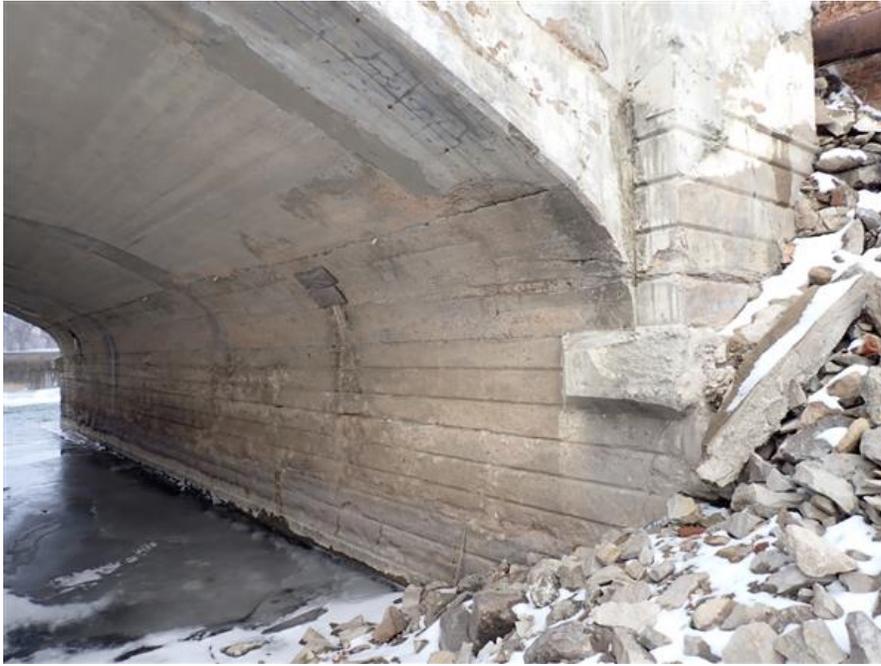
Photo Number: 11

NORTH ABUTMENT SPRINGLINE DETERIORATION

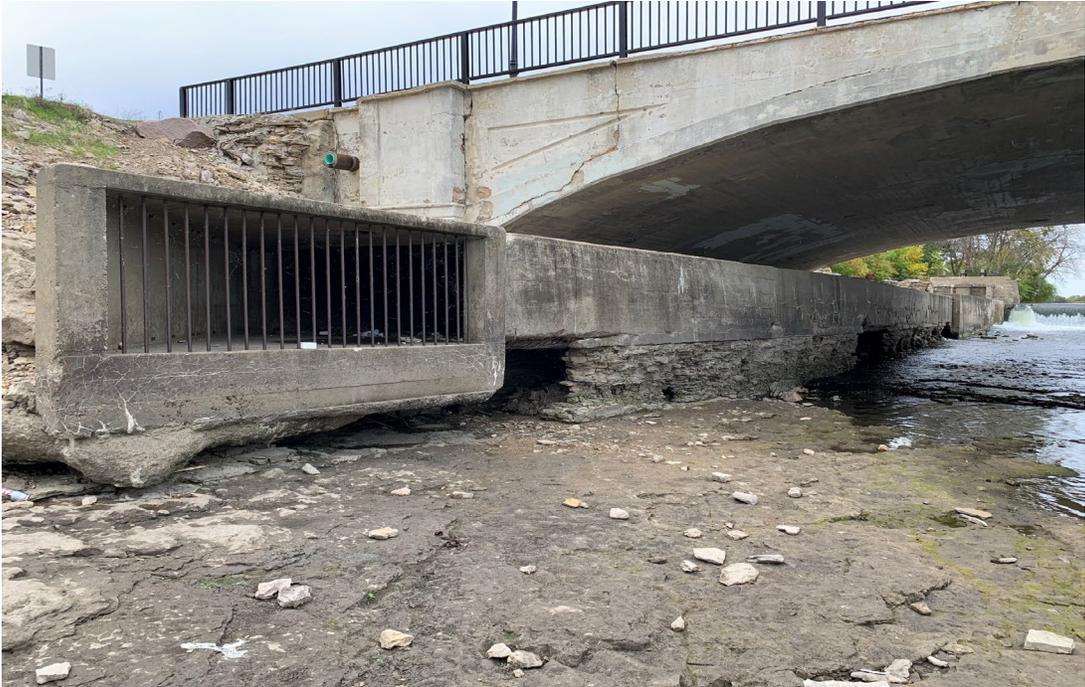
UNDERMINED OUTLET OF SOUTH BANK FLUME

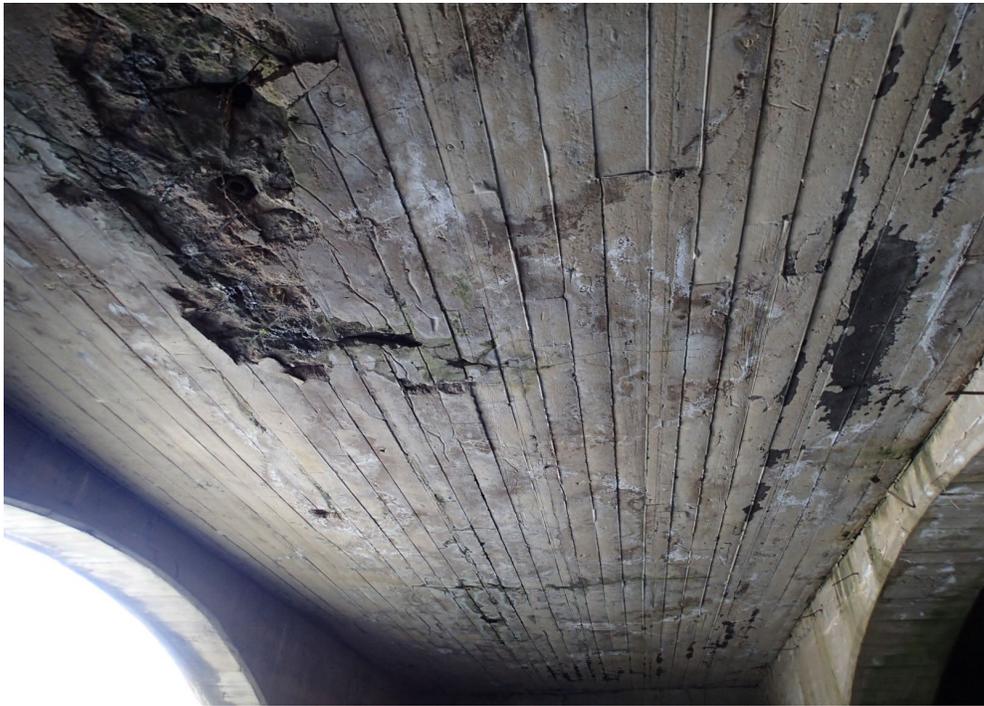
HEAVING LEACHING AND SPALLING SLAB WITH CORRODED REINFORCING

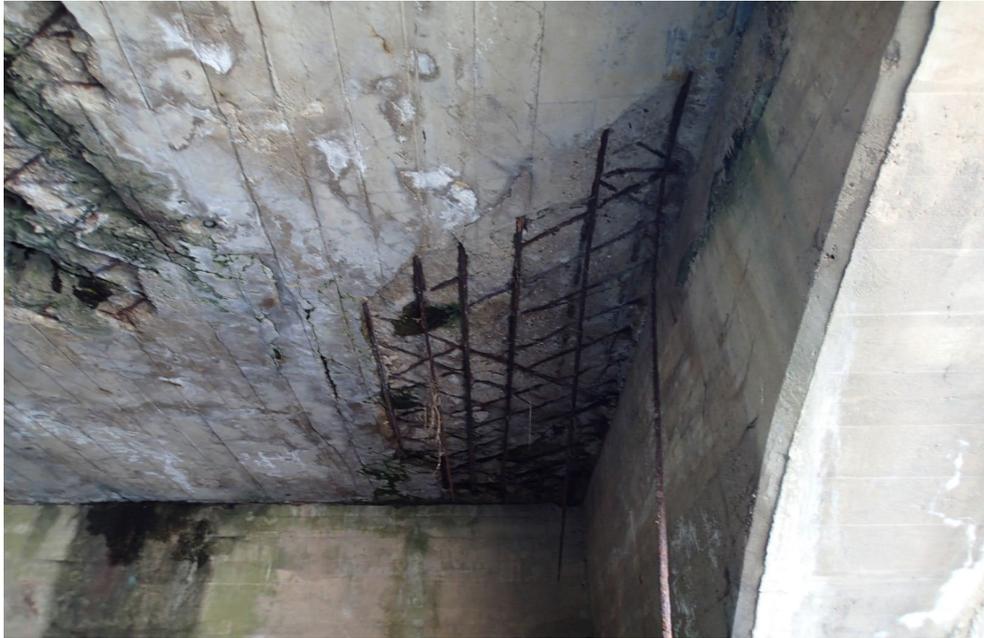
HEAVY LEACHING AND SPALLING SLAB WITH CORRODED REINFORCING

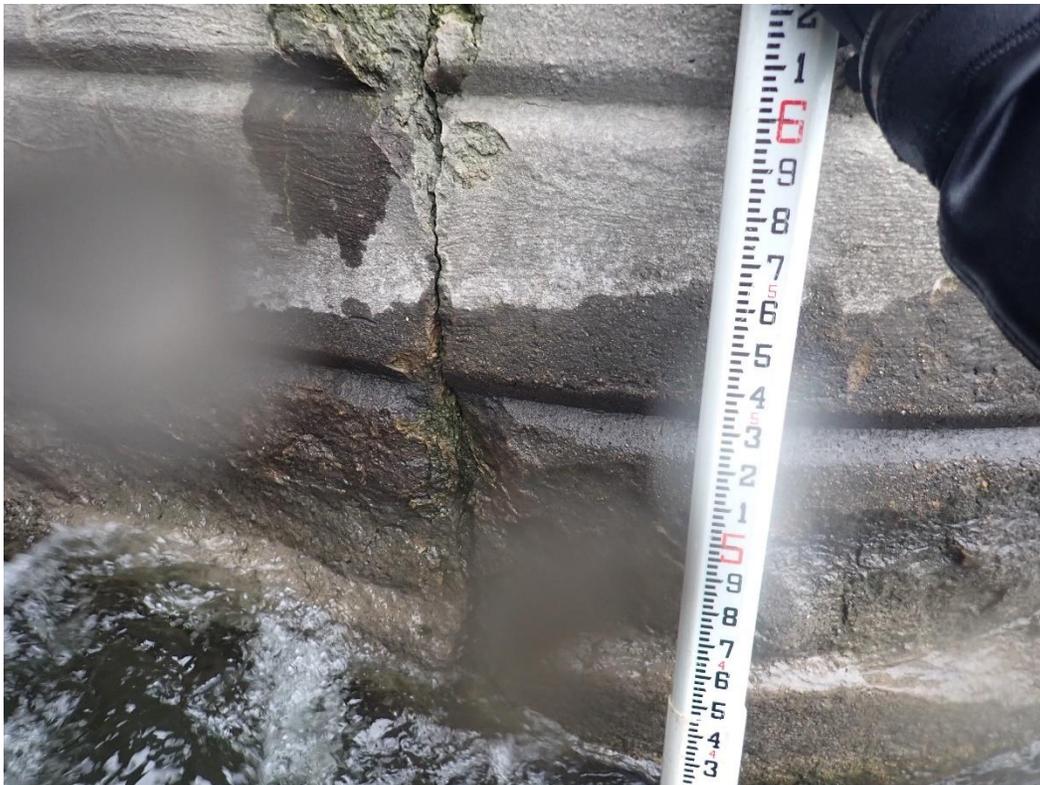
PHOTO 31. NORTH PIER UPSTREAM END VERTICAL CRACK LOOKING SOUTHEAST

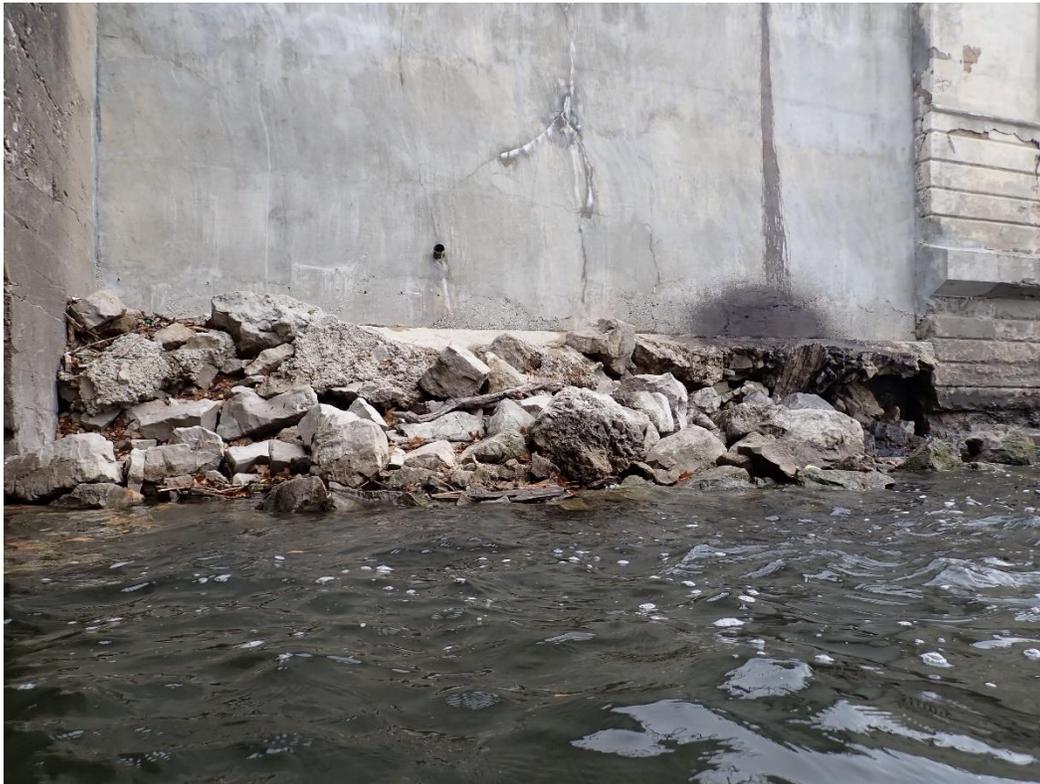
PHOTO 36. NORTHWEST WINGWALL CONDITION LOOKING EAST

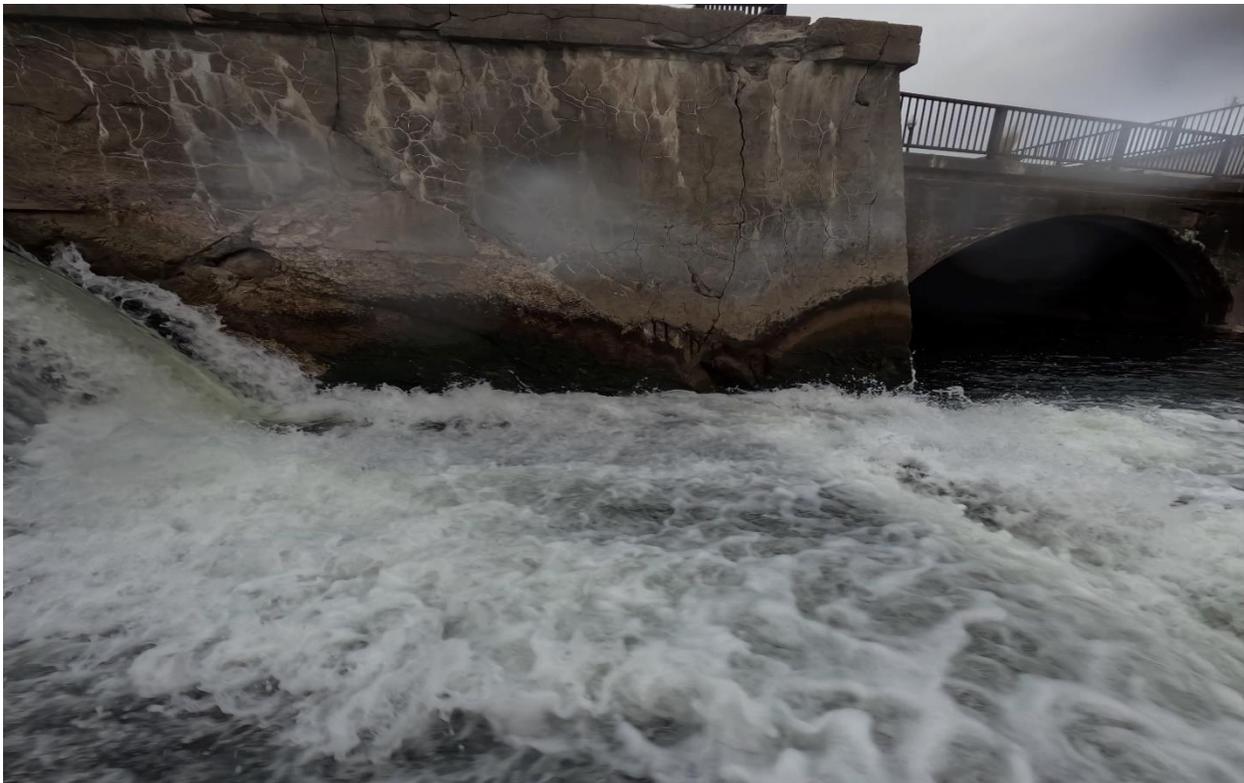
PHOTO 42. AREA OF HEAVY SCALING ON THE NORTH RETAINING WALL ADJACENT TO THE DAM LOOKING NORTH

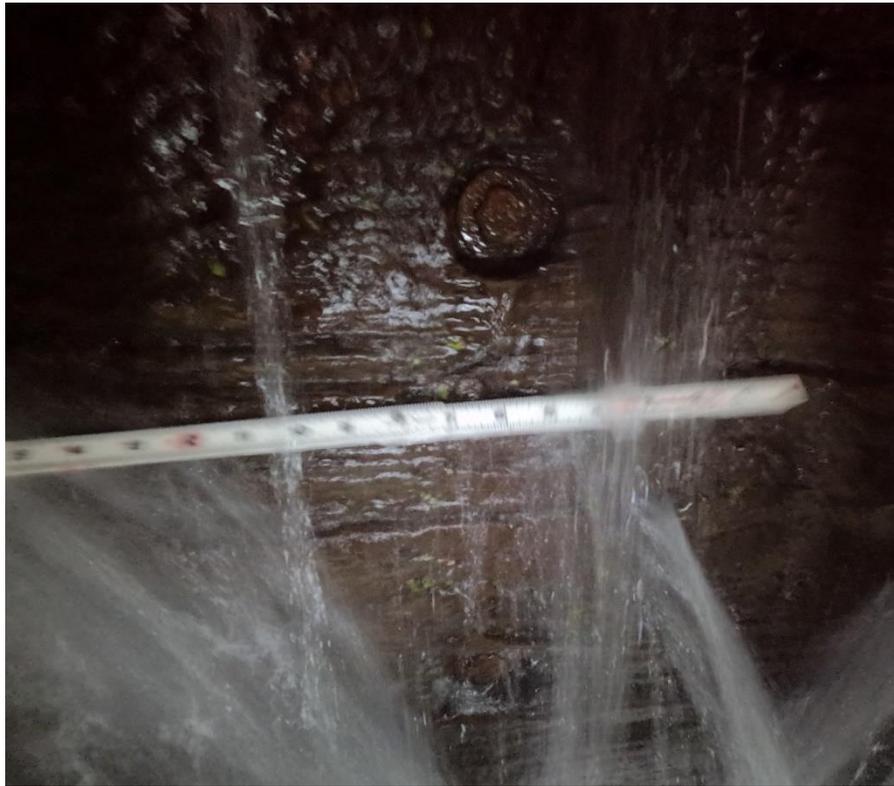
PHOTO 49. TYPICAL TIMBER INLET GATE CONDITION LOOKING WEST

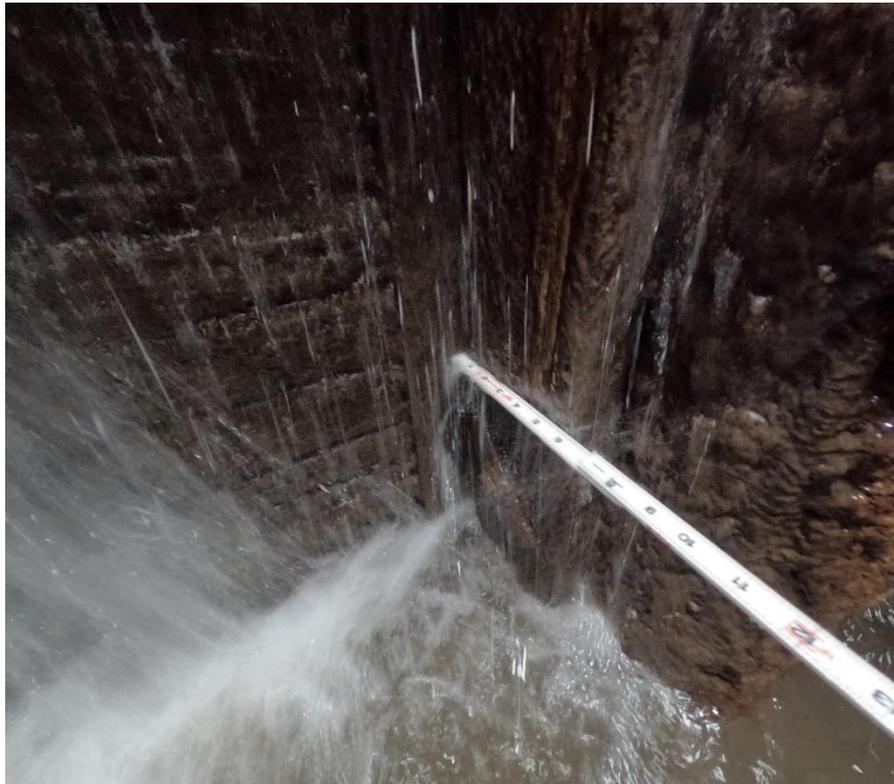
PHOTO 51. HEAVY SEEPAGE THROUGH INLET GATE AT NORTH END LOOKING NORTHWEST

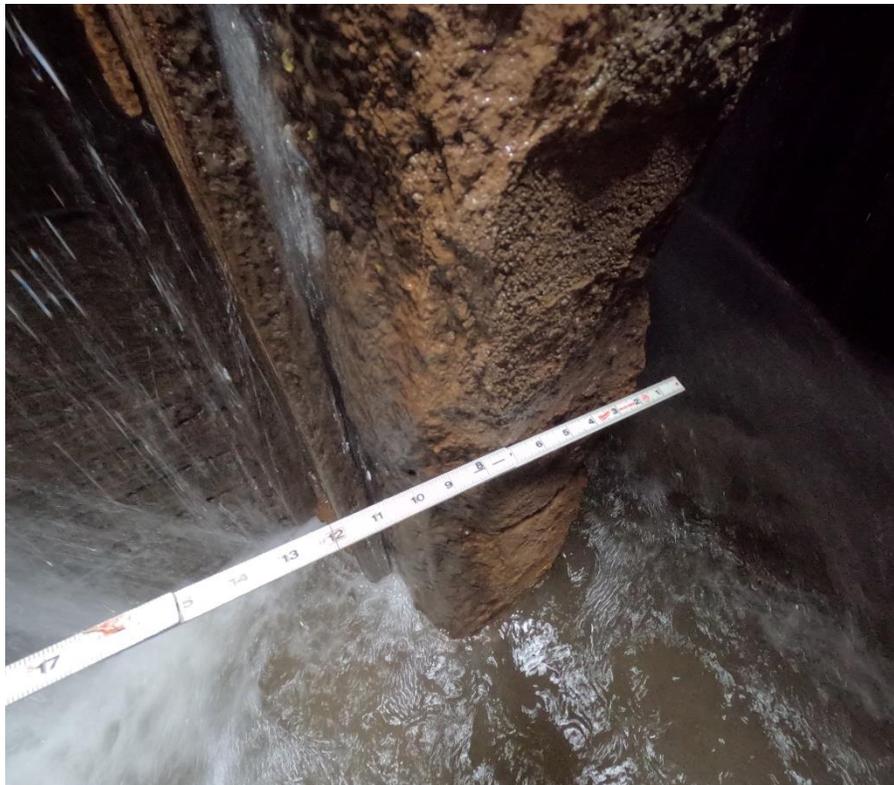
PHOTO 52. SCALING OF VERTICAL CONCRETE INLET GATE SUPPORTS LOOKING WEST

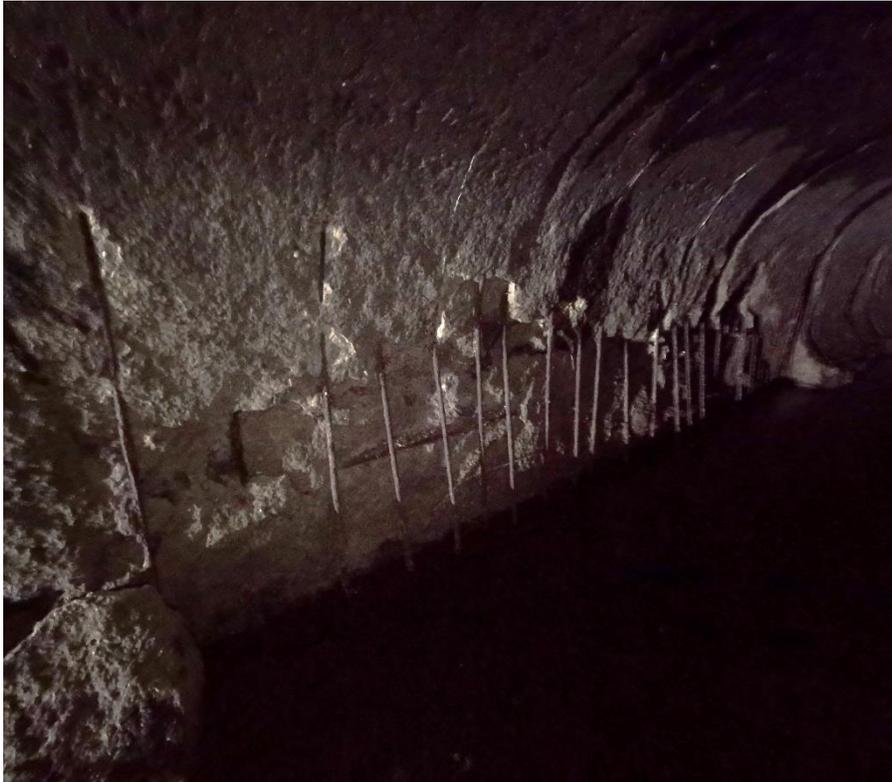
PHOTO 53. HEAVY SCALING IN SOUTH WALL NEAR INLET LOOKING SOUTHWEST
