**MAIN STREET BRIDGE FEASIBILITY
FHWA NO. 001820**

**RE: FEASIBILITY STUDY
MAIN STREET BRIDGE IN CHARLES CITY
OVER CEDAR RIVER
FHWA No. 001820
CB&A No. 2022192**

STRUCTURE CONDITION REPORT
BRIDGE (001820), DAM, FLUME AND
FLOUR MILL FOUNDATION
MAIN STREET over CEDAR RIVER

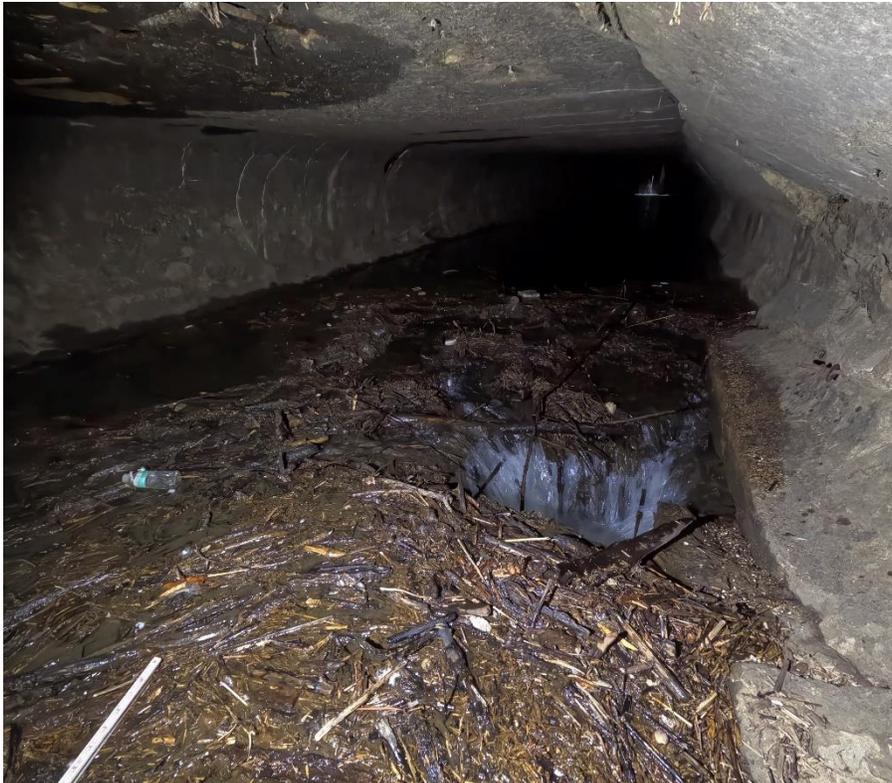
PHOTO 54. TIMBER DEBRIS AND FLOOR THROUGH HOLE LOOKING WEST

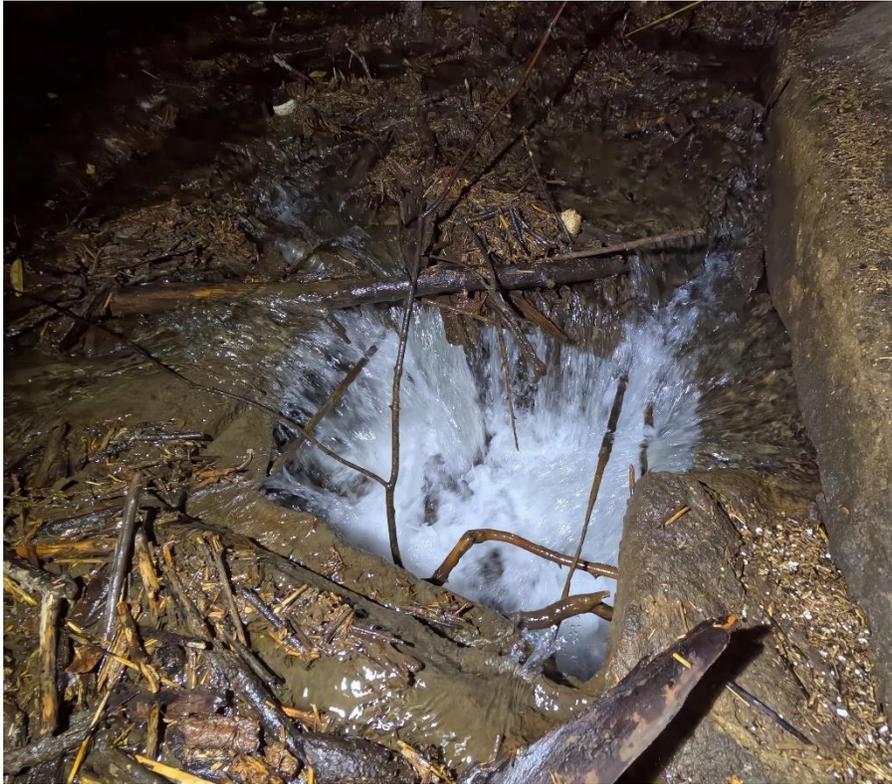
PHOTO 55. FLOOR THROUGH HOLE LOOKING WEST

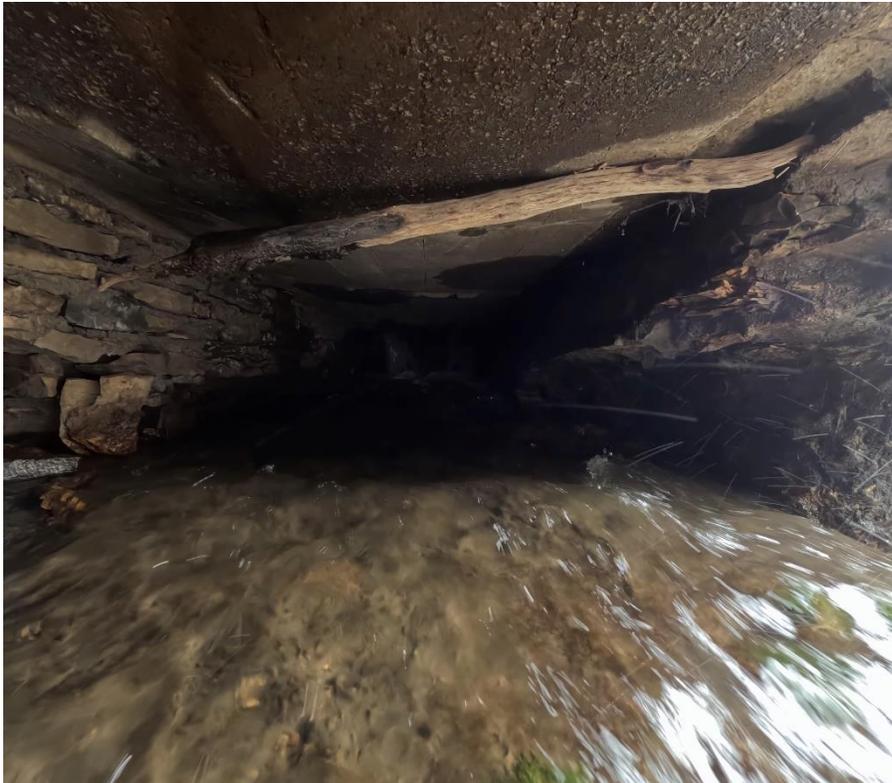
PHOTO 56. UNDERMINING NEAR FLOOR THROUGH HOLE LOOKING WEST

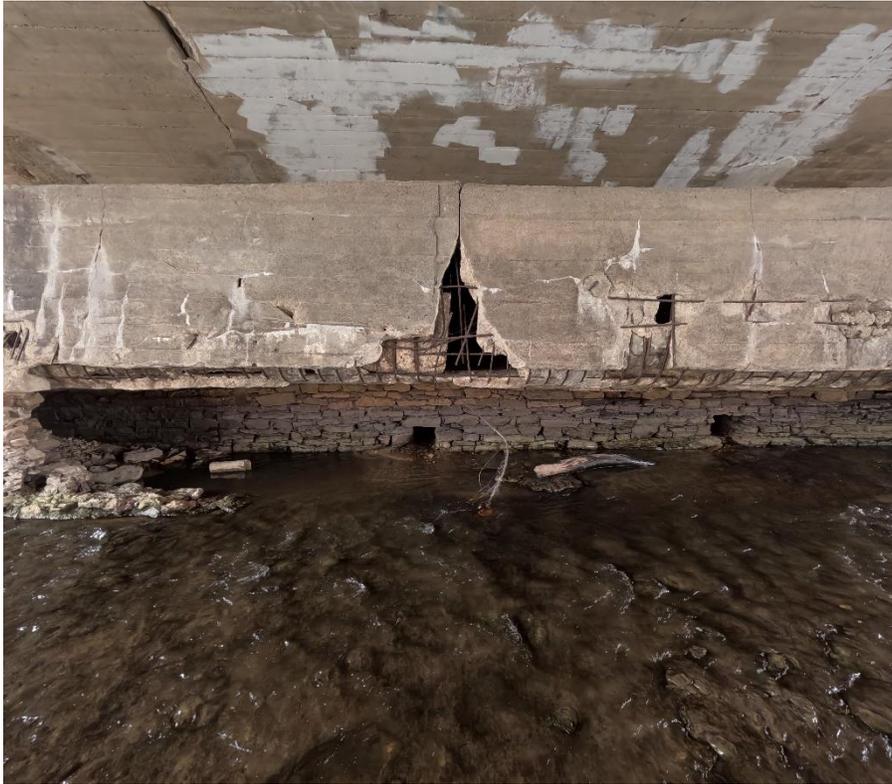
PHOTO 65. FRACTURE 50 FEET FROM OUTLET LOOKING SOUTH

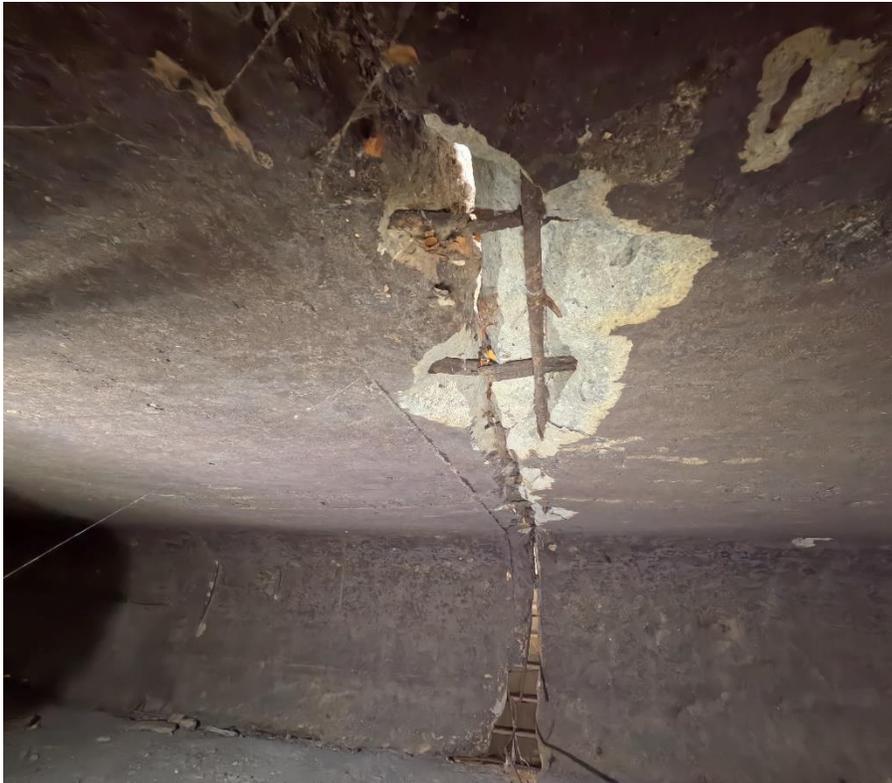
PHOTO 66. FRACTURE 50 FEET FROM OUTLET LOOKING SOUTH

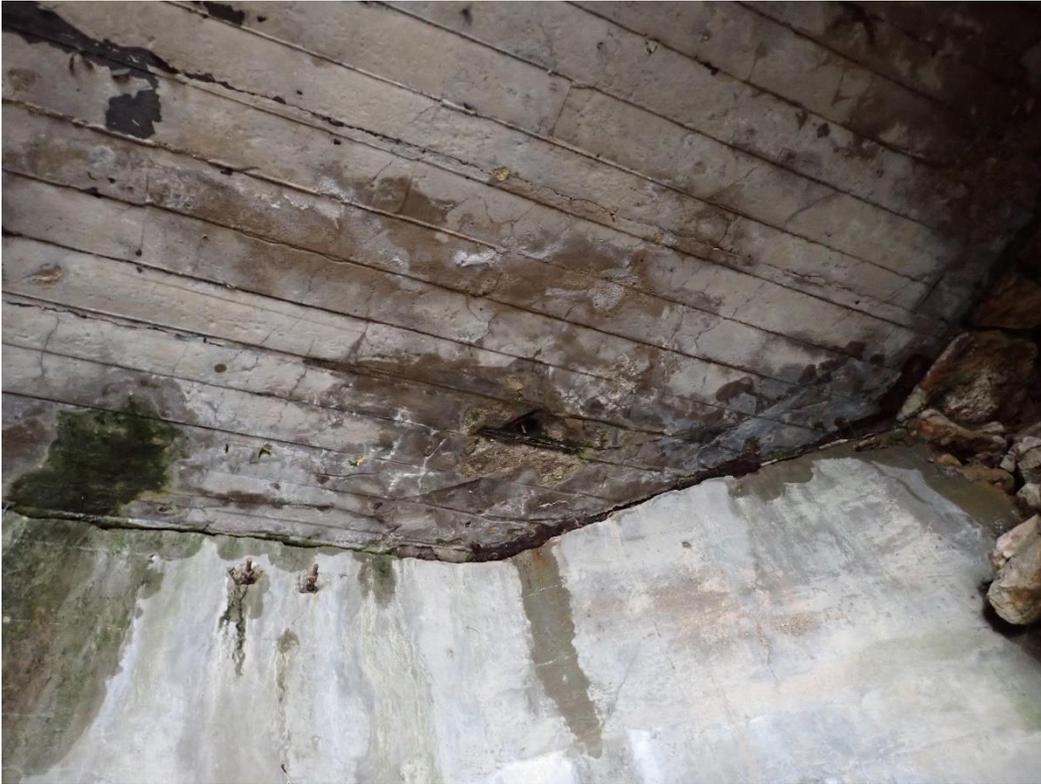
PHOTO 83. FLOUR MILL NORTH BAY CEILING TYPICAL CONDITION LOOKING NORTHEAST

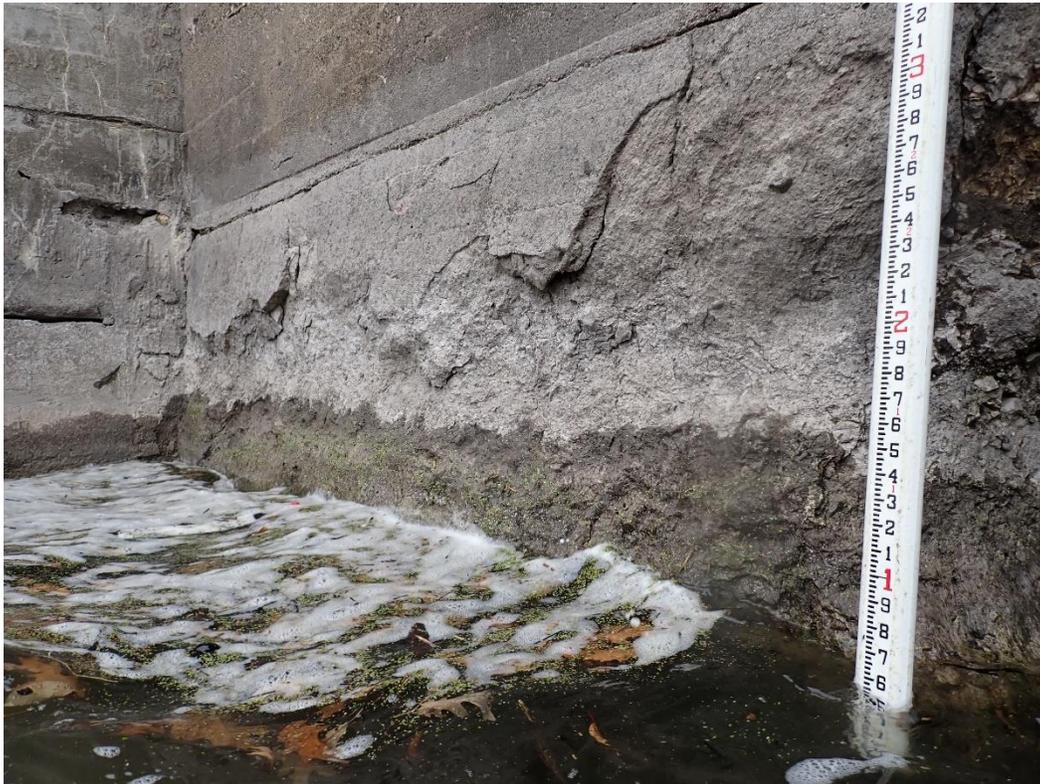
PHOTO 89. FLOUR MILL SOUTHWEST CORNER (SOUTH FACE) SECTION LOSS LOOKING NORTHWEST

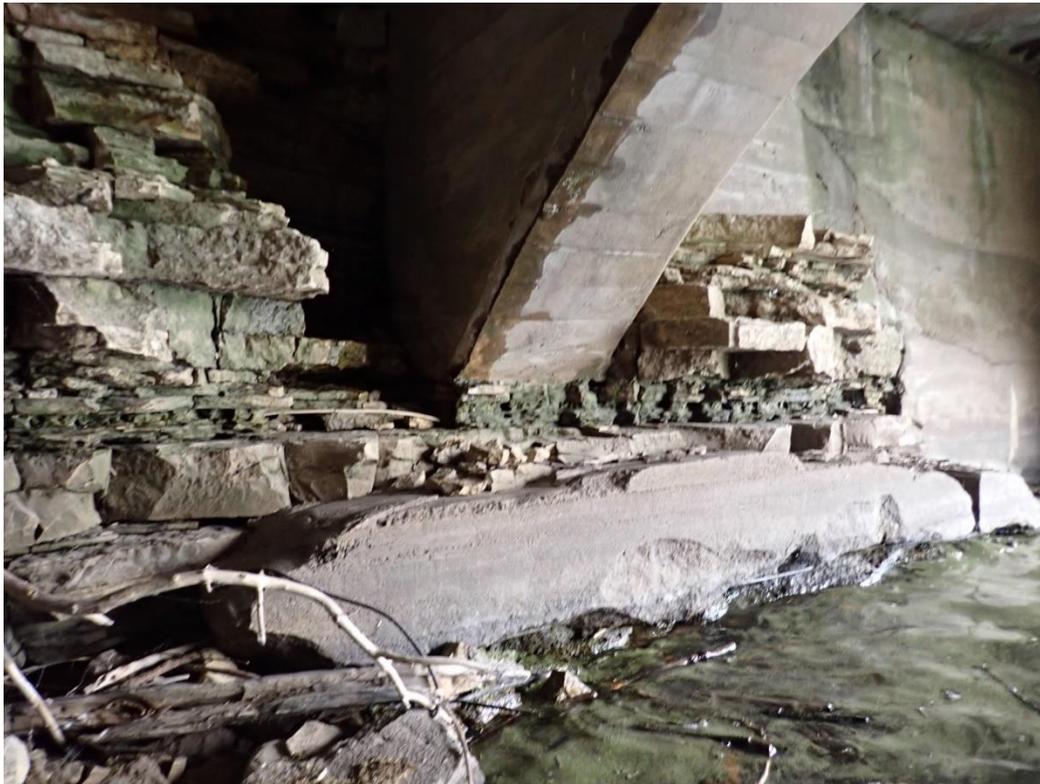
PHOTO 91. FLOUR MILL NORTH ARCH EAST END FOUNDATION LOOKING SOUTHEAST

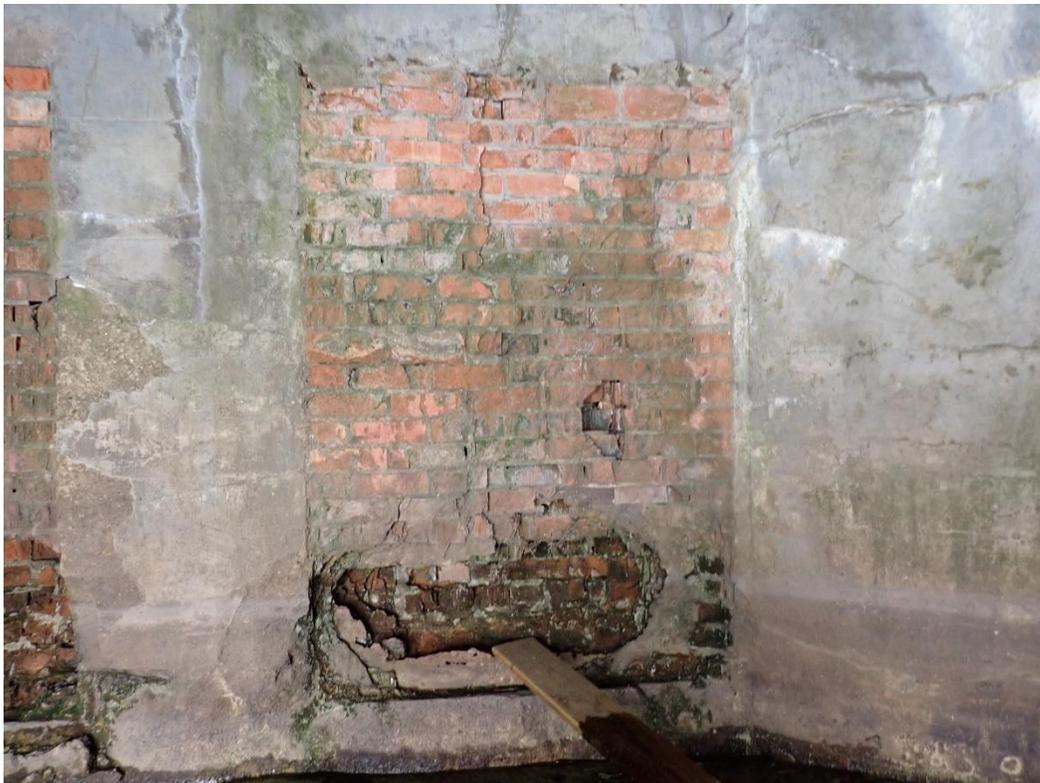
PHOTO 96. FLOUR MILL NORTH WALL TYPICAL MASONRY FILLED OUTTAKE LOOKING NORTH

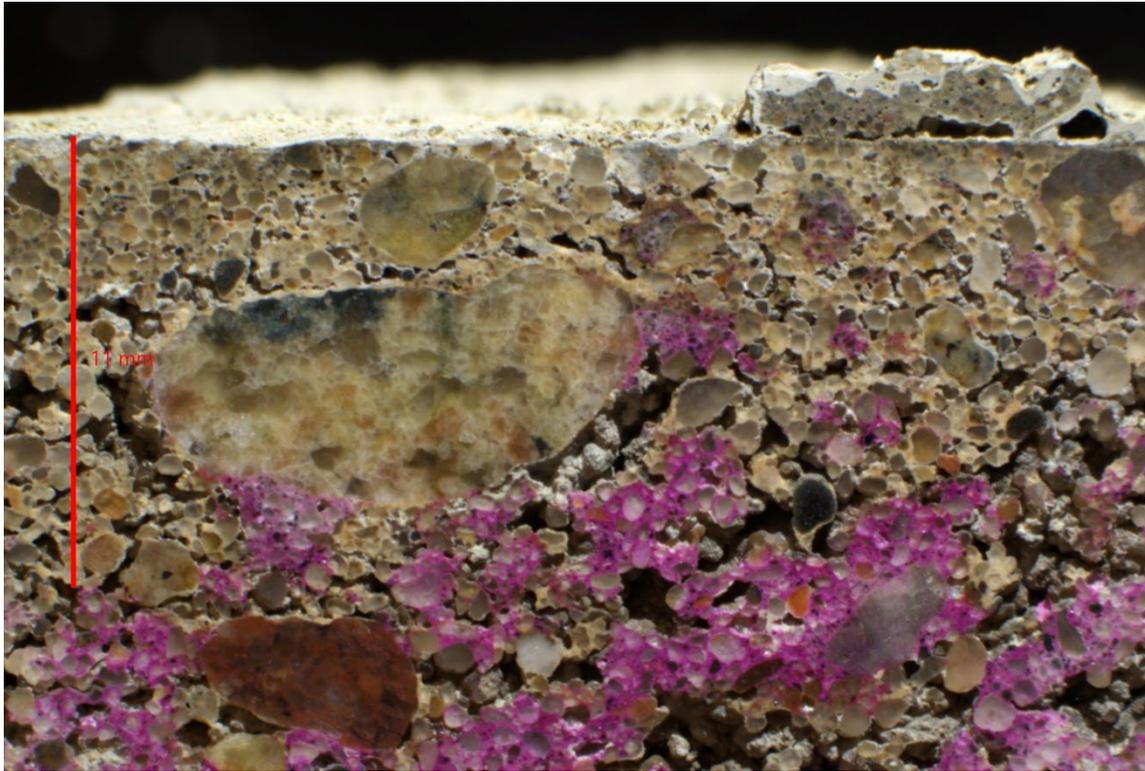
Photo: 19

1B
5x

Description: Carbonation (unstained paste) proceeded up to 11 mm (7/16") from the outer surface (top); on a saw-cut and lapped cross section of the core sample after application of phenolphthalein pH indicator (pink stain). Note the consolidation voids.

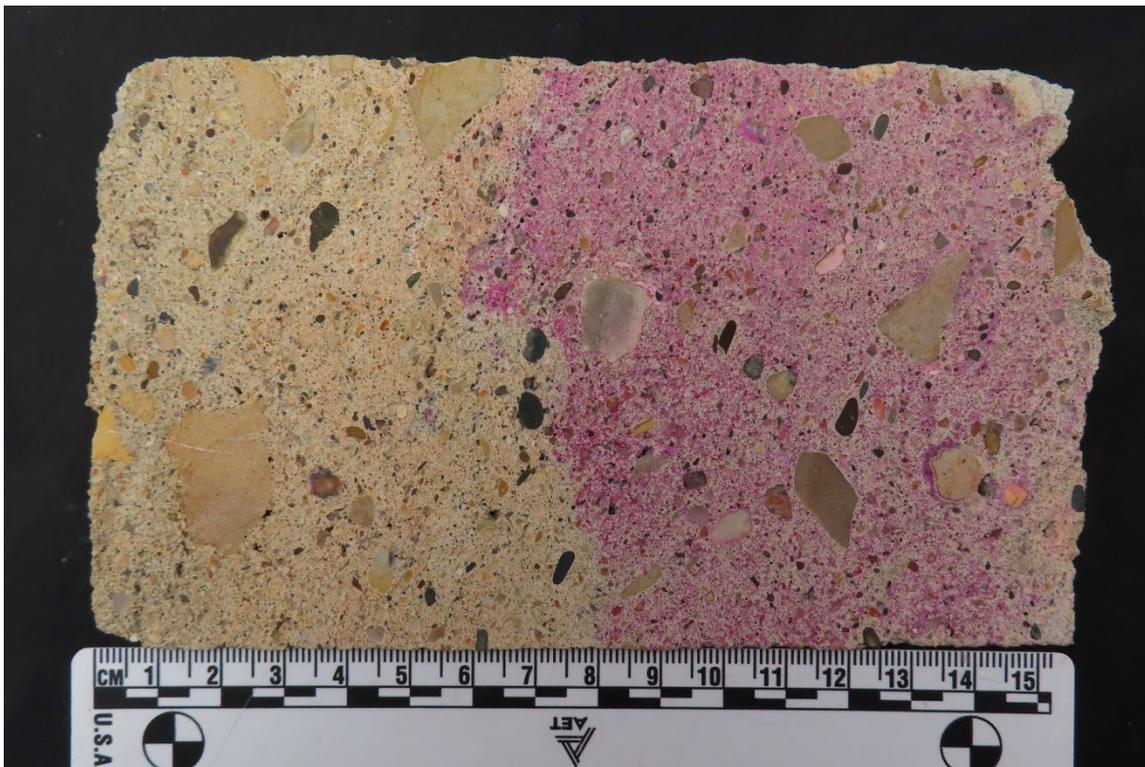
Photo: 22

4B

Description: Carbonation (unstained paste) proceeded up to 80 mm (3-1/8") from the outer surface (oriented left) of the concrete.
